I-110 to Davis Highway

Existing Site Conditions

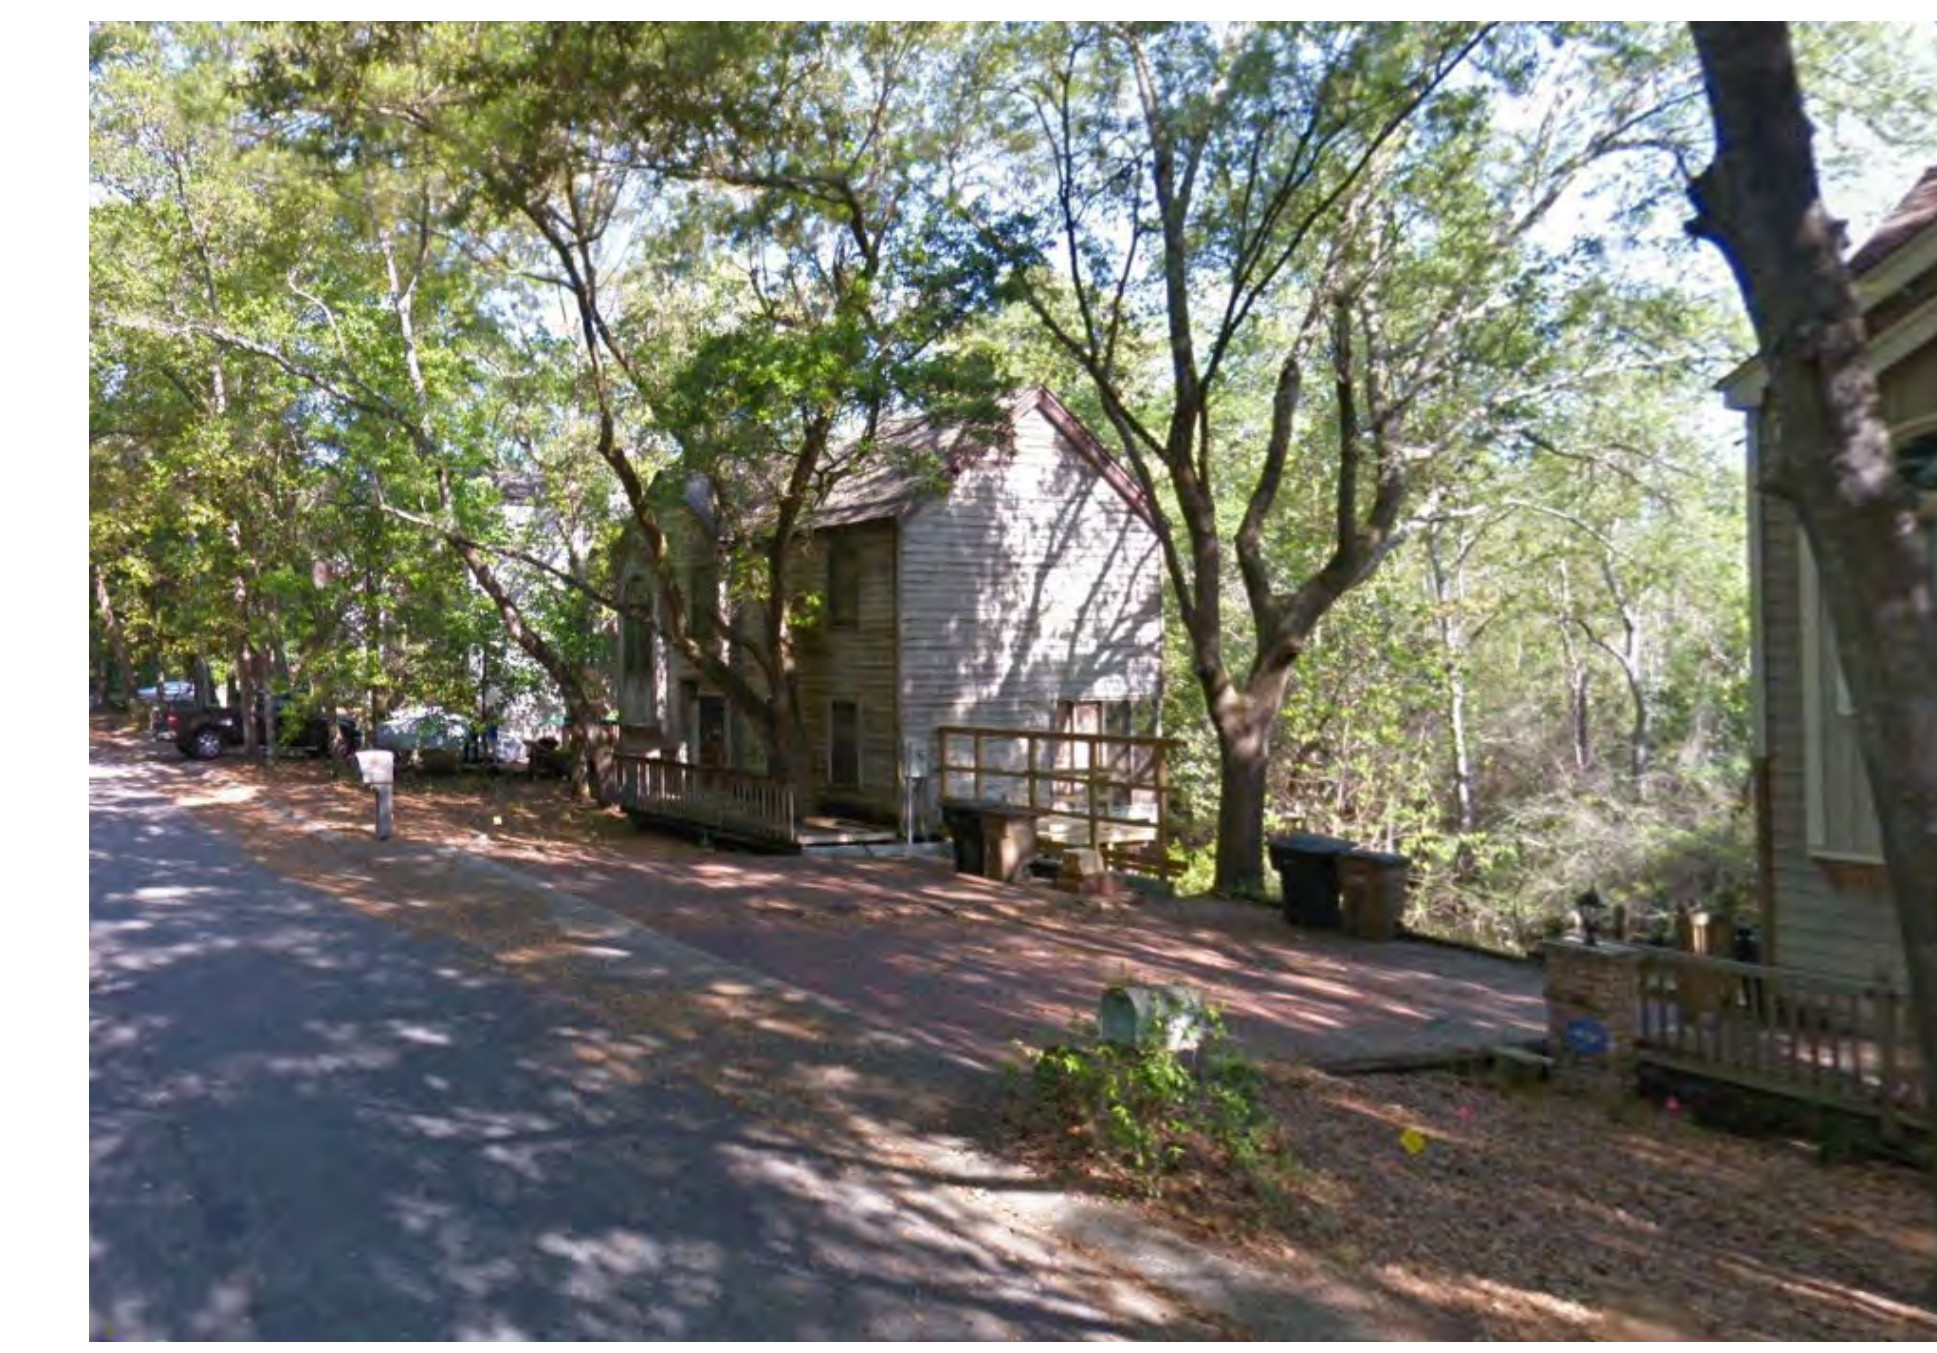
4 Creek-facing homes along Walton St vulnerable to property damage due to erosion and slope bank failure.

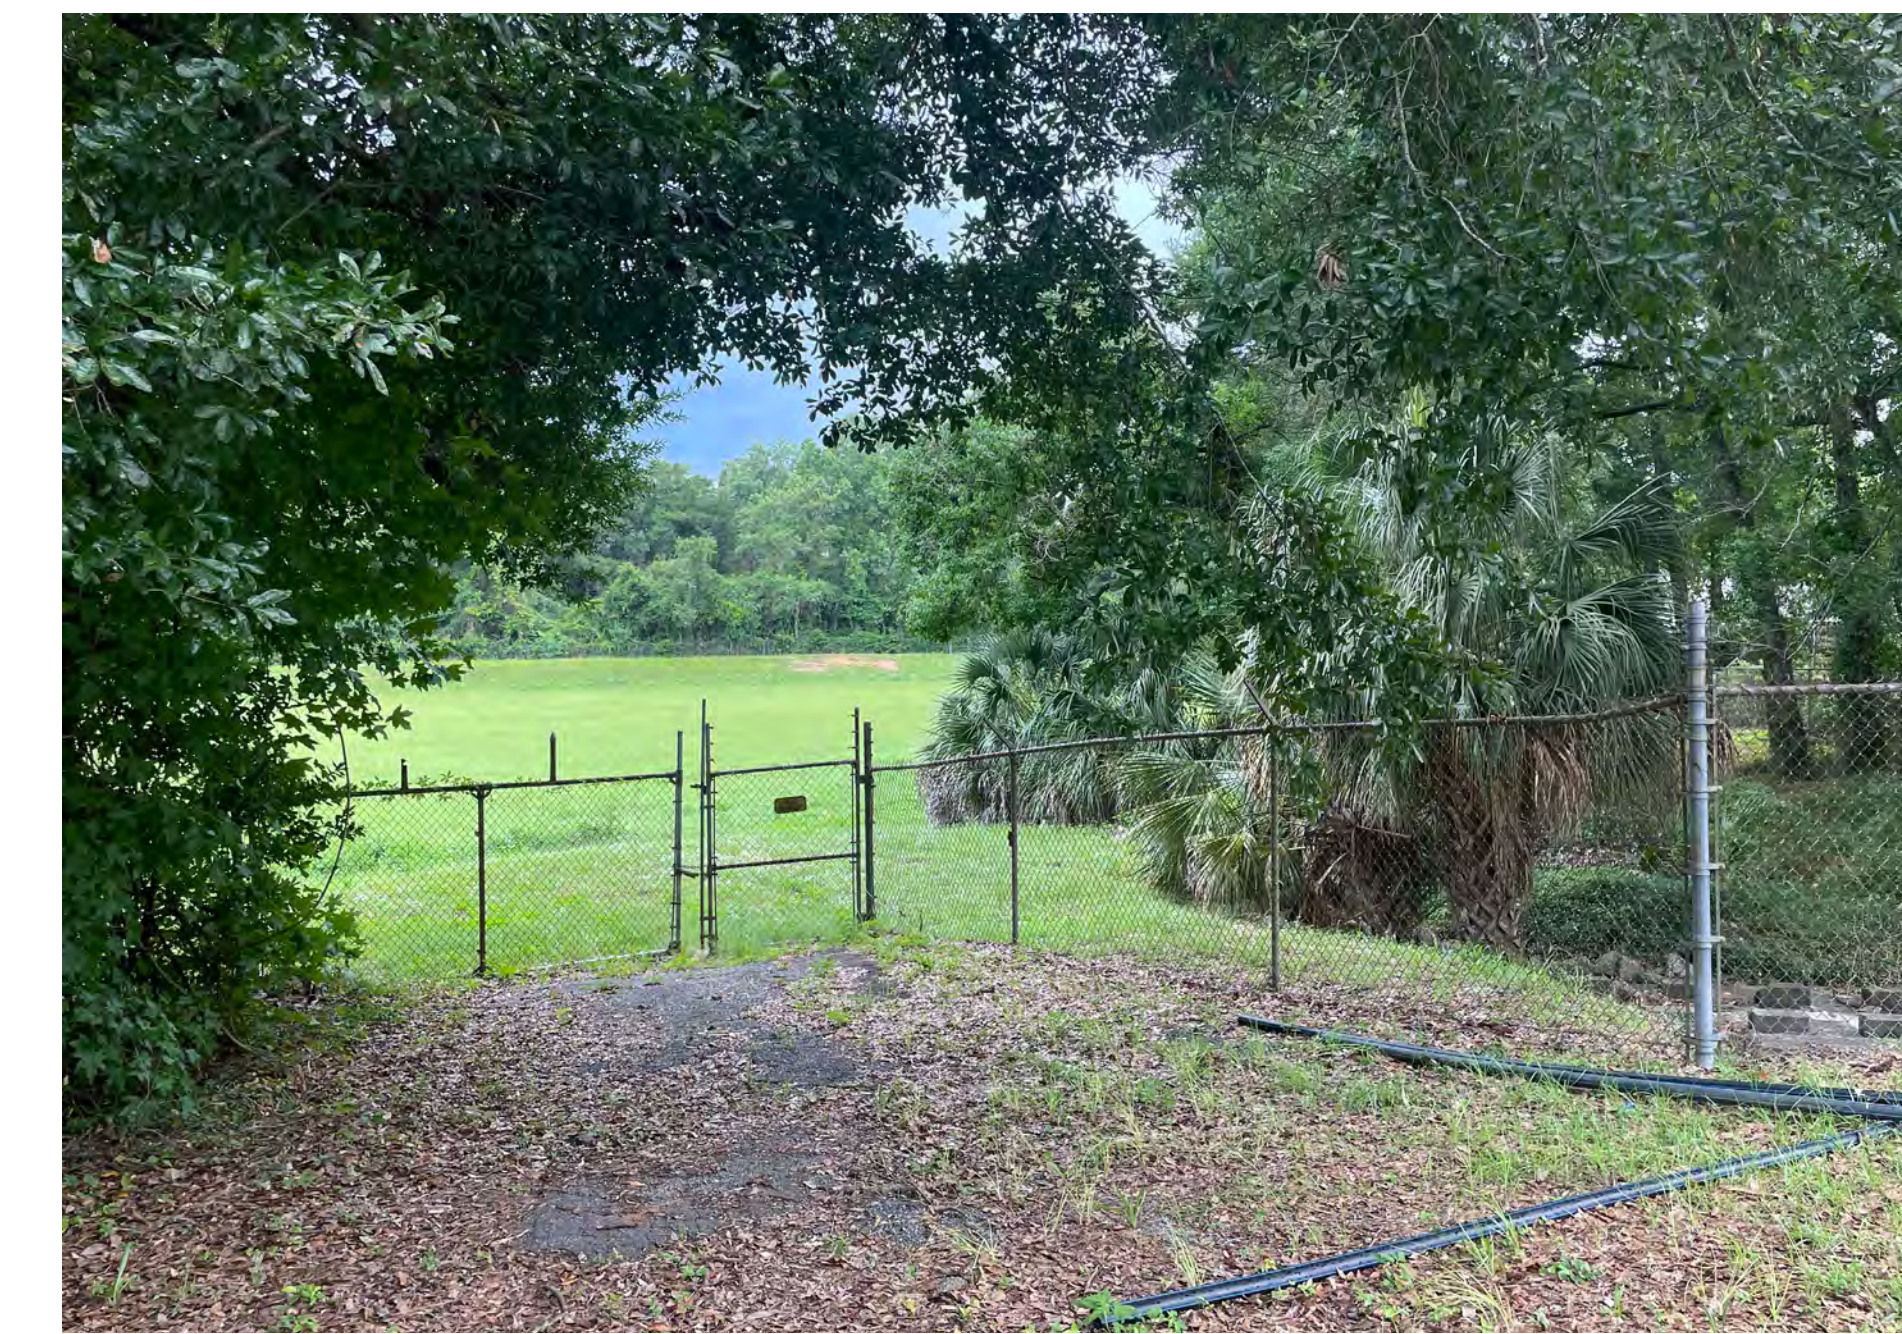
1 Stormwater Pond bordering the creek as seen from Hermitage Drive, site of WMP access recommendations.

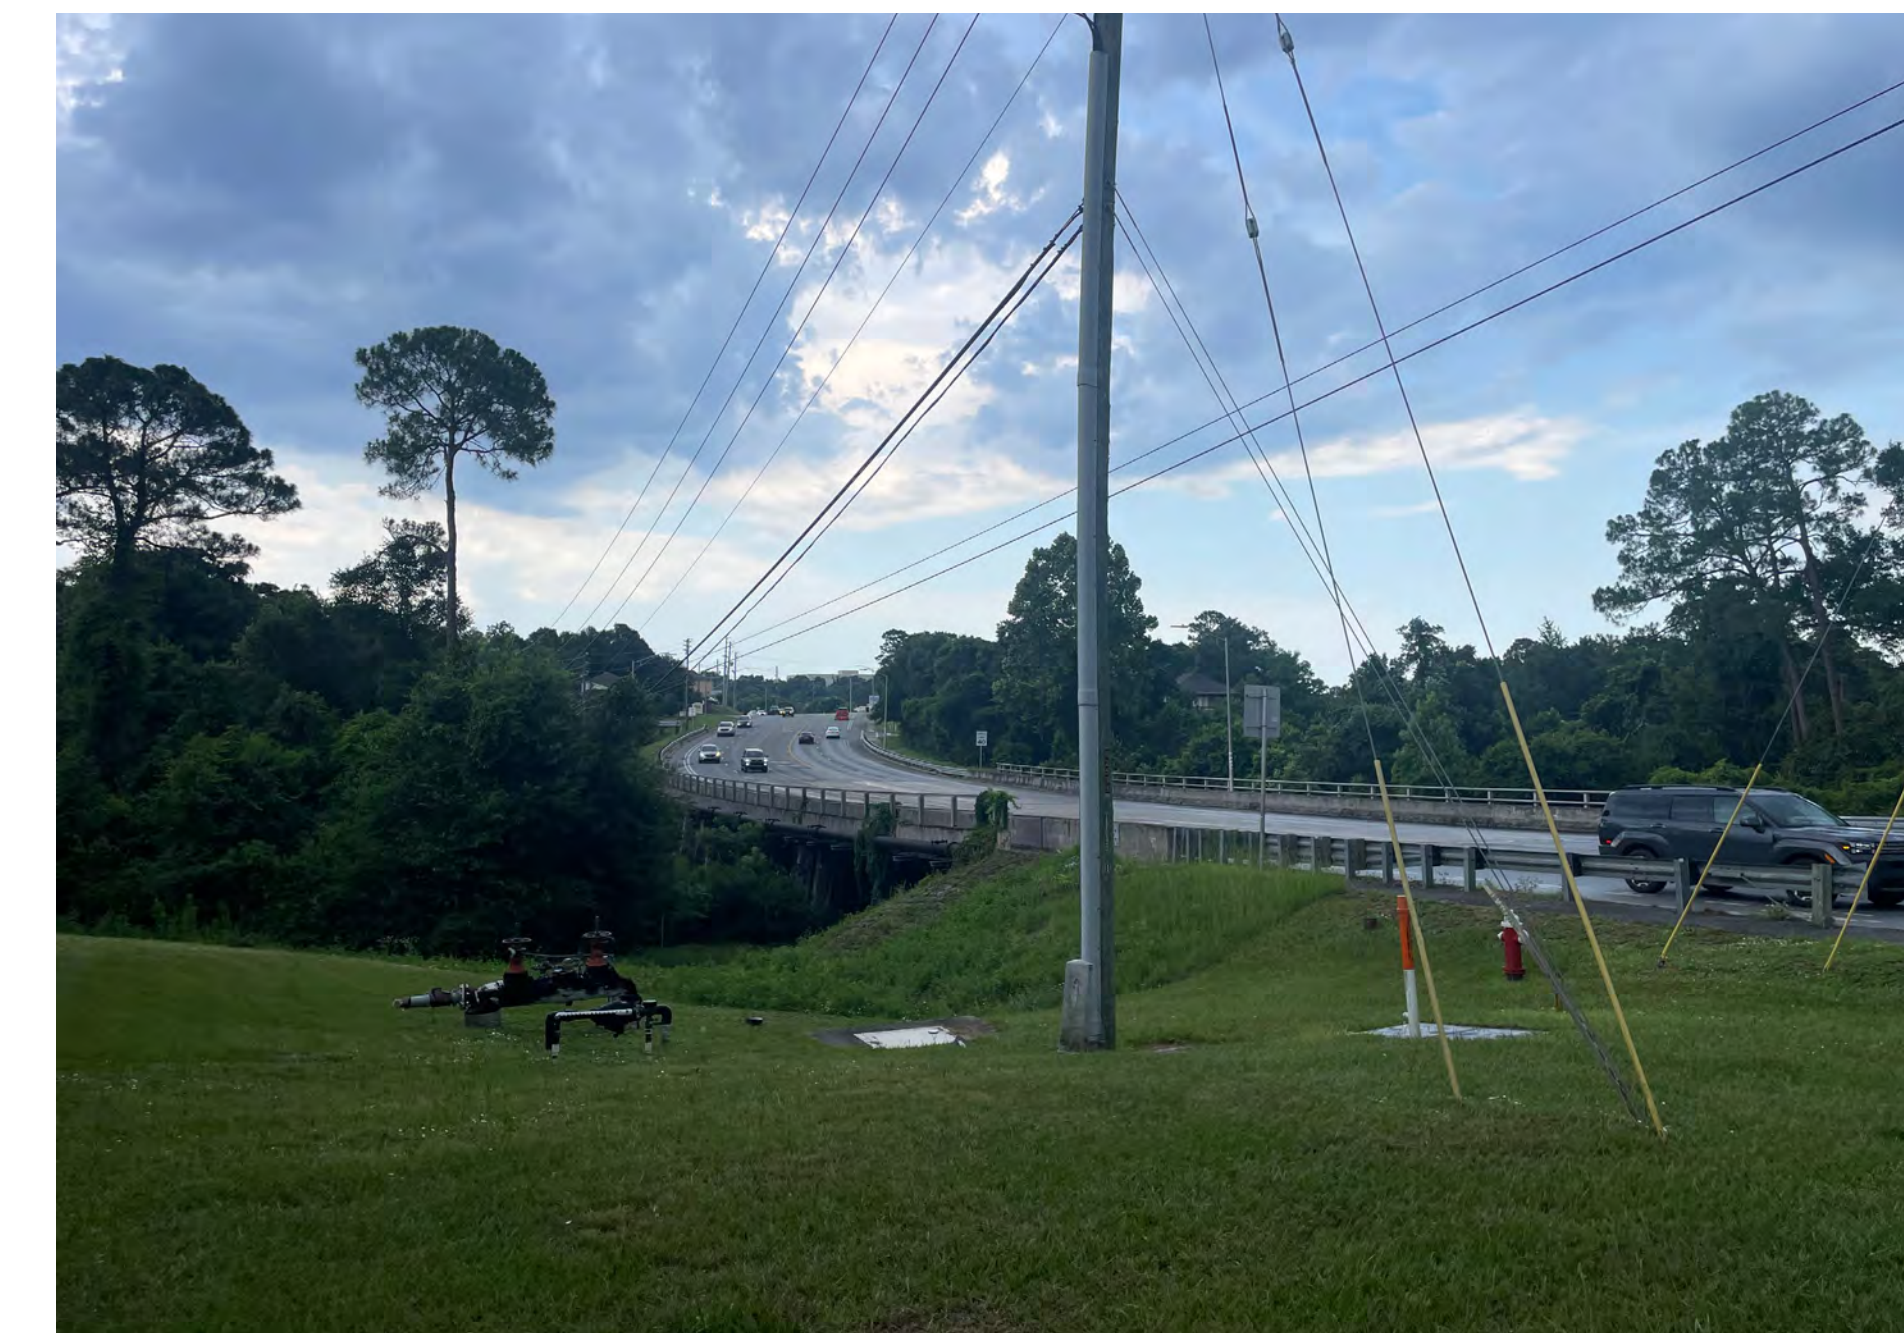
2 Airport Blvd crossing over Carpenter Creek.

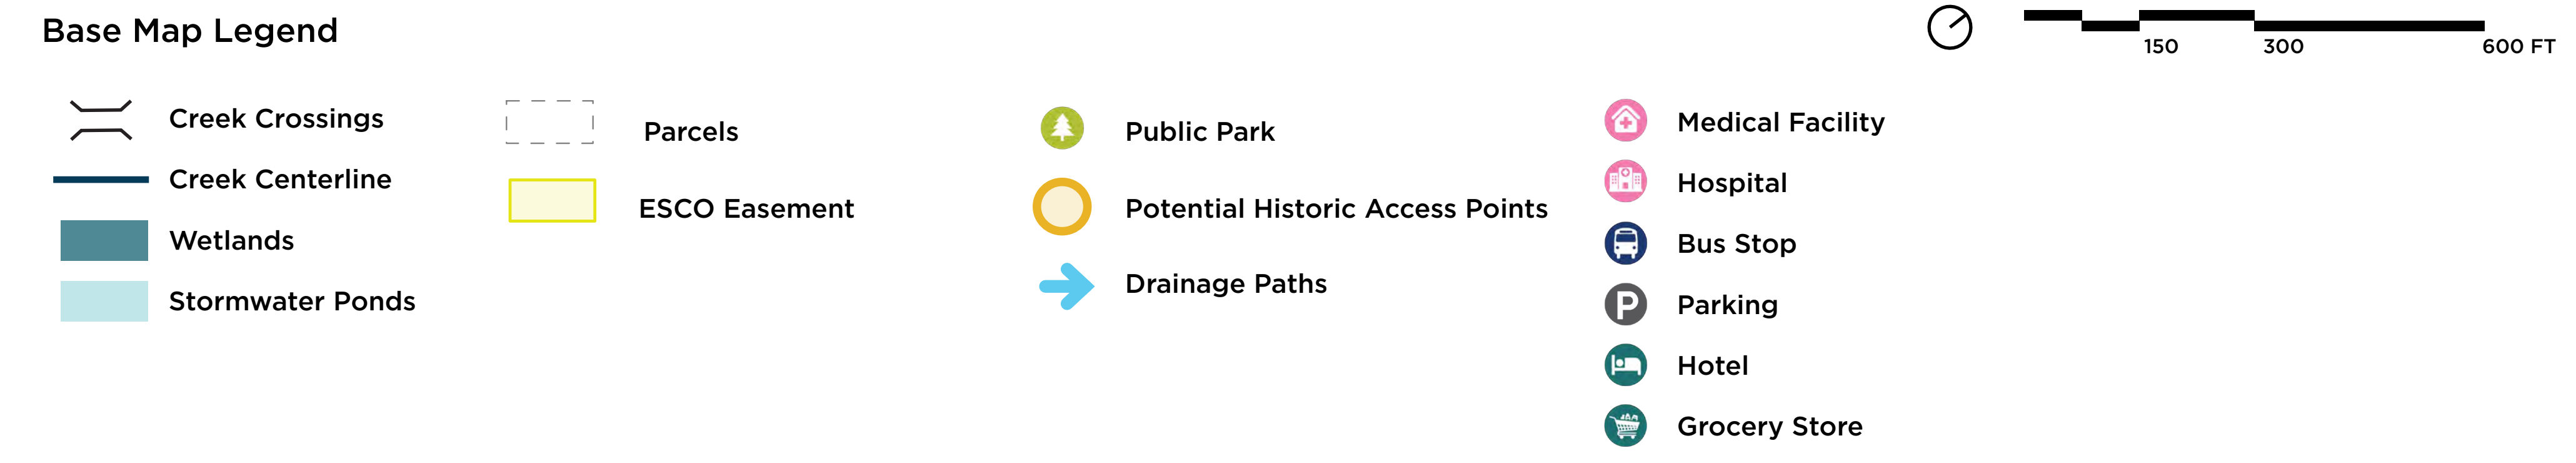
Existing Site Conditions

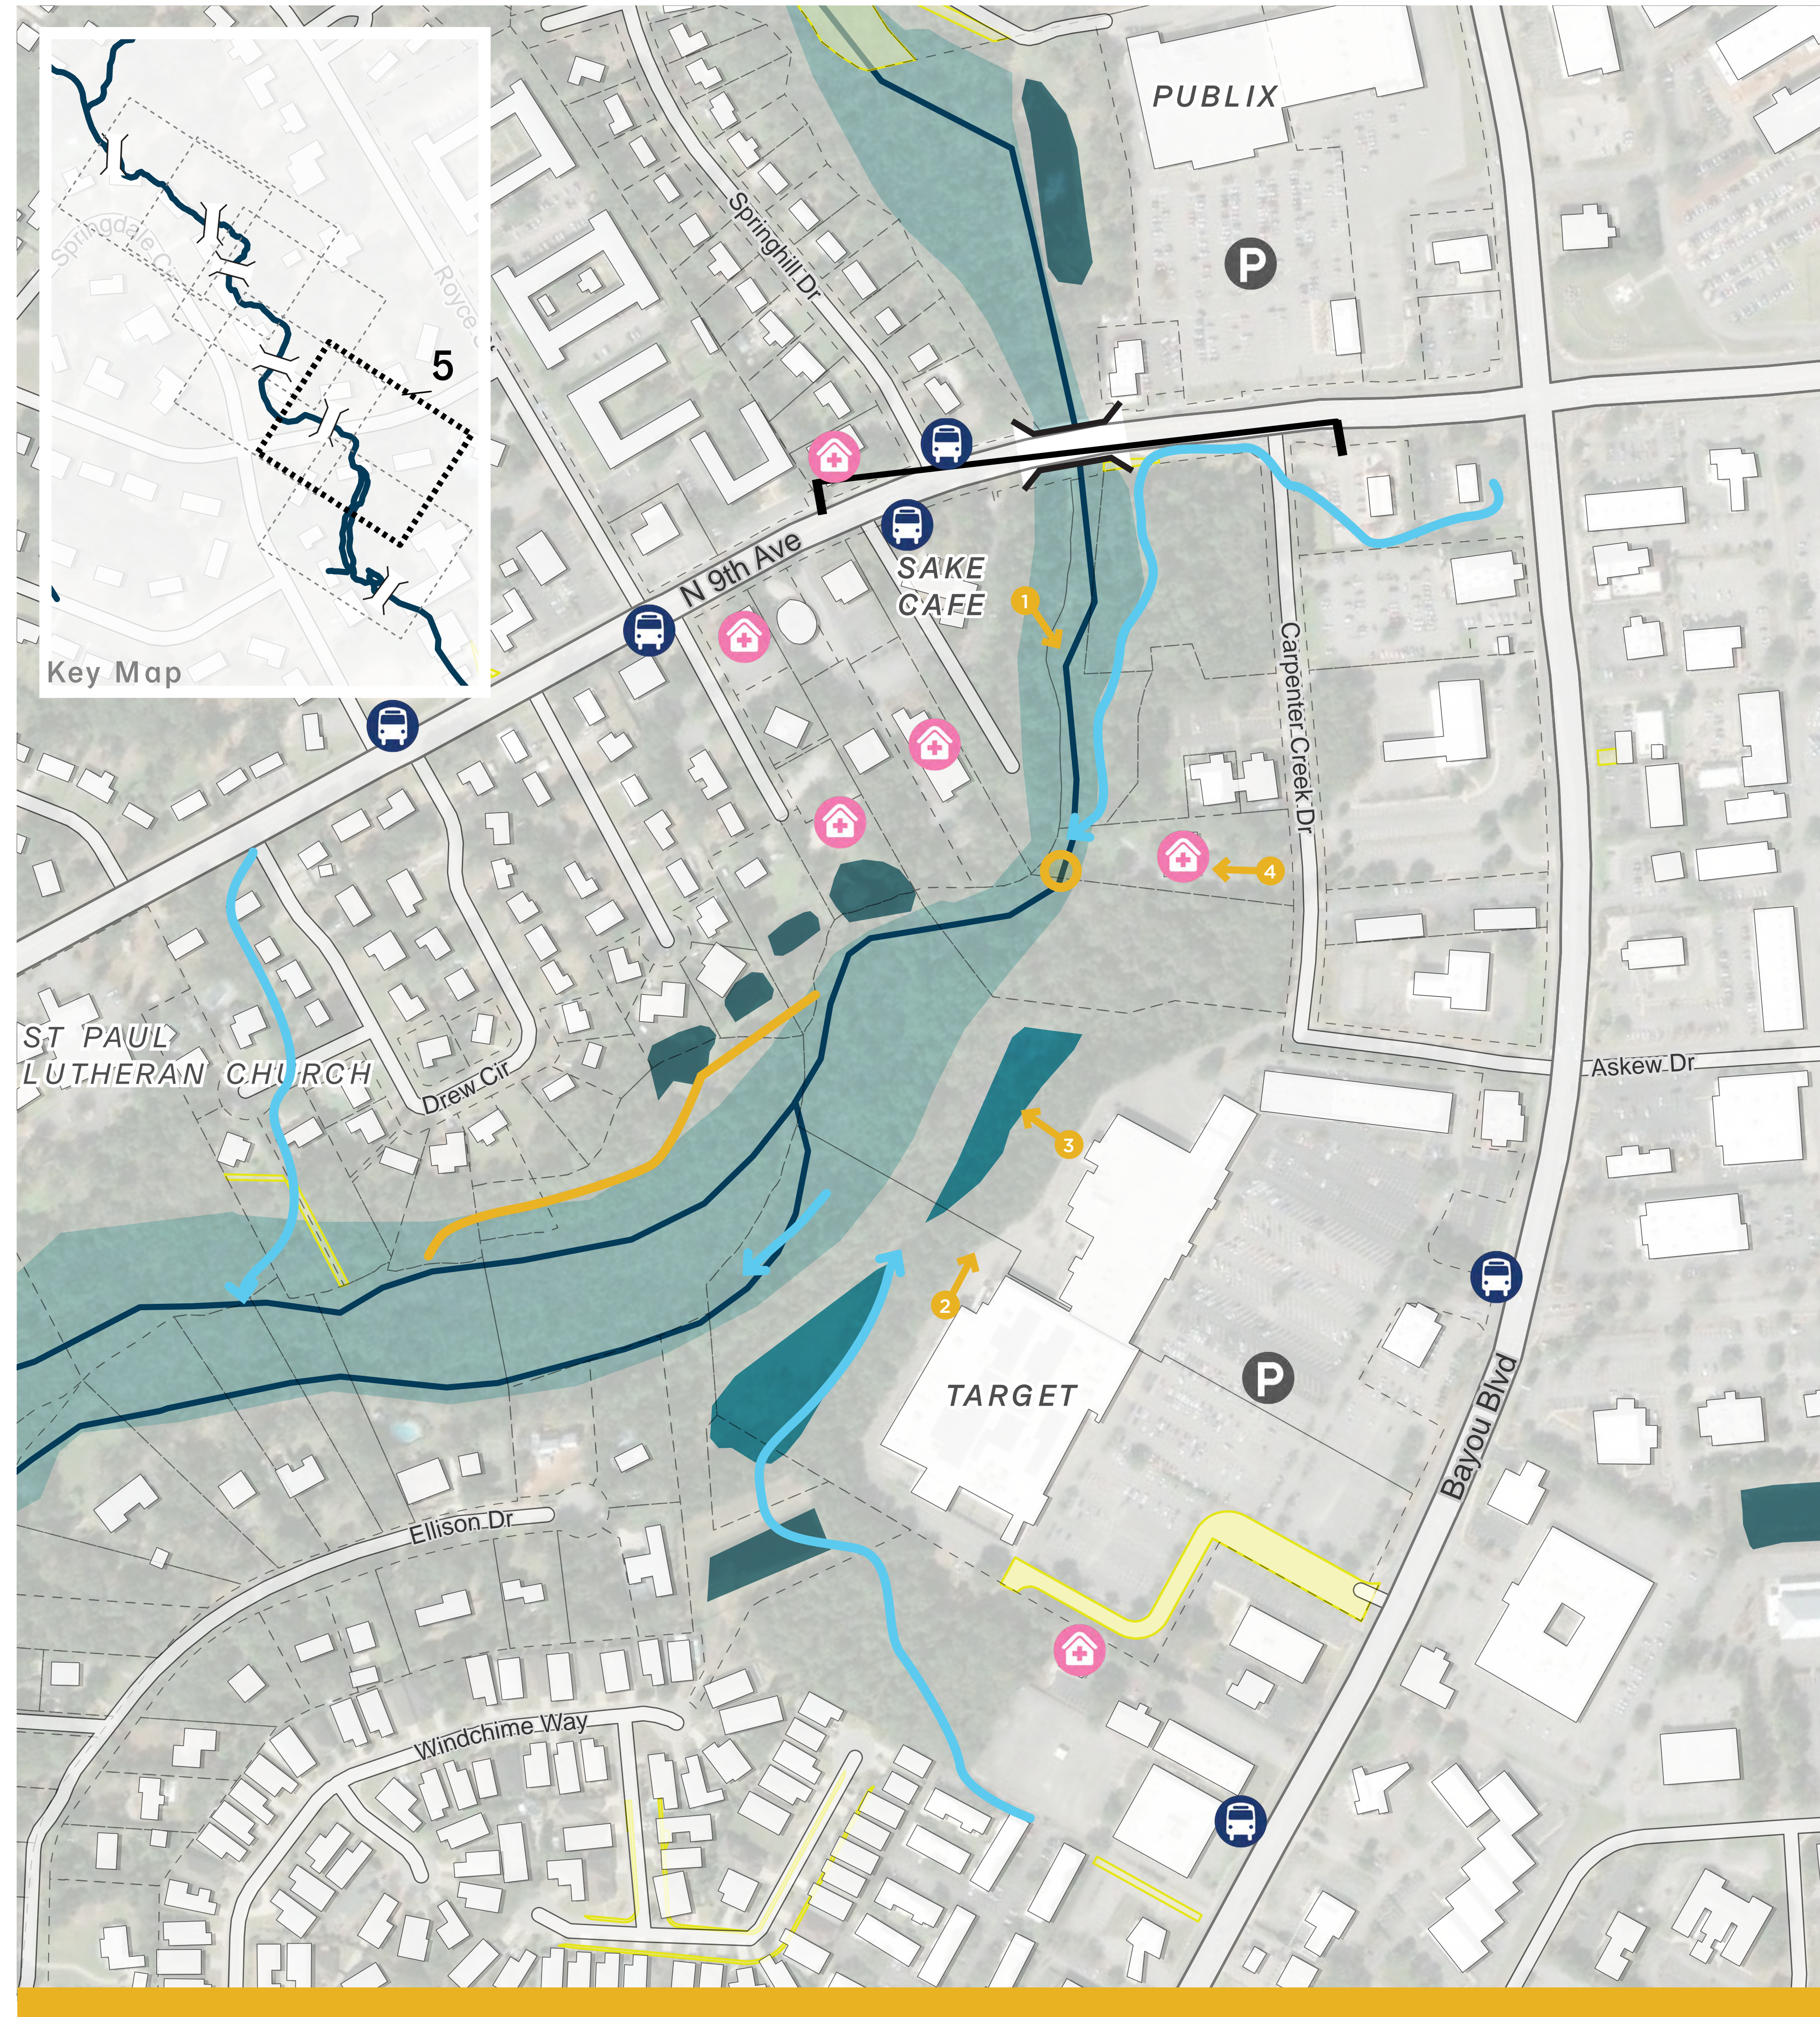
Existing Site Conditions

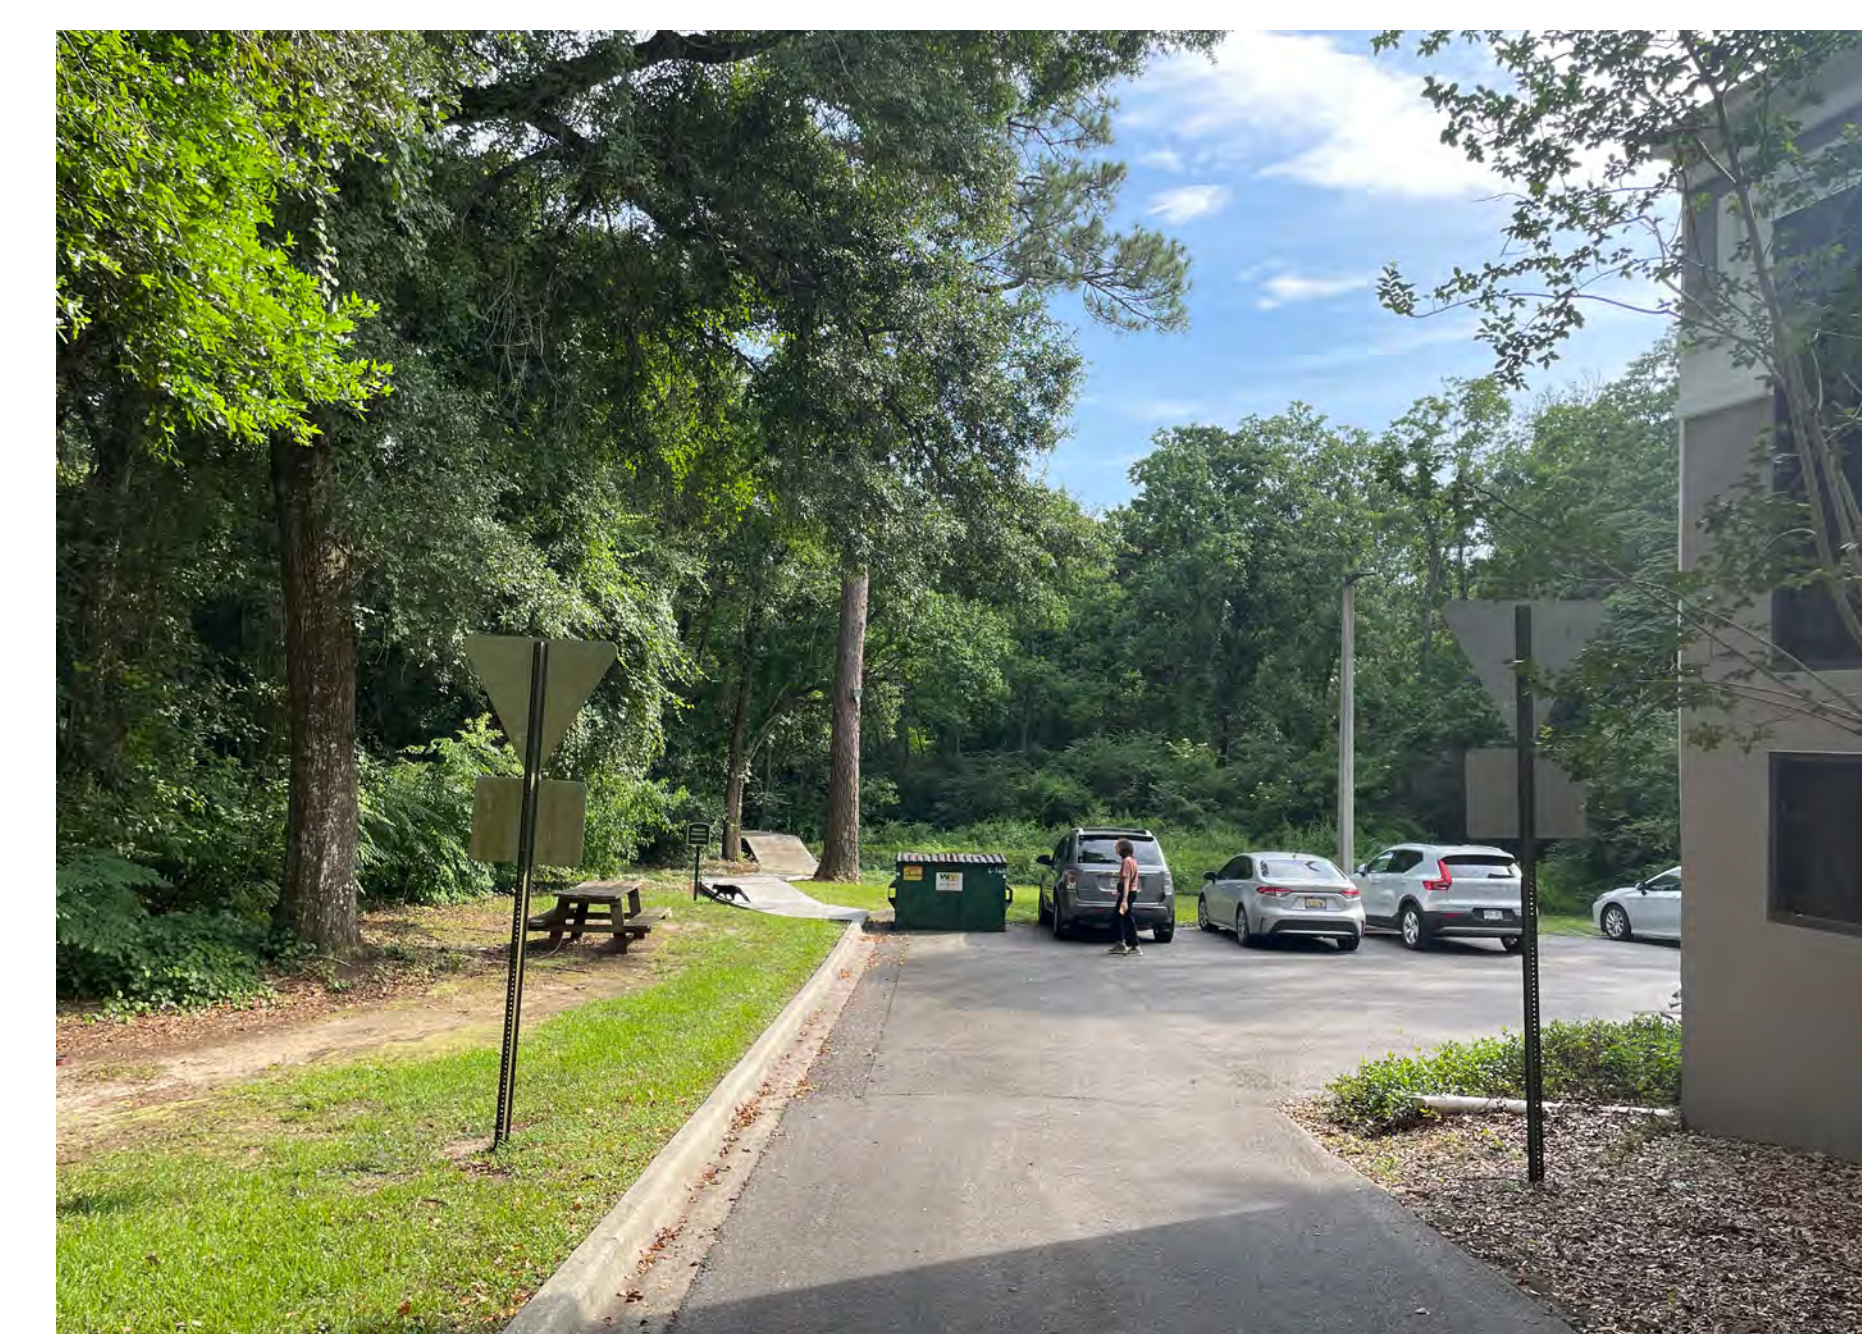
4 Behind the medical office Rawson Braxton & Chicola, boardwalks provide creek access on private property from the rear office parking lot.

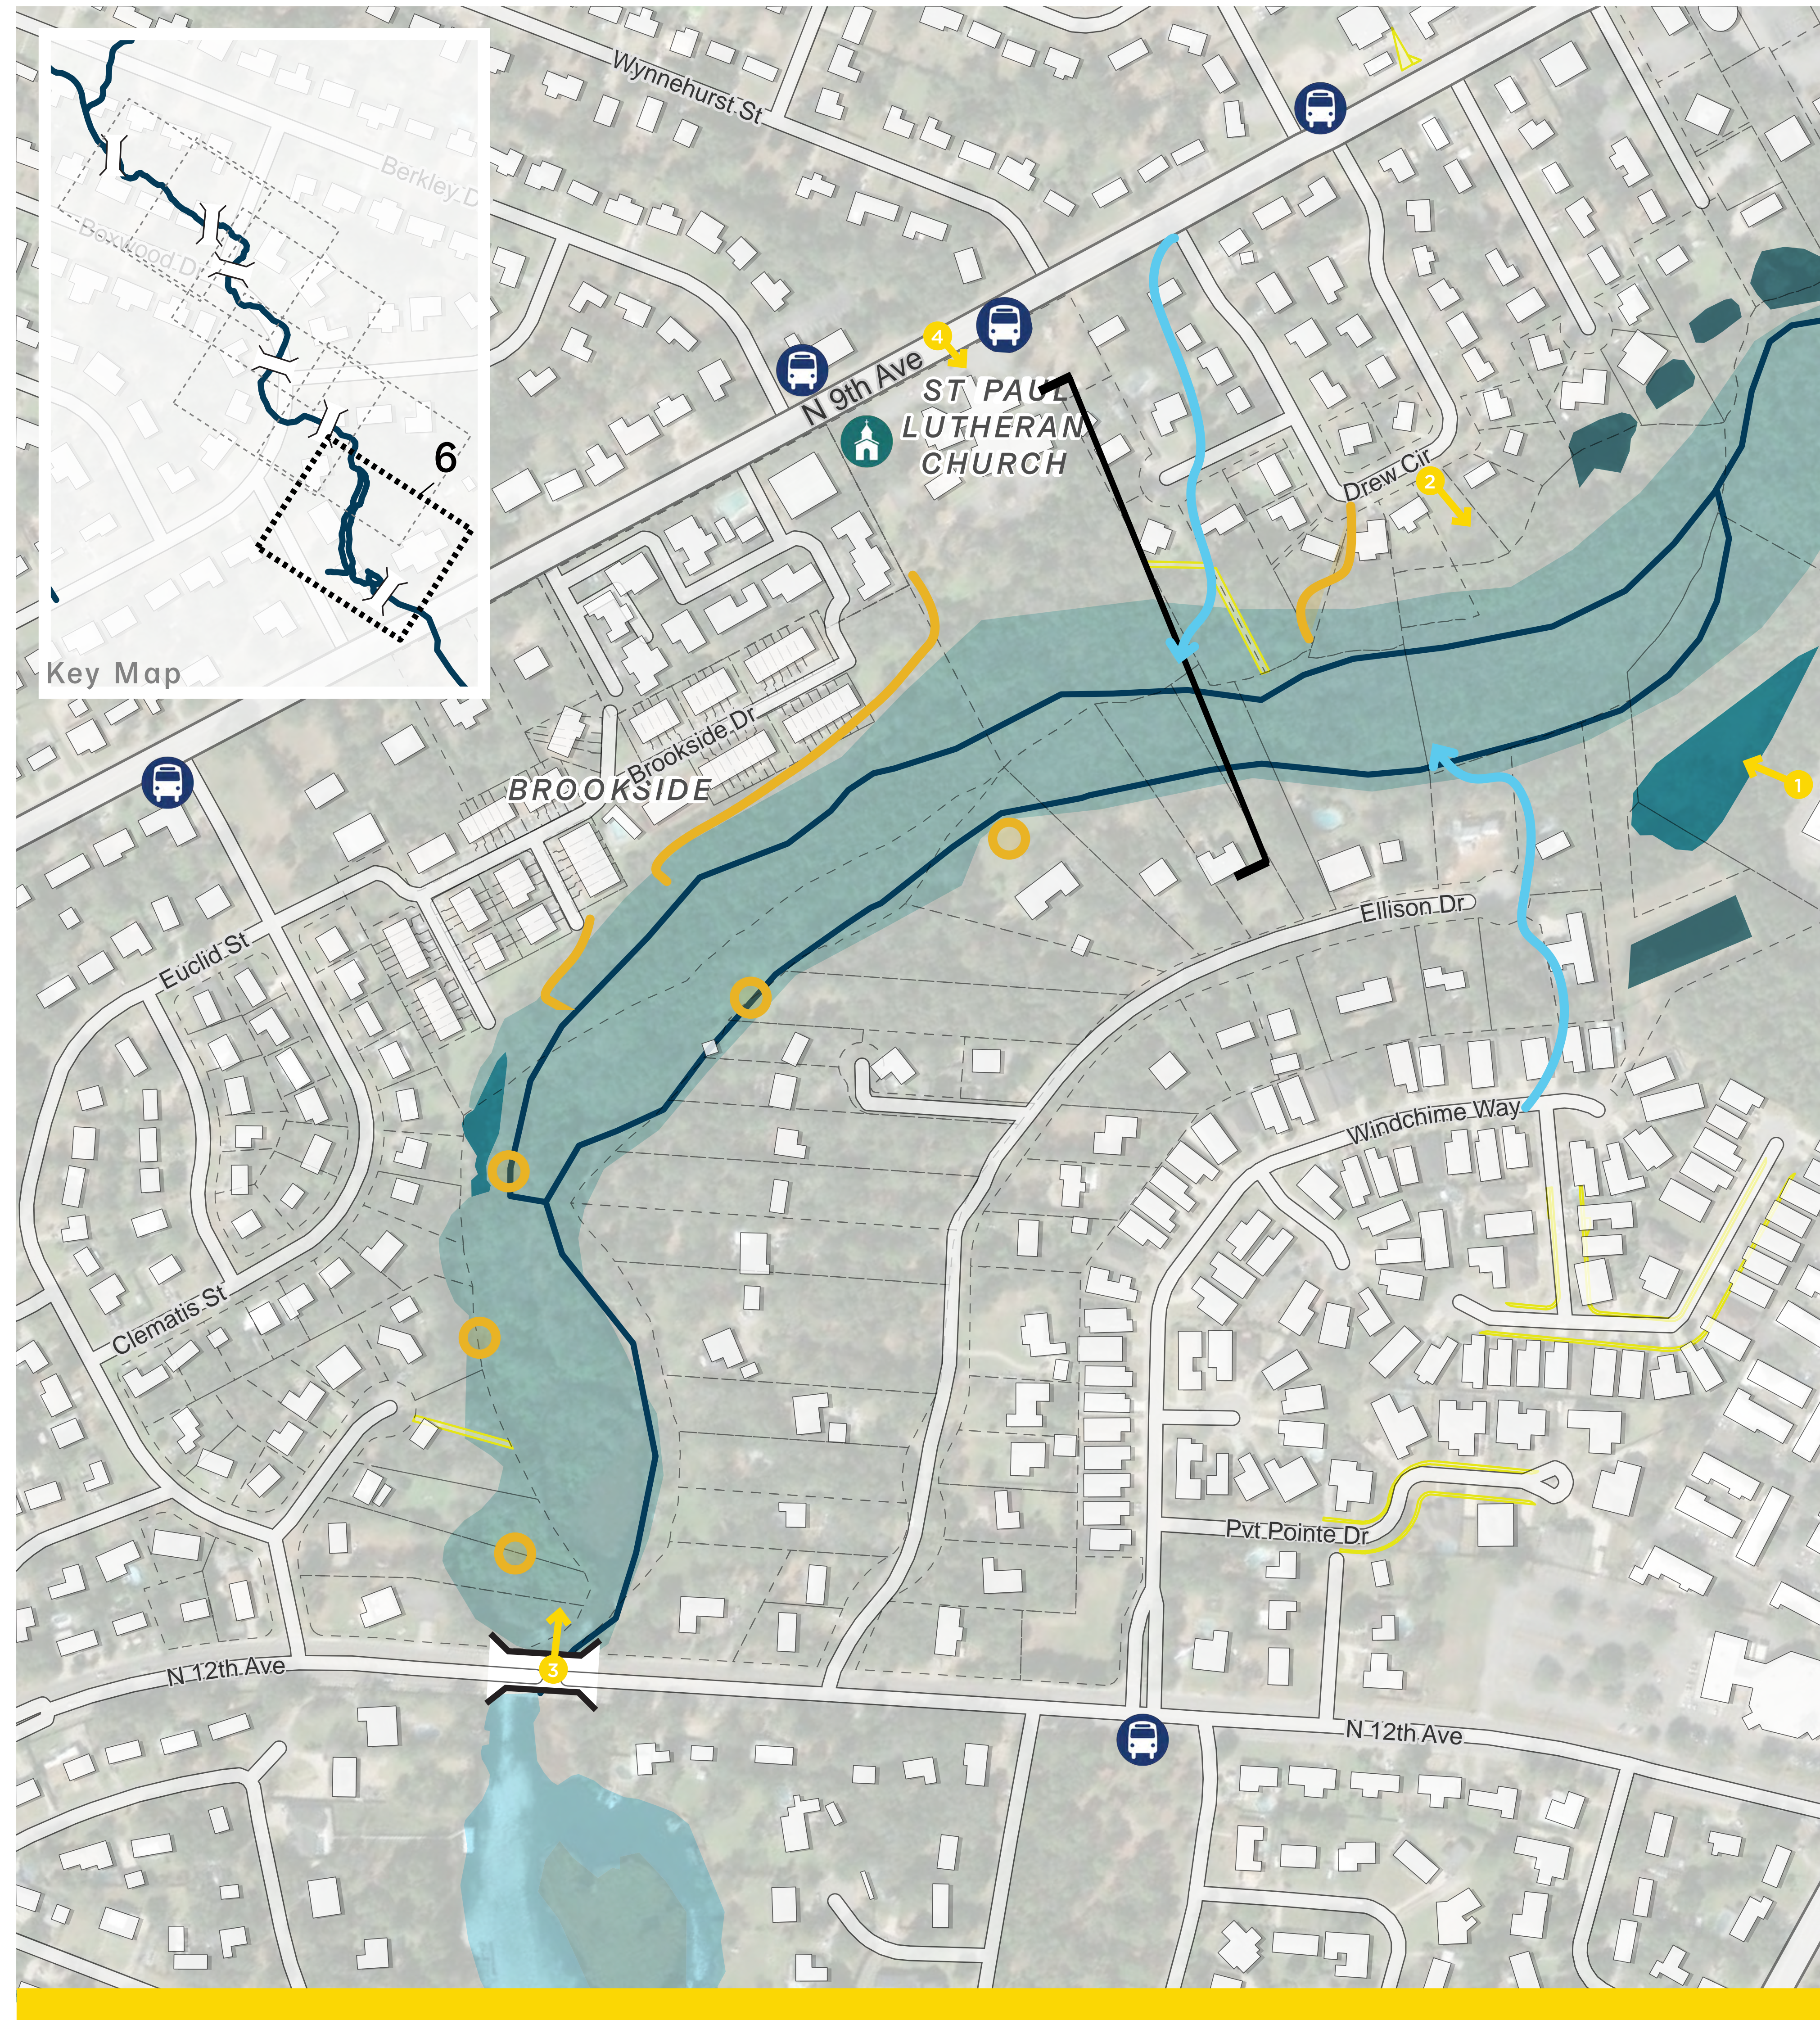
Existing Site Conditions
