***ESCAMBIA BAY & PENSACOLA BAY
INTERTIDAL
OYSTER REEF
MAPPING & ASSESSMENT***

***Located in
Escambia Bay & Pensacola Bay
Escambia County
Florida***

***Prepared for
Escambia County, Florida***

***Prepared by
Gabriel Johnson
OLDEB Certified Oyster Biologist
MREC Environmental, LLC***

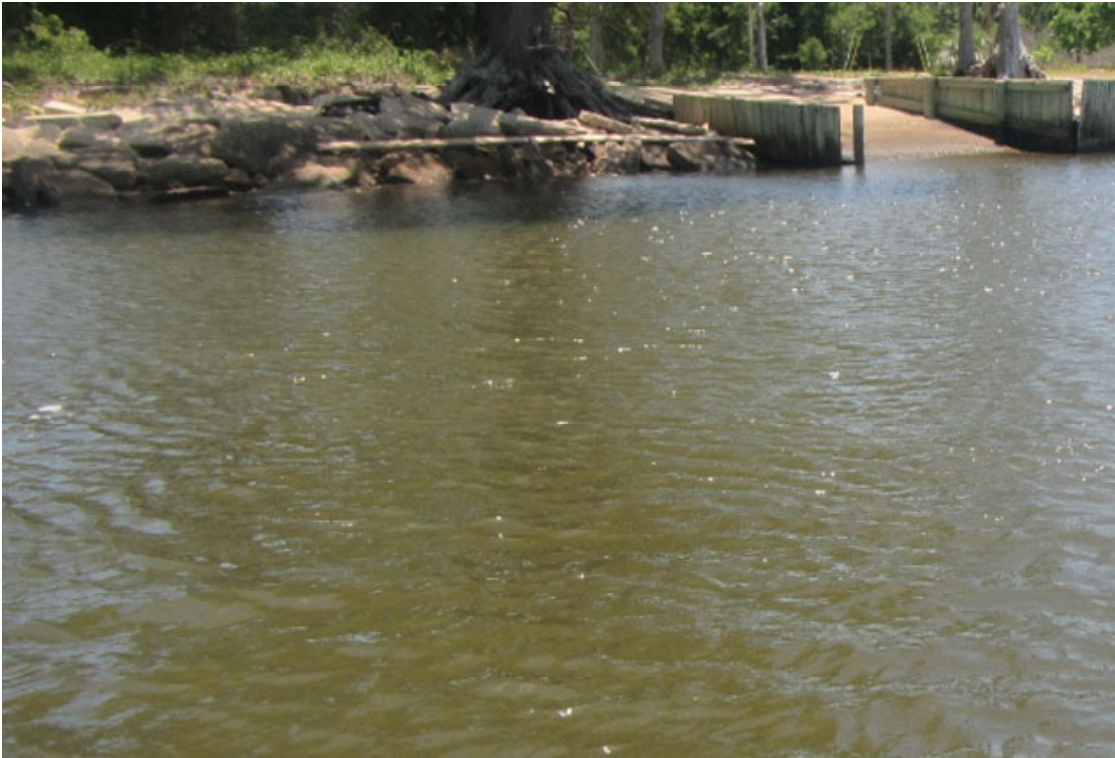
Figure 10. Station 1.

Intertidal Oyster Investigation		
<i>Escambia Bay</i>		
<i>Station:</i>		<i>1</i>
County:	Escambia County	Latitude: 30°27.2443'N
Sample Date:	5/20/2021	Longitude: 87°06.0241'W

Notes		
Oyster Presence:	No	
No oysters were present at this site. Large piles of rocks used for bulkhead material, including submerged rocks, were identified at this location. The surrounding water bottom in this location was sandy.

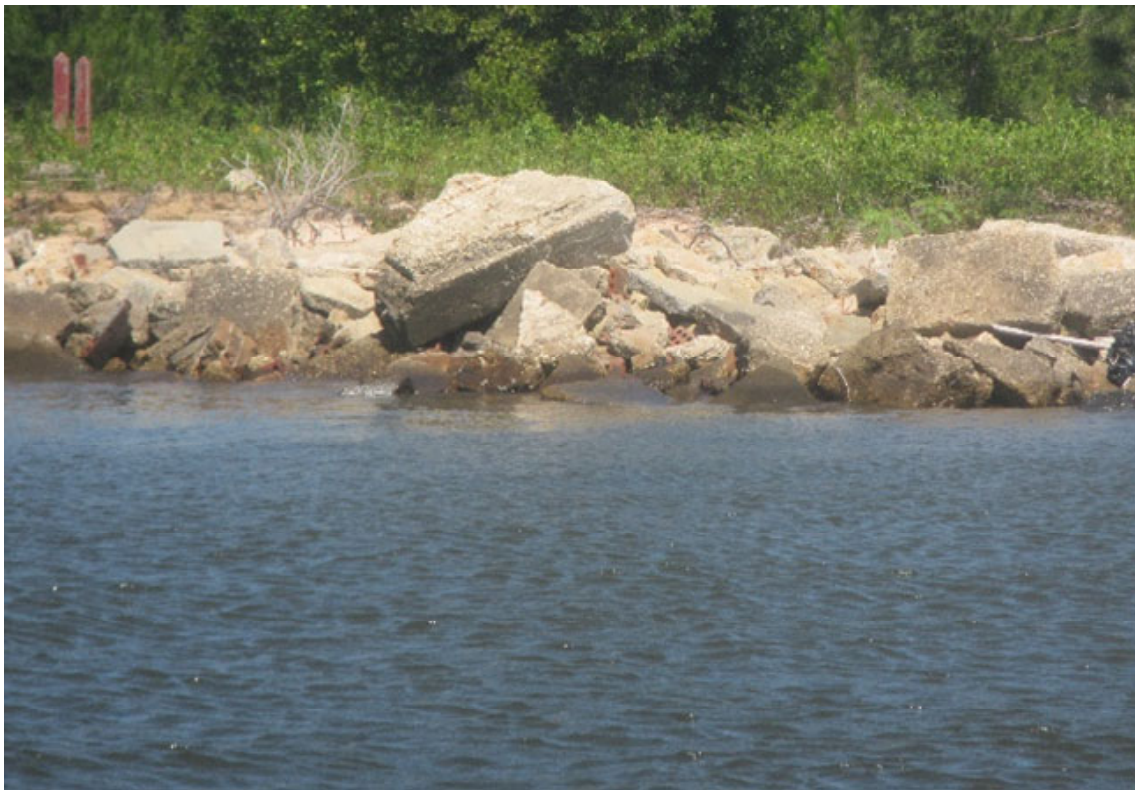
Figure 11. Station 2.

Intertidal Oyster Investigation			
Escambia Bay		Station:	2
County:	Escambia County	Latitude:	30°27.3329'N
Sample Date:	5/20/2021	Longitude:	87°05.9881'W

Notes			
Oyster Presence:	No		
<p>No oysters were present at this site. Large piles of rocks used for bulkhead material, including submerged rocks, were identified at this location. The surrounding water bottom in this location was comprised of moderately firm mud/sand mix.</p>

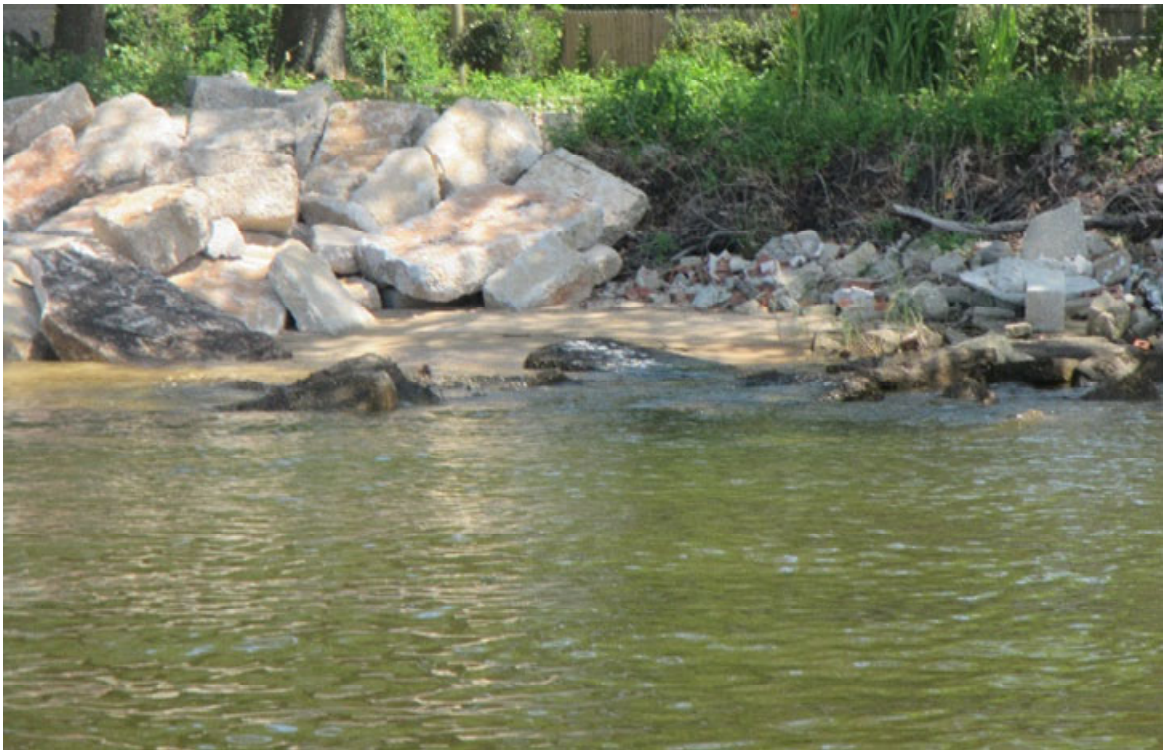
Figure 12. Station 3.

Intertidal Oyster Investigation		
Escambia Bay		Station: 3
County:	Escambia County	Latitude: 30°27.4911'N
Sample Date:	5/20/2021	Longitude: 87°05.9092'W

Notes		
Oyster Presence:	No	
No oysters were present at this site. Large piles of rocks used for bulkhead material, including submerged rocks, were identified at this location. The surrounding water bottom in this location was comprised of moderately firm mud/sand mix.

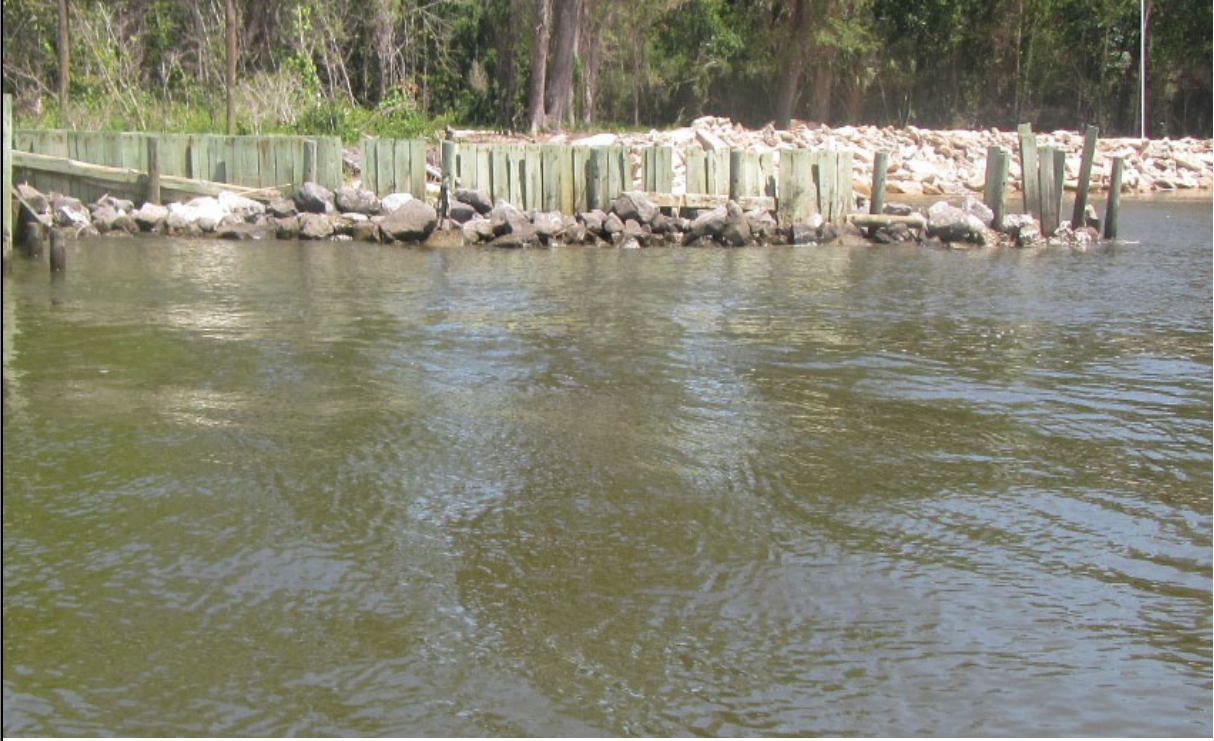
Figure 13. Station 4.

No oysters were present at this site. Rocks used for bulkhead material, including submersed rocks and driftwood were visible from the surface, and miscellaneous debris on the water bottom were noted. The surrounding water bottom was sandy.

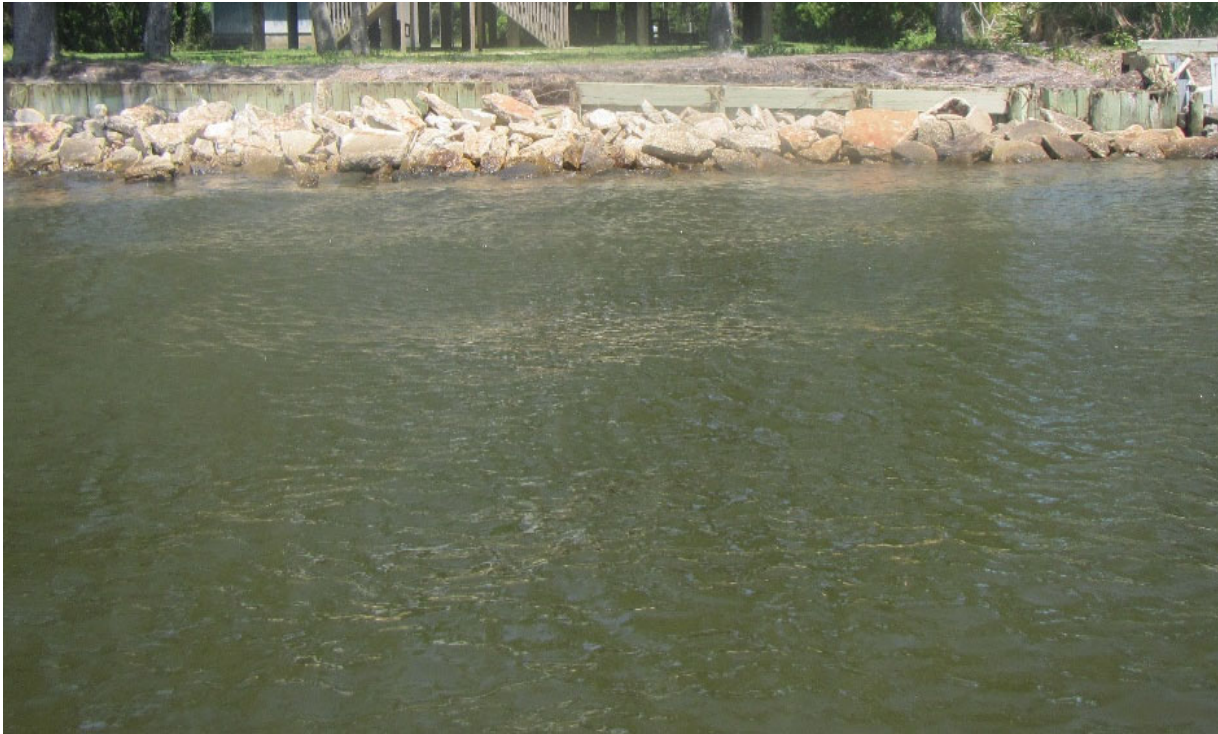
Figure 14. Station 5.

Intertidal Oyster Investigation		
Escambia Bay		Station: 5
County:	Escambia County	Latitude: 30°28.0361'N
Sample Date:	5/20/2021	Longitude: 87°05.7593'W

Notes		
Oyster Presence:	No	
<p>No oysters were present at site. Large piles of rocks, including some submerged rocks, were used for bulkhead material, were identified at this location. The surrounding water bottom was composed of sand and moderately firm mud/sand mix.</p>

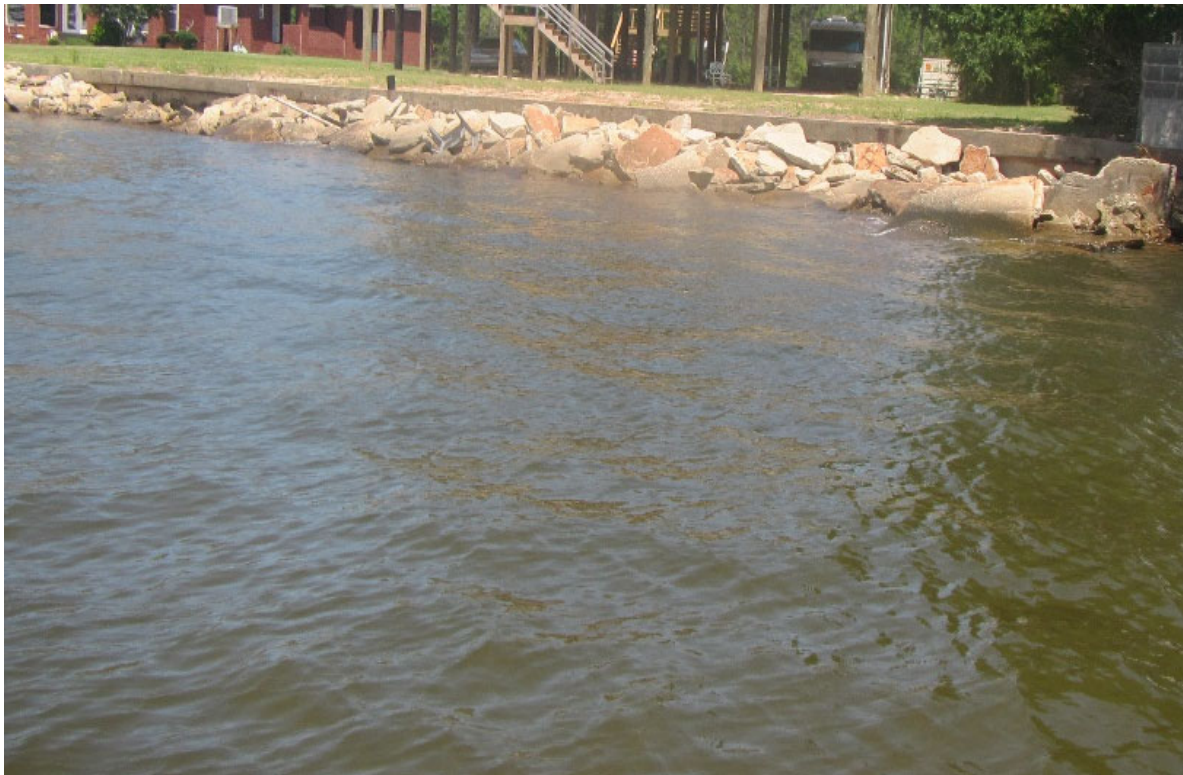
Figure 15. Station 6.

Intertidal Oyster Investigation			
Escambia Bay		Station:	6
County:	Escambia County	Latitude:	30°28.3024'N
Sample Date:	5/20/2021	Longitude:	87°05.7313'W

Notes			
Oyster Presence:	No		
No oysters were present at this site. Large piles of rocks used for bulkhead material, including submerged rocks, were identified at this location. The surrounding water bottom in this location was comprised of moderately firm mud/sand mix.

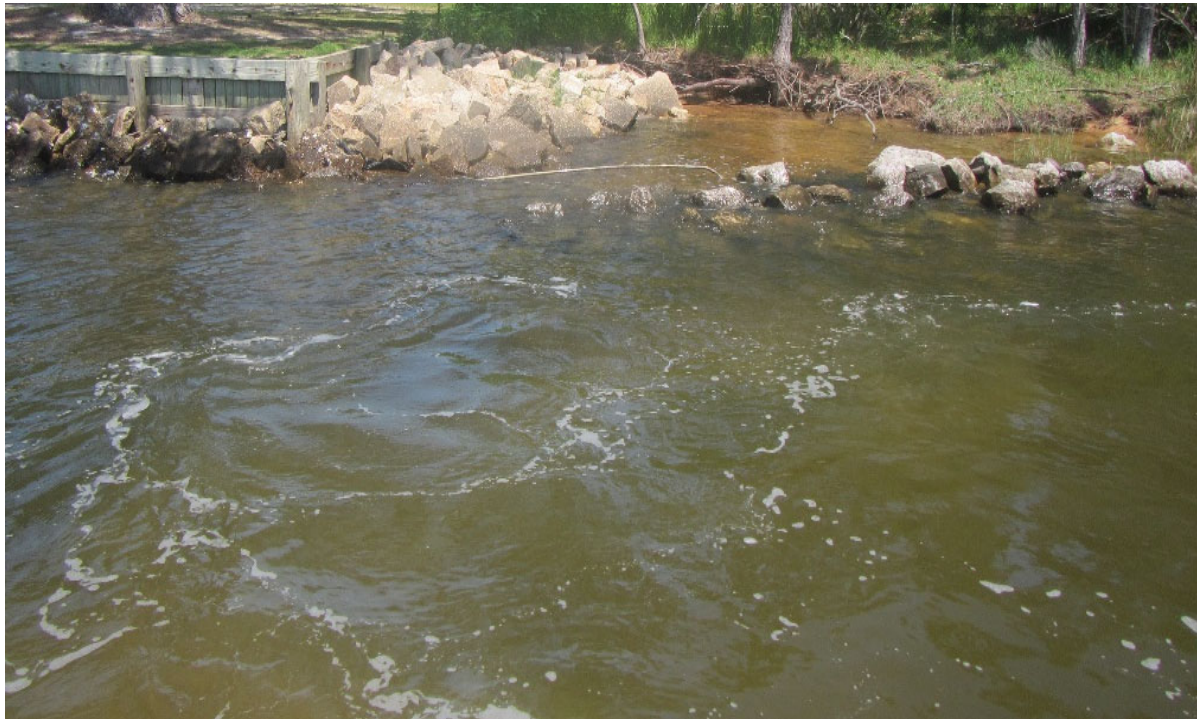
Figure 16. Station 7.

Intertidal Oyster Investigation		
Escambia Bay		Station: 7
County:	Escambia County	Latitude: 30°28.4115'N
Sample Date:	5/20/2021	Longitude: 87°05.6645'W

Notes		
Oyster Presence:	No	
No oysters were present at site. Large piles of rocks, including some submerged rocks, were used for bulkhead material, were identified at this location. The surrounding water bottom was composed of sand and moderately firm mud/sand mix.

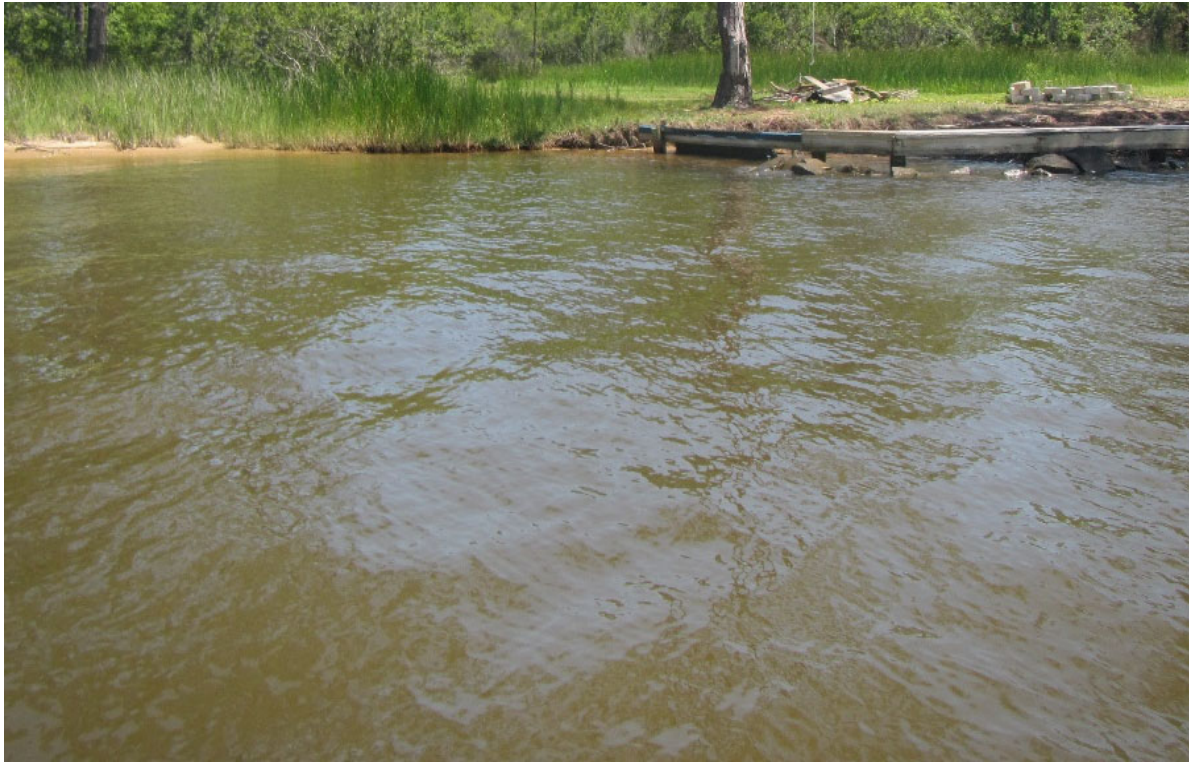
Figure 17. Station 8.

Intertidal Oyster Investigation		
Escambia Bay		Station: 8
County:	Escambia County	Latitude: 30°30.0206'N
Sample Date:	5/20/2021	Longitude: 87°05.8576'W

Notes		
Oyster Presence:	No	
No oysters were present at this site. Large piles of pieces of concrete used for bulkhead material, including submerged rocks, were identified at this location. The surrounding water bottom in this location was sandy.

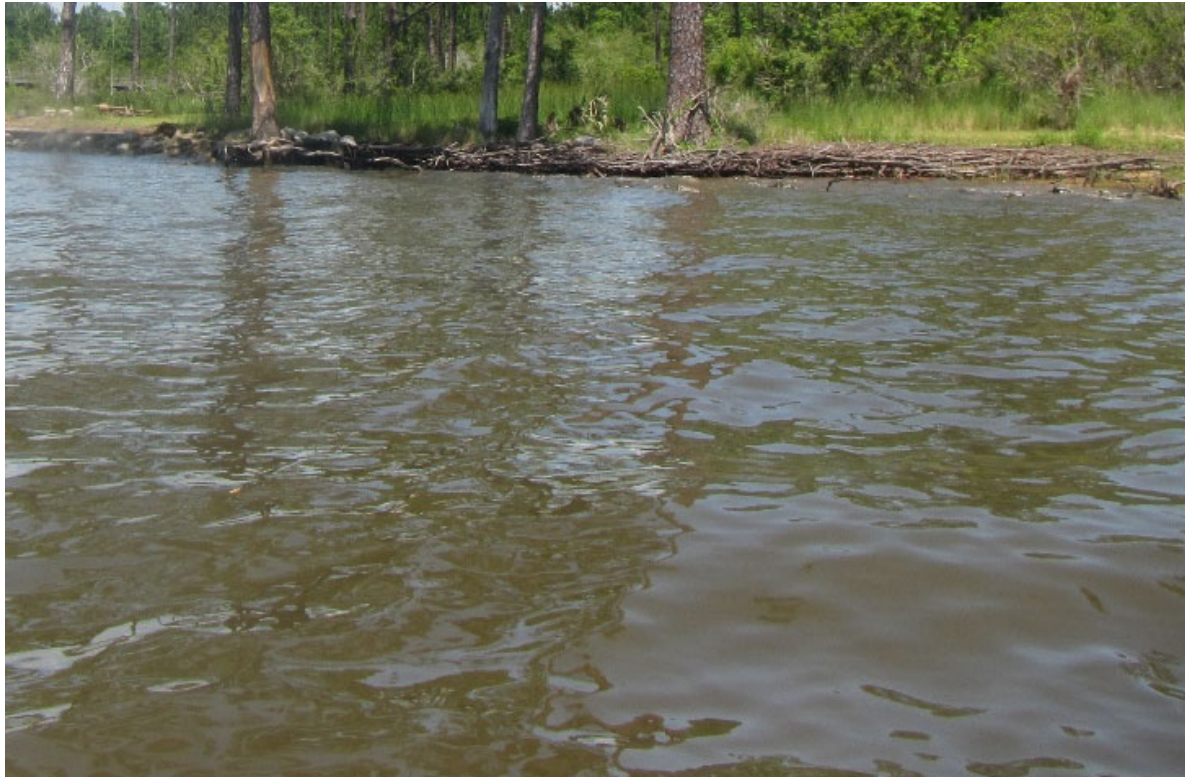
Figure 18. Station 9.

Intertidal Oyster Investigation			
Escambia Bay		Station:	9
County:	Escambia County	Latitude:	30°30.0036'N
Sample Date:	5/20/2021	Longitude:	87°05.8600'W

Notes			
Oyster Presence:	No		
No oysters were present at this site. Submerged rocks and grass were identified at this location. The surrounding water bottom consisted of a moderately firm sandy/mud mix.

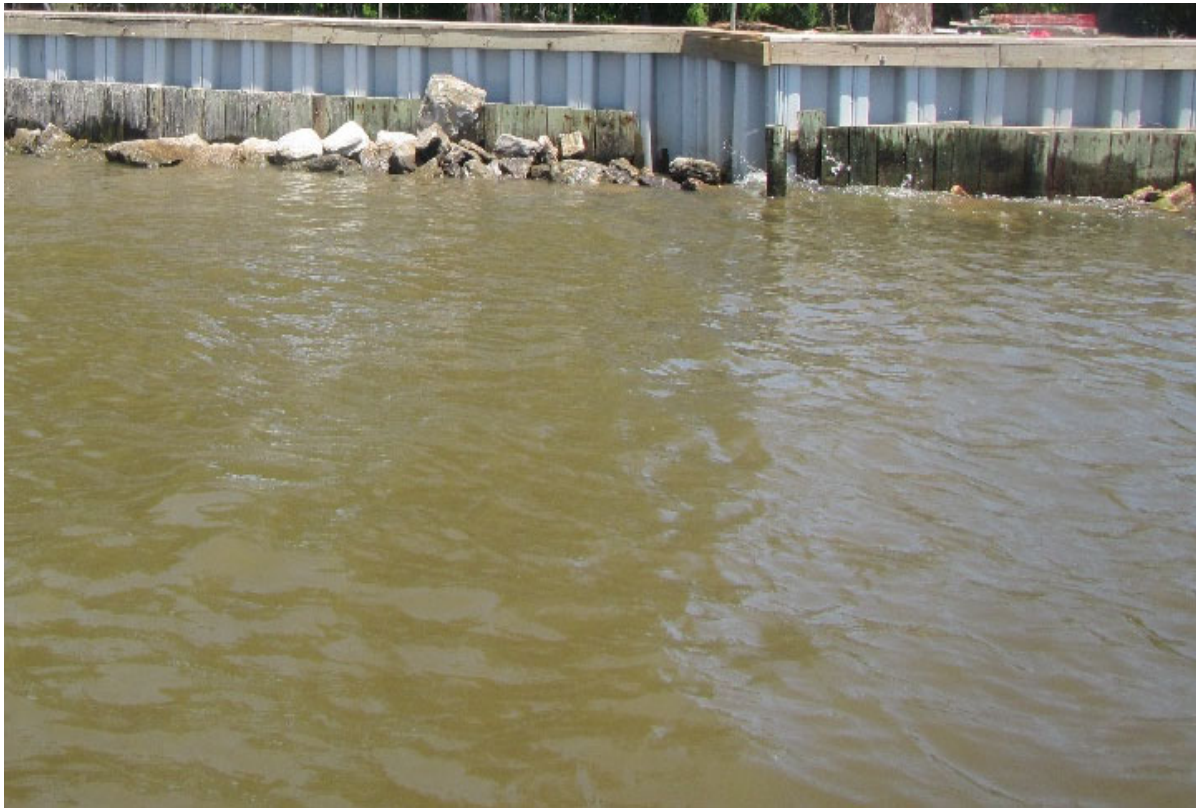
Figure 19. Station 10.

Intertidal Oyster Investigation			
Escambia Bay		Station:	10
County:	Escambia County	Latitude:	30°30.2020'N
Sample Date:	5/20/2021	Longitude:	87°05.8062'W

Notes			
Oyster Presence:	No		
No oysters were present at site. Large piles of rocks, including some submerged rocks, were used for bulkhead material, were identified at this location. The surrounding water bottom was composed of sand.

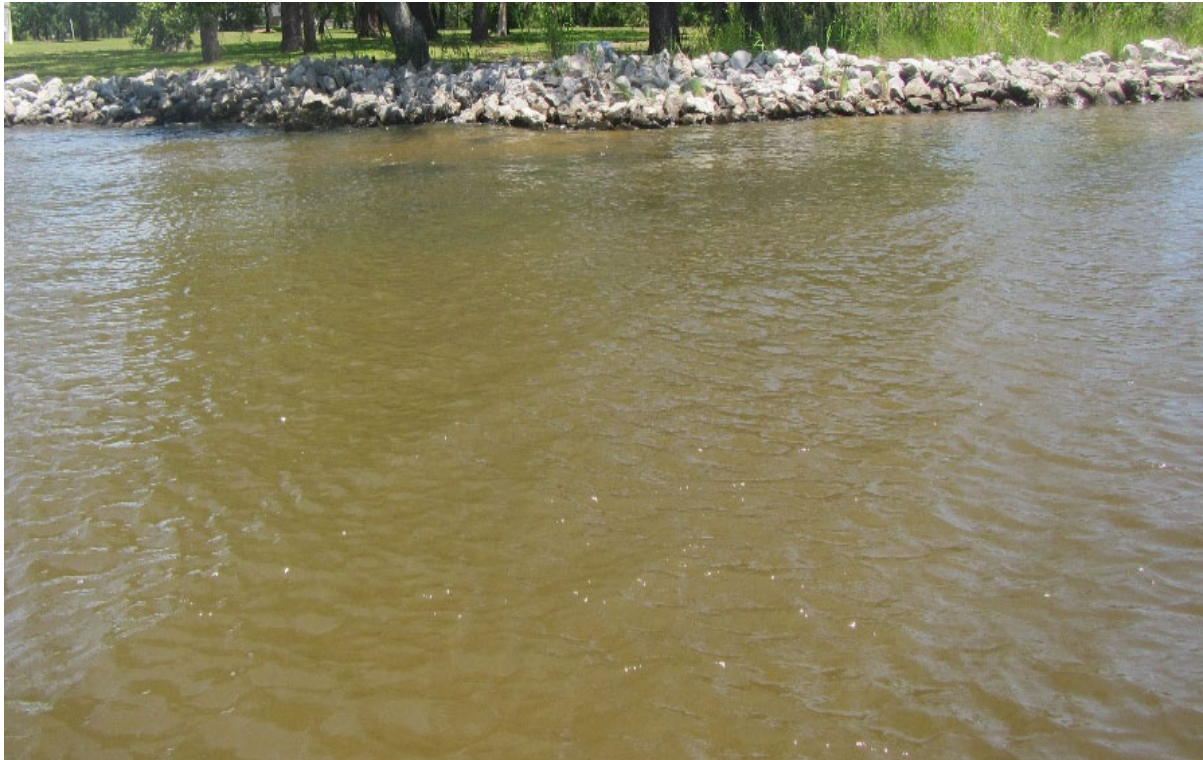
Figure 20. Station 11.

Intertidal Oyster Investigation		
Escambia Bay		
Station:		11
County:	Escambia County	Latitude: 30°30.8424'N
Sample Date:	5/20/2021	Longitude: 87°5.8798'W

Notes		
Oyster Presence:	No	
<p>No oysters were present at site. Large piles of rocks, including some submerged rocks, were used for bulkhead material, were identified at this location. The surrounding water bottom was composed of sand.</p>

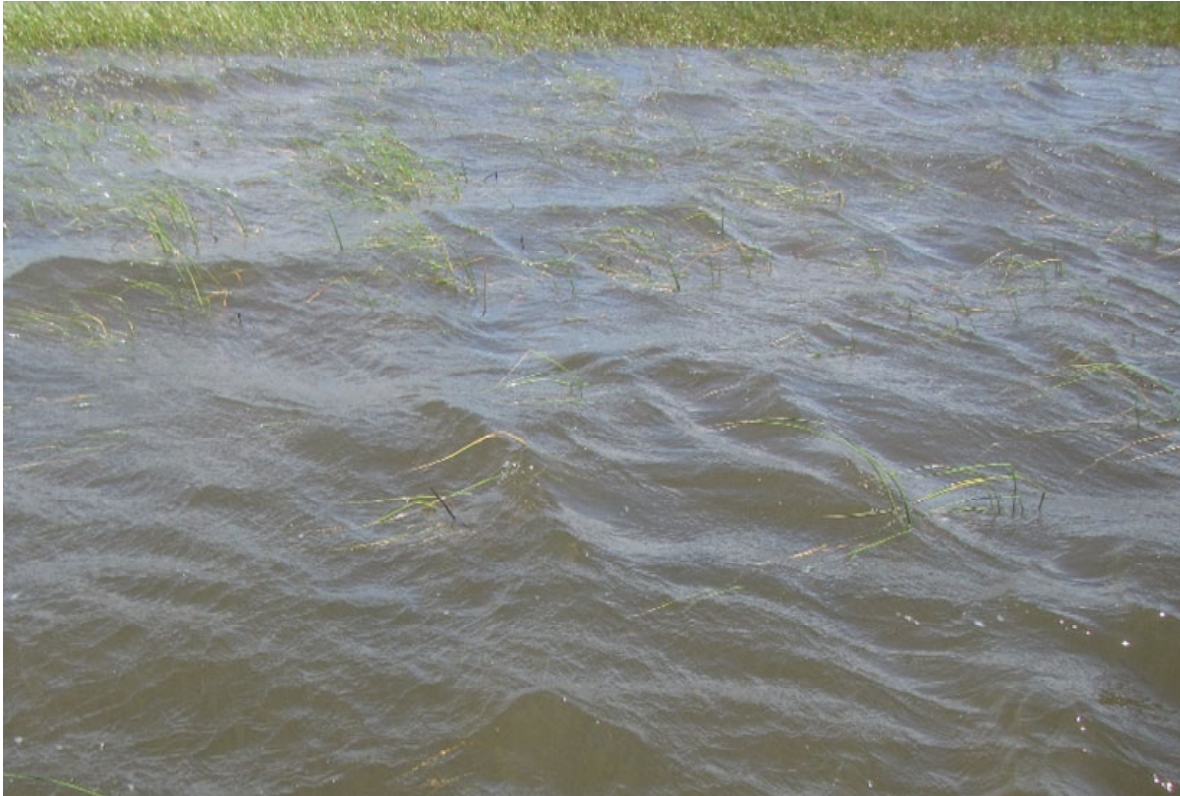
Figure 21. Station 12.

Intertidal Oyster Investigation		
Escambia Bay		Station: 12
County:	Escambia County	Latitude: 30°30.8680'N
Sample Date:	5/20/2021	Longitude: 87°5.8730'W

Notes		
Oyster Presence:	No	
No oysters were found in this location. Partially submerged marsh grass was noted to have been found on-site.

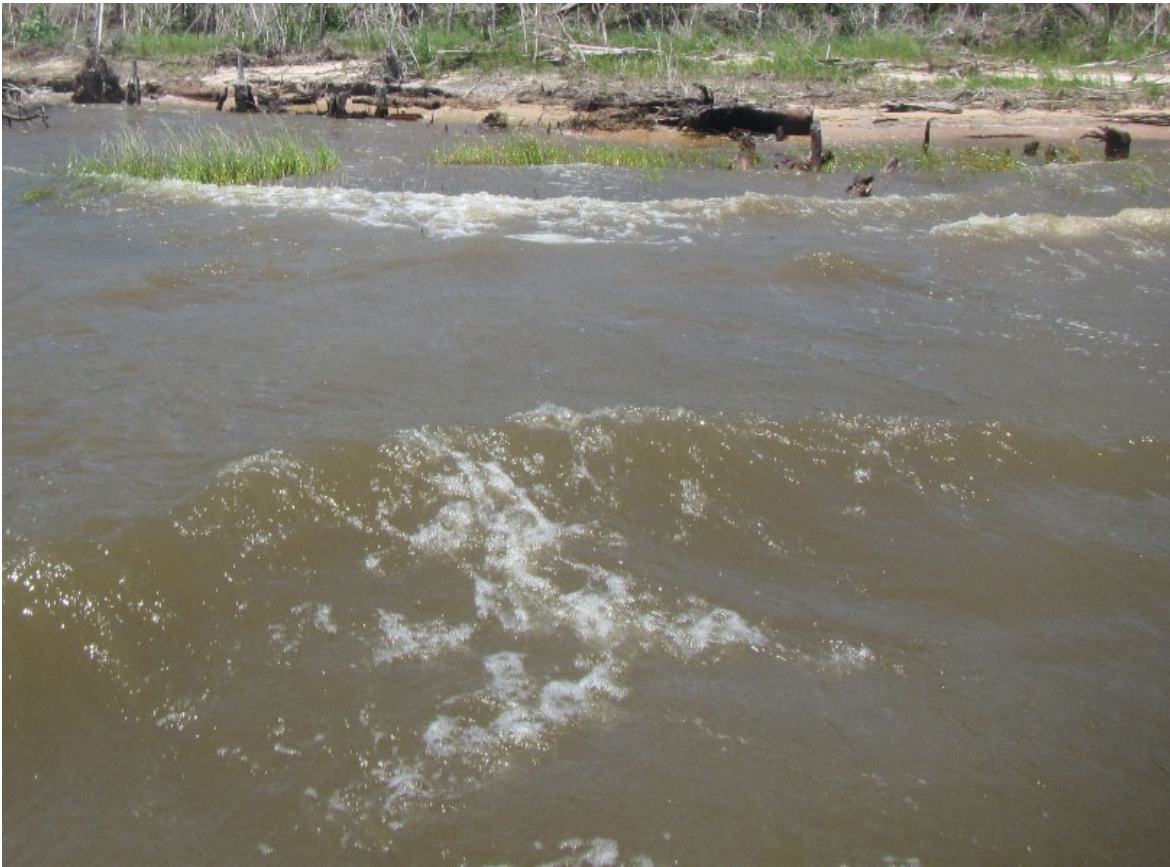
Figure 22. Station 13.

Intertidal Oyster Investigation		
Escambia Bay		Station: 13
County:	Escambia County	Latitude: 30°31.2427'N
Sample Date:	5/20/2021	Longitude: 87°6.2362'W

Notes		
Oyster Presence:	No	
No oysters were found in this location. Partially submerged marsh grass and driftwood was noted to have been found on-site.

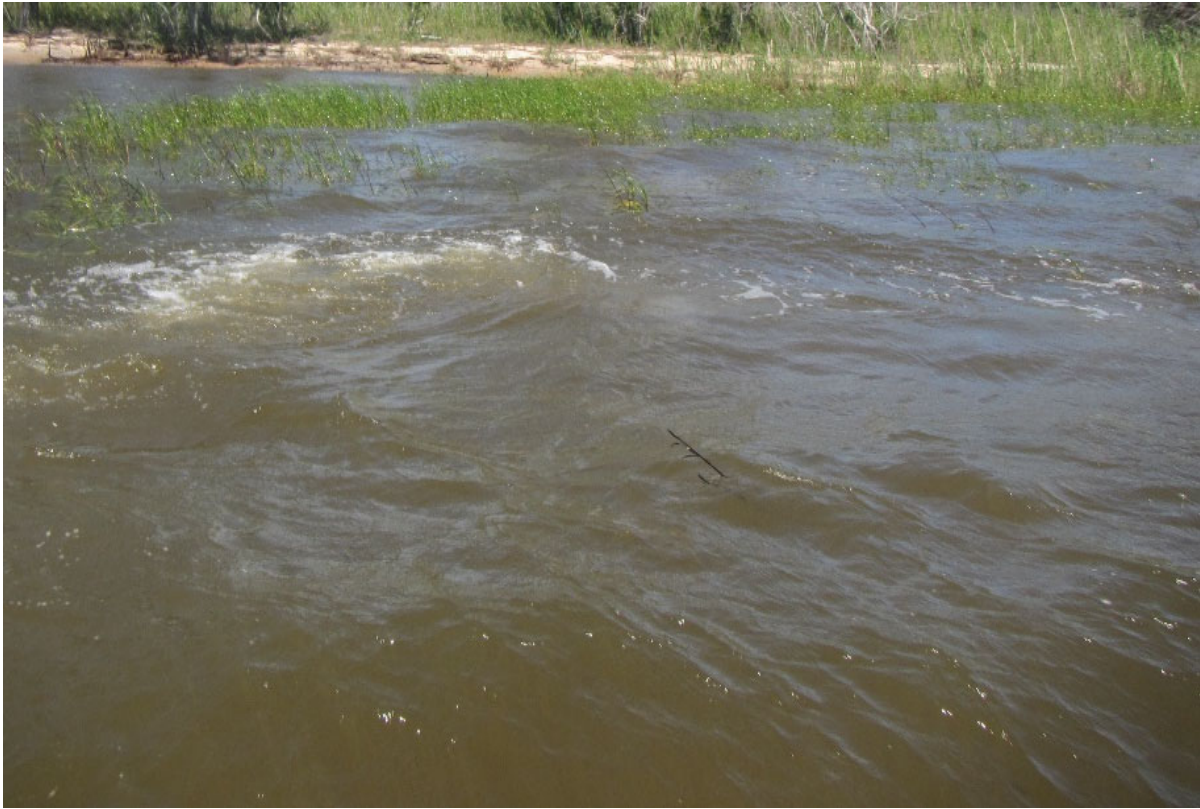
Figure 23. Station 14.

Intertidal Oyster Investigation		
Escambia Bay		Station: 14
County:	Escambia County	Latitude: 30°31.5787'N
Sample Date:	5/20/2021	Longitude: 87°6.8735'W

Notes		
Oyster Presence:	No	
No oysters were found in this location. Partially submerged marsh grass was noted to have been found on-site.

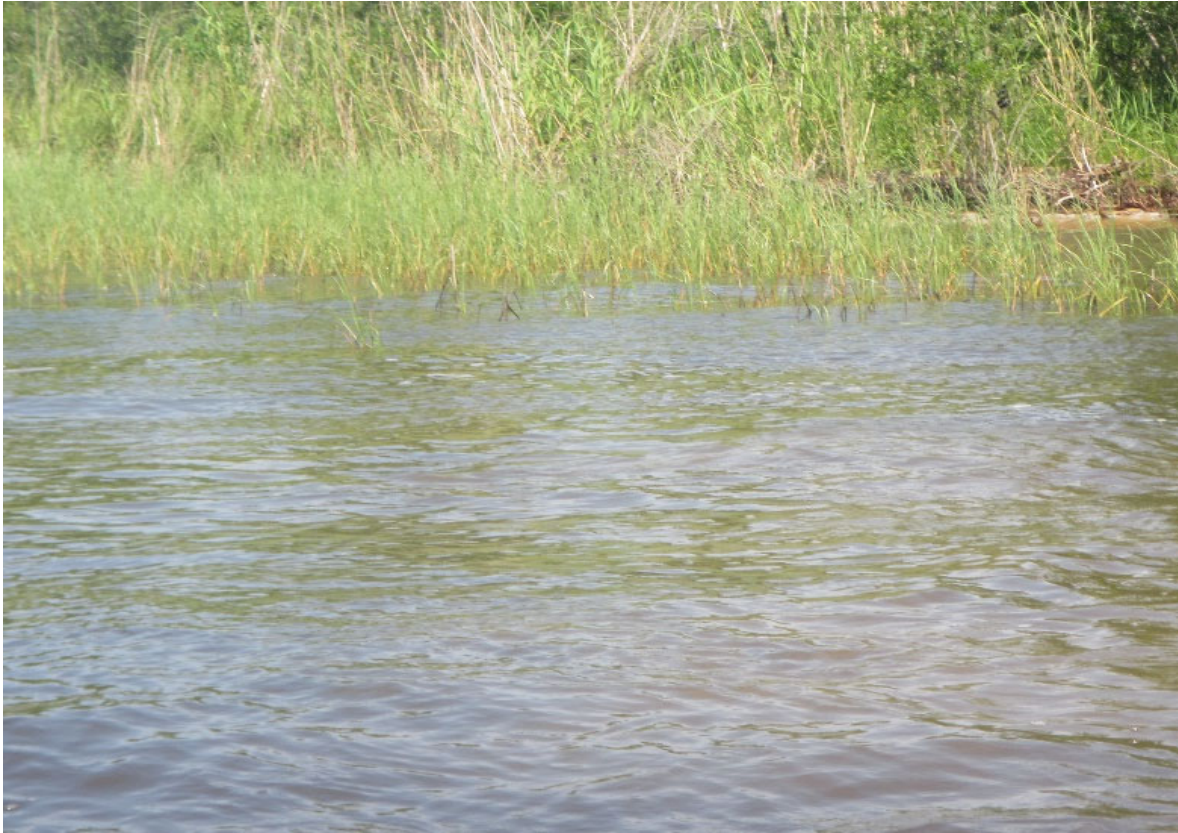
Figure 24. Station 15.

Intertidal Oyster Investigation		
Escambia Bay		Station: 15
County:	Escambia County	Latitude: 30°31.5416'N
Sample Date:	5/20/2021	Longitude: 87°6.7245'W

Notes		
Oyster Presence:	No	
No oysters were found in this location. Partially submerged marsh grass was noted to have been found on-site.

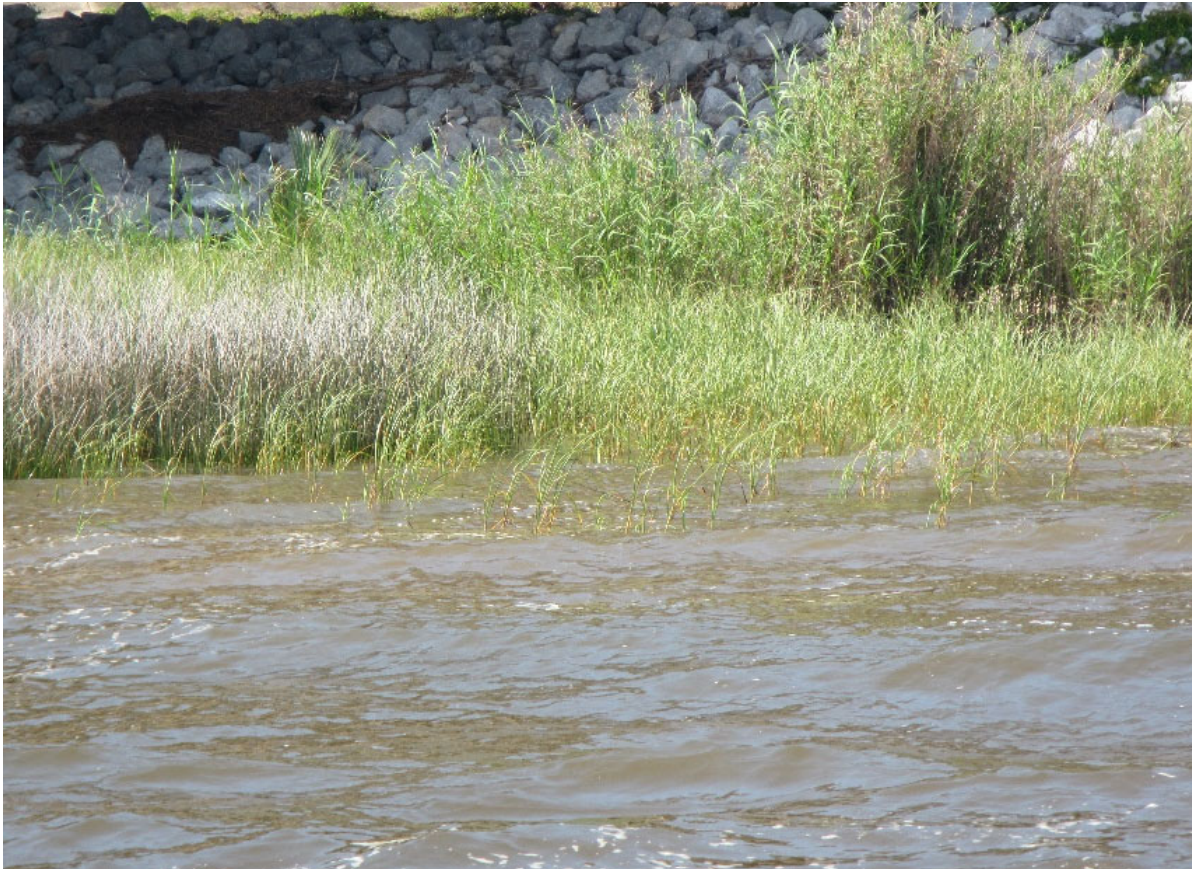
Figure 25. Station 16.

Intertidal Oyster Investigation		
Escambia Bay		Station: 16
County:	Escambia County	Latitude: 30°31.8129'N
Sample Date:	5/20/2021	Longitude: 87°7.7086'W

Notes		
Oyster Presence:	No	
No oysters were found in this location. Partially submerged marsh grass and rocks was noted to have been found on-site.

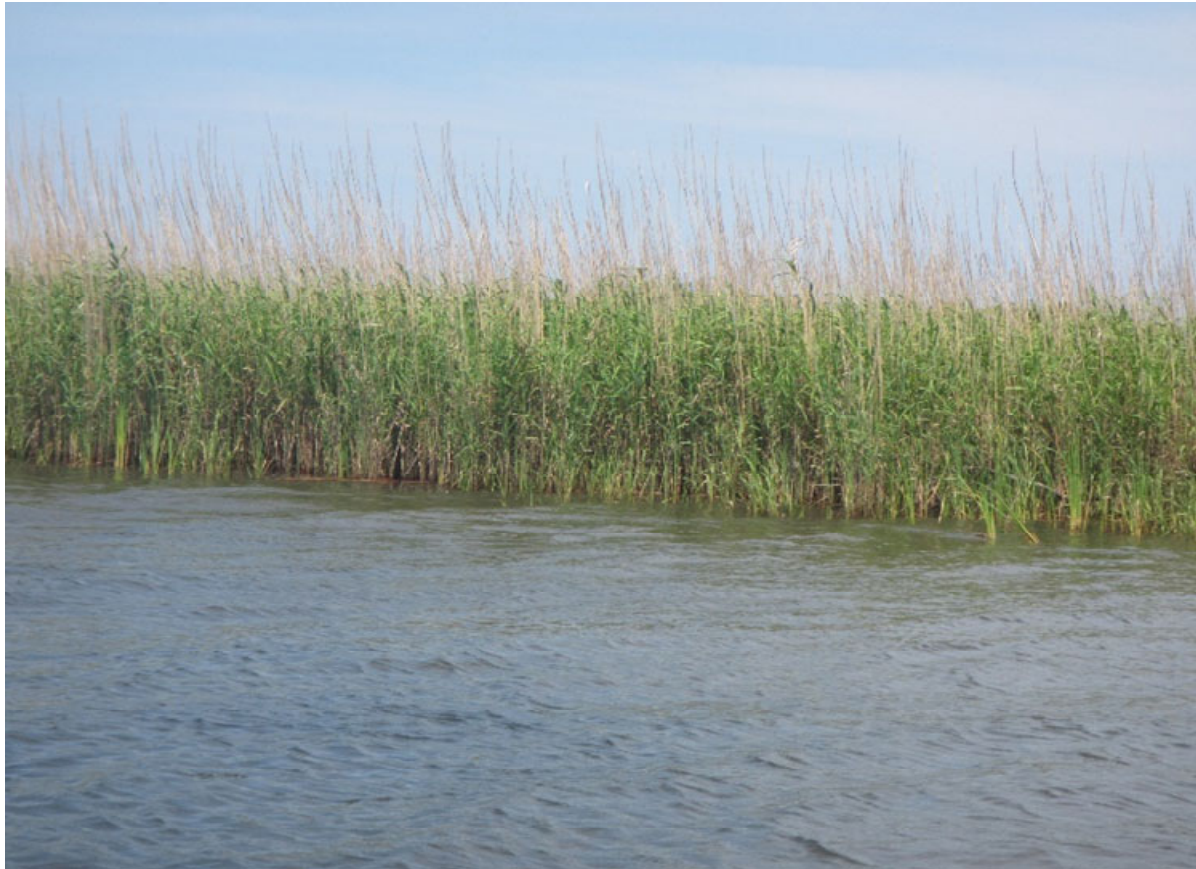
Figure 26. Station 17.

Intertidal Oyster Investigation		
<i>Escambia Bay</i>		
<i>Station:</i>		<i>17</i>
County:	Escambia County	Latitude: 30°31.9051'N
Sample Date:	5/20/2021	Longitude: 87°7.7777'W

Notes		
Oyster Presence:	No	
No oysters were found in this location. Partially submerged marsh grass was noted to have been found on-site.

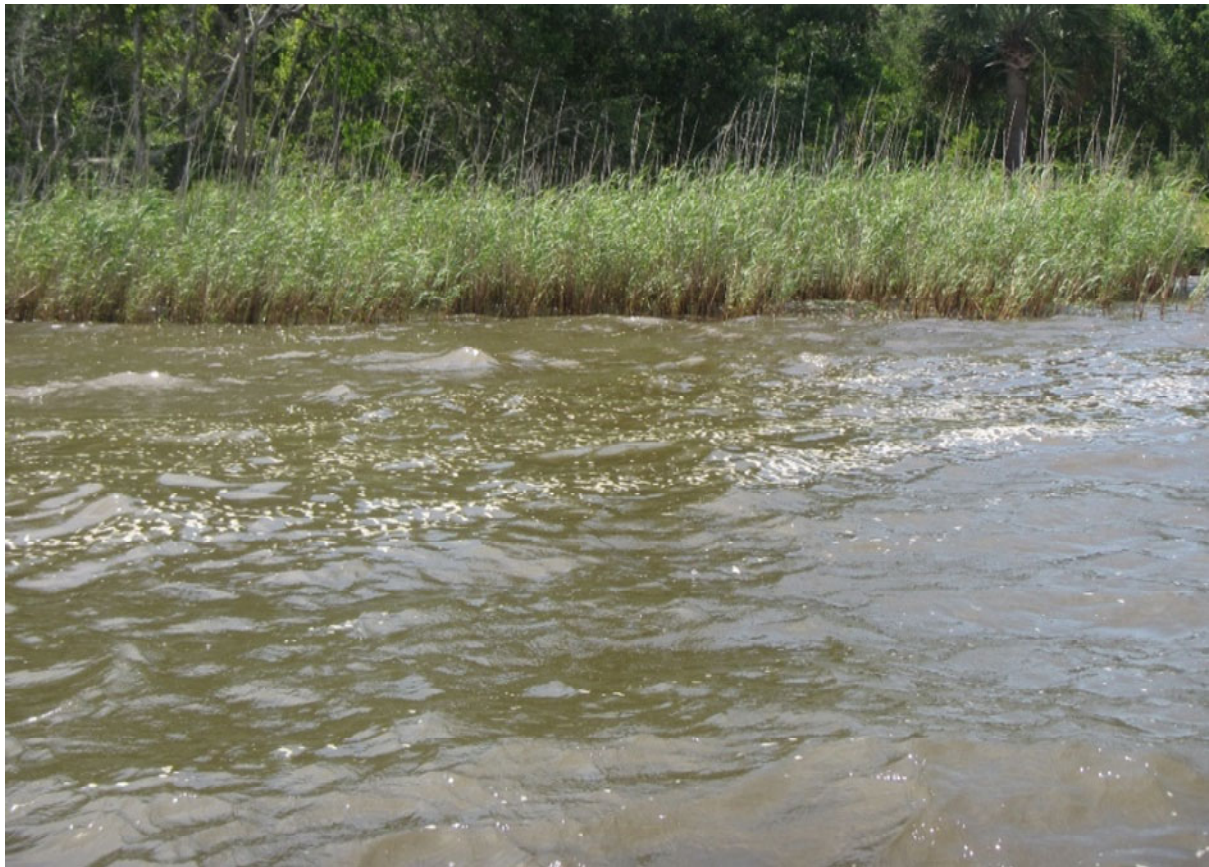
Figure 27. Station 18.

Intertidal Oyster Investigation		
Escambia Bay		Station: 18
County:	Escambia County	Latitude: 30°32.5169'N
Sample Date:	5/20/2021	Longitude: 87°10.8180'W

Notes		
Oyster Presence:	No	
<p>No oysters were found in this location. Partially submerged marsh grass and rocks was noted to have been found on-site.</p>

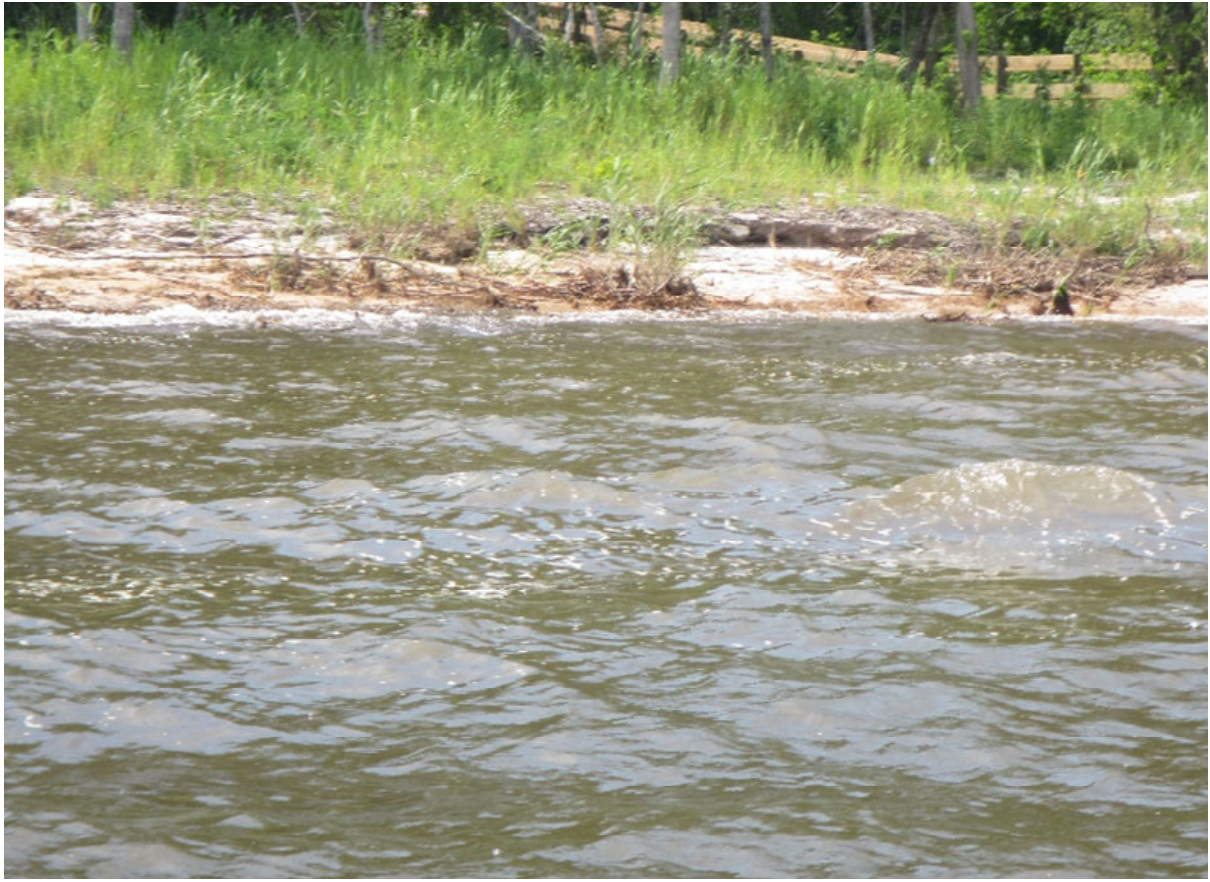
Figure 28. Station 19.

Intertidal Oyster Investigation		
Escambia Bay	Station:	19
County:	Escambia County	Latitude: 30°32.3762'N
Sample Date:	5/20/2021	Longitude: 87°11.2795'W

Notes		
Oyster Presence:	No	
<p>No oysters were found in this location. Partially submerged marsh grass was noted to have been found on-site.</p>

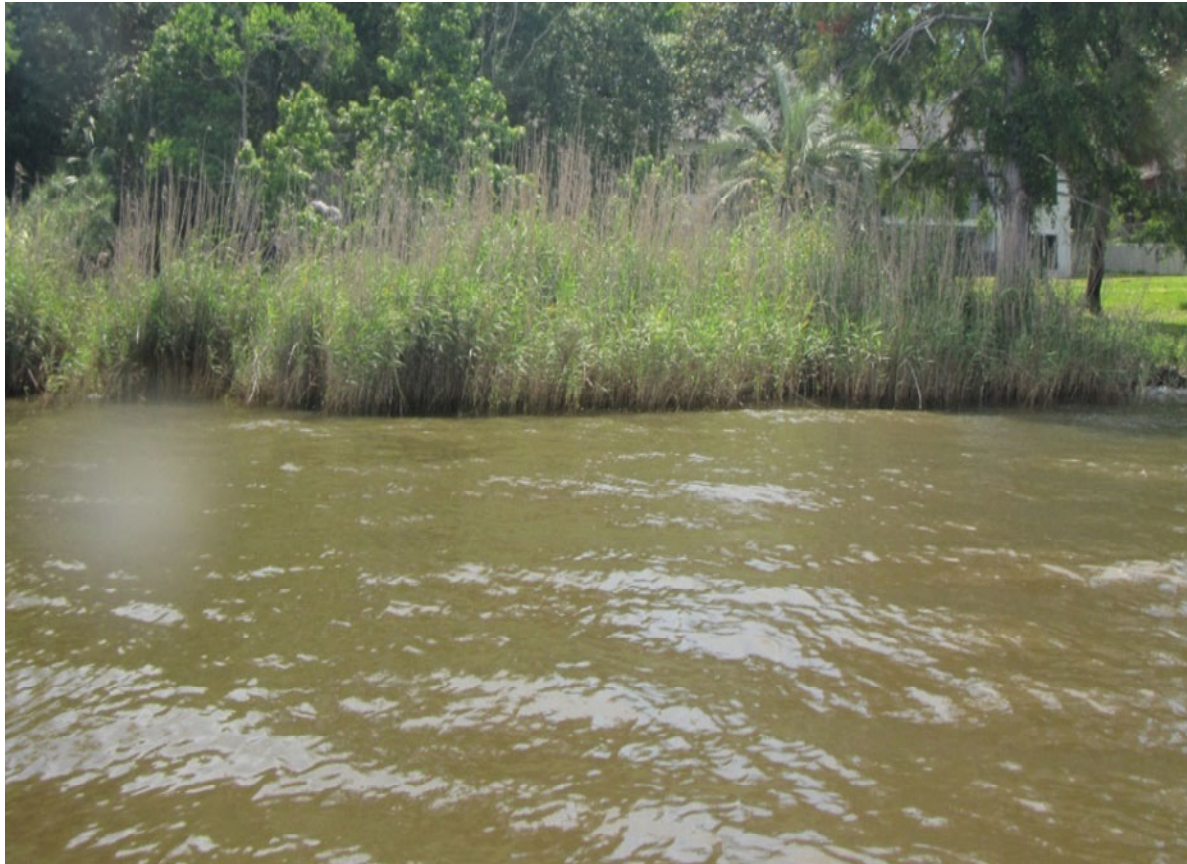
Figure 29. Station 20.

Intertidal Oyster Investigation		
Escambia Bay	Station	20
County:	Escambia County	Latitude: 30°32.2588'N
Sample Date:	5/20/2021	Longitude: 87°11.3245'W

Notes		
Oyster Presence:	No	
No oysters were found in this location. Partially submerged marsh grass was noted to have been found on-site.

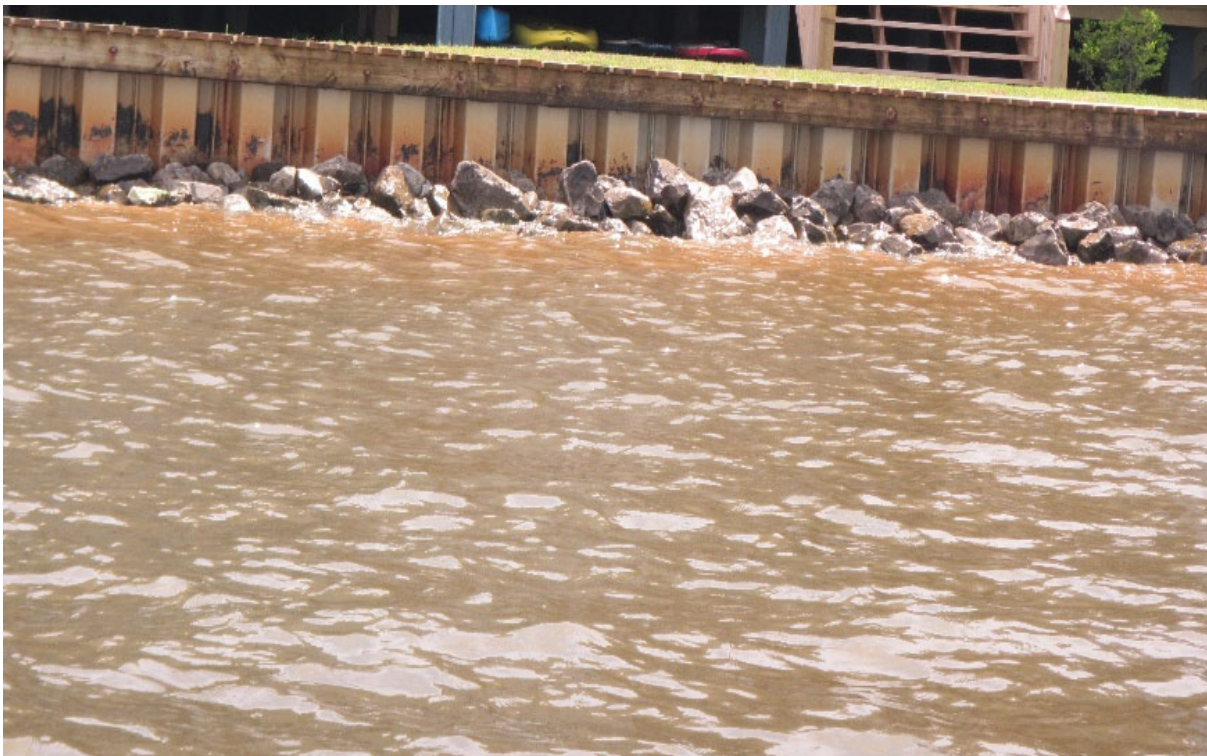
Figure 30. Station 21.

Intertidal Oyster Investigation		
Escambia Bay		Station 21
County:	Escambia County	Latitude: 30°31.9556'N
Sample Date:	5/20/2021	Longitude: 87°11.3232'W

Notes		
Oyster Presence:	No	
No oysters were present at site. Large piles of rocks, including some submerged rocks, were used for bulkhead material, were identified at this location. The surrounding water bottom was composed of sand.
