***ESCAMBIA BAY & PENSACOLA BAY
INTERTIDAL
OYSTER REEF
MAPPING & ASSESSMENT***

***Located in
Escambia Bay & Pensacola Bay
Escambia County
Florida***

***Prepared for
Escambia County, Florida***

***Prepared by
Gabriel Johnson
OLDEB Certified Oyster Biologist
MREC Environmental, LLC***

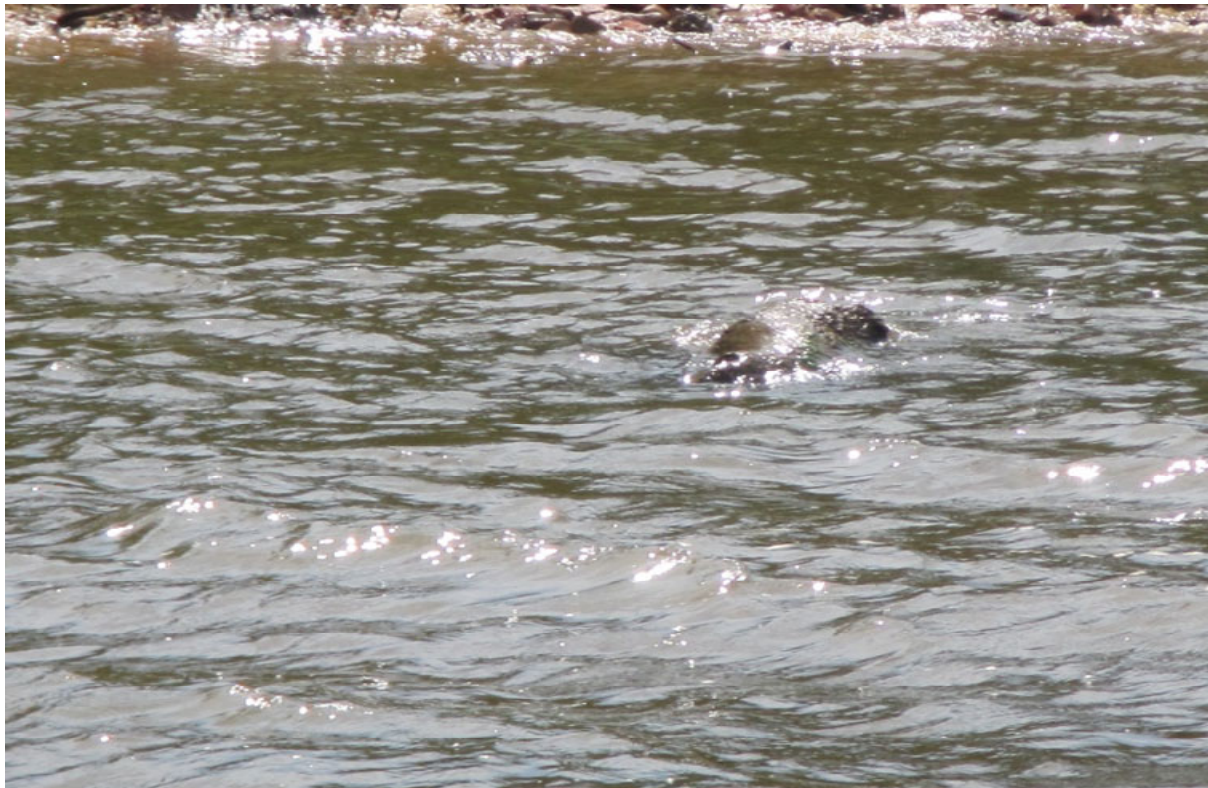
Figure 31. Station 22.

Intertidal Oyster Investigation		
Escambia Bay		Station: 22
County:	Escambia County	Latitude: 30°30.9974'N
Sample Date:	5/20/2021	Longitude: 87°9.8881'W

Notes		
Oyster Presence:	No	
<p>No oysters were present at site. Rocks and driftwood was noted to have been found on-site.</p>

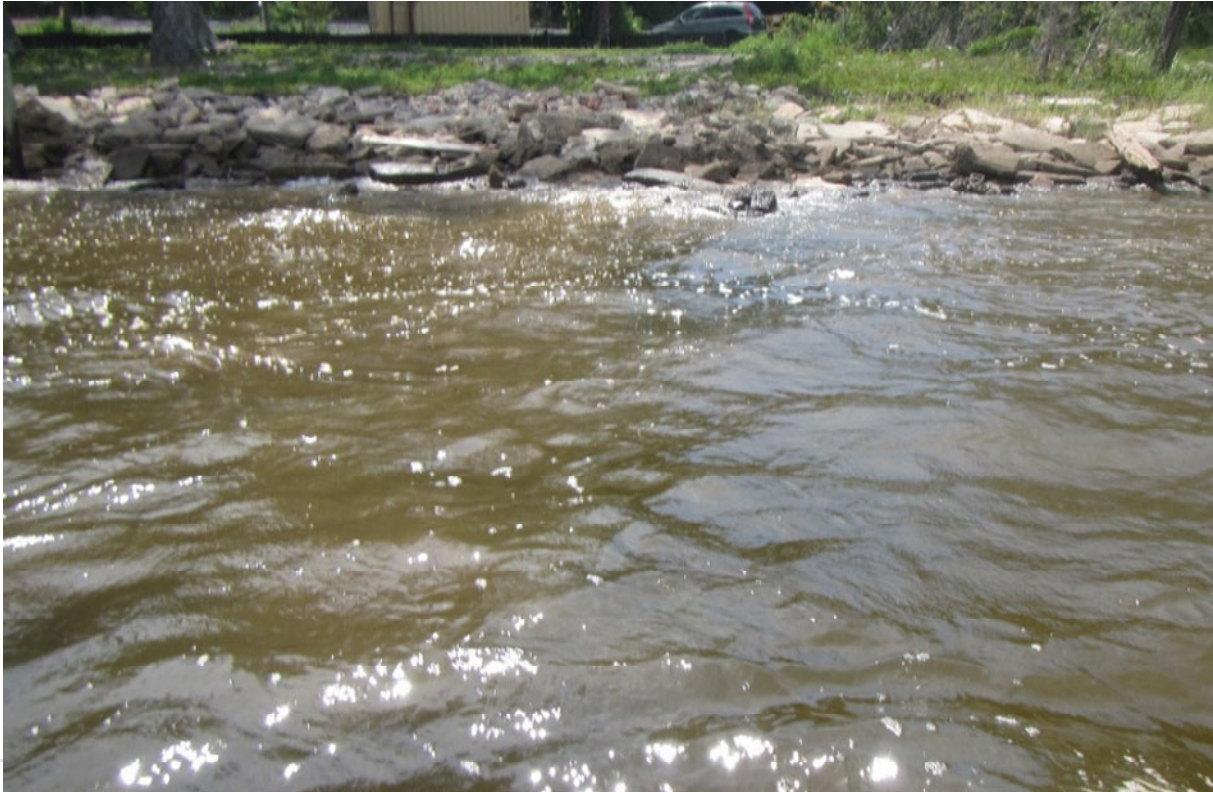
Figure 32. Station 23.

Intertidal Oyster Investigation		
<i>Escambia Bay</i>		
Station:		23
County:	Escambia County	Latitude: 30°28.1519'N
Sample Date:	5/20/2021	Longitude: 87°9.6073'W

Notes		
Oyster Presence:	No	
<p>No oysters were present at site. Large piles of rocks, including some submerged rocks, were used for bulkhead material, were identified at this location. The surrounding water bottom was composed of sand.</p>

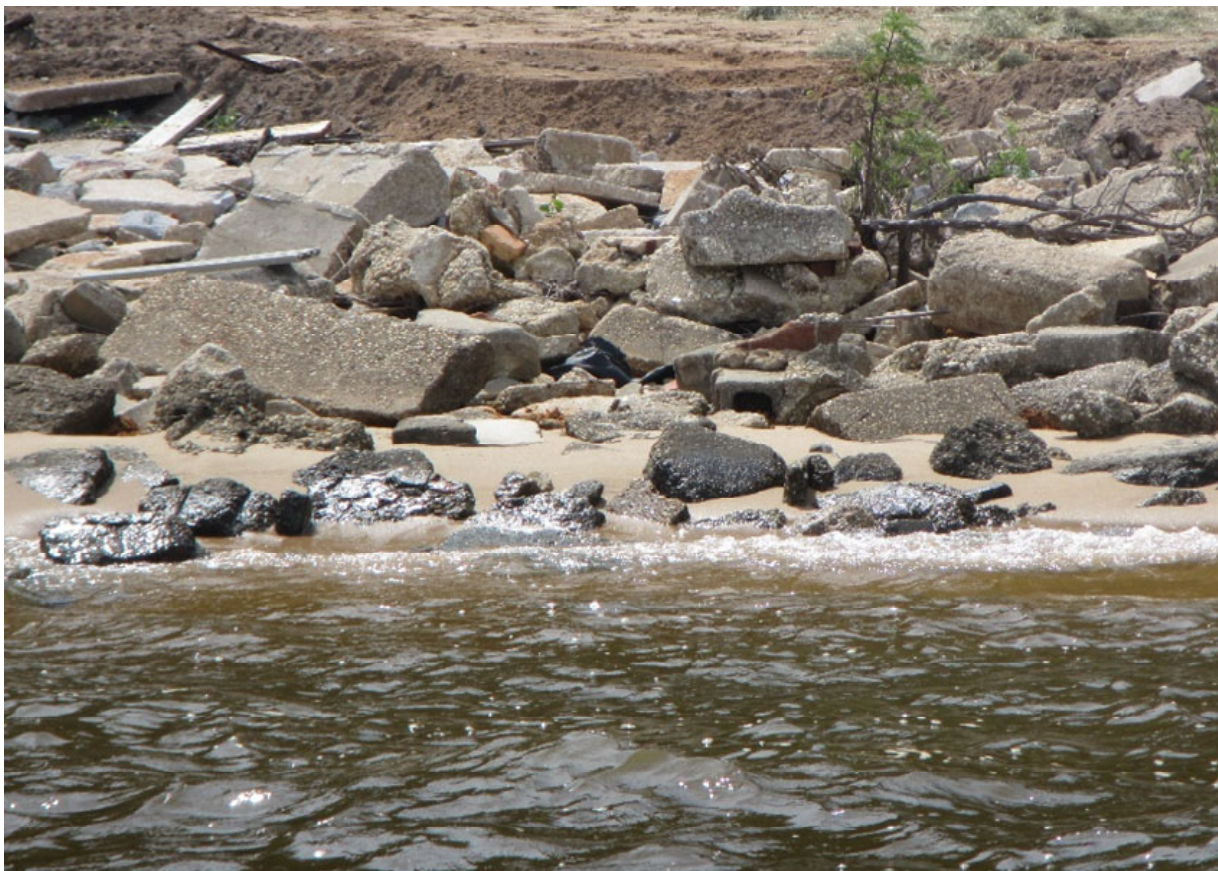
Figure 33. Station 24.

Intertidal Oyster Investigation		
Escambia Bay		Station: 24
County:	Escambia County	Latitude: 30°28.1407'N
Sample Date:	5/20/2021	Longitude: 87°9.6146'W

Notes		
Oyster Presence:	No	
No oysters were present at site. Submerged rocks and sandy shorelines were found on-site.

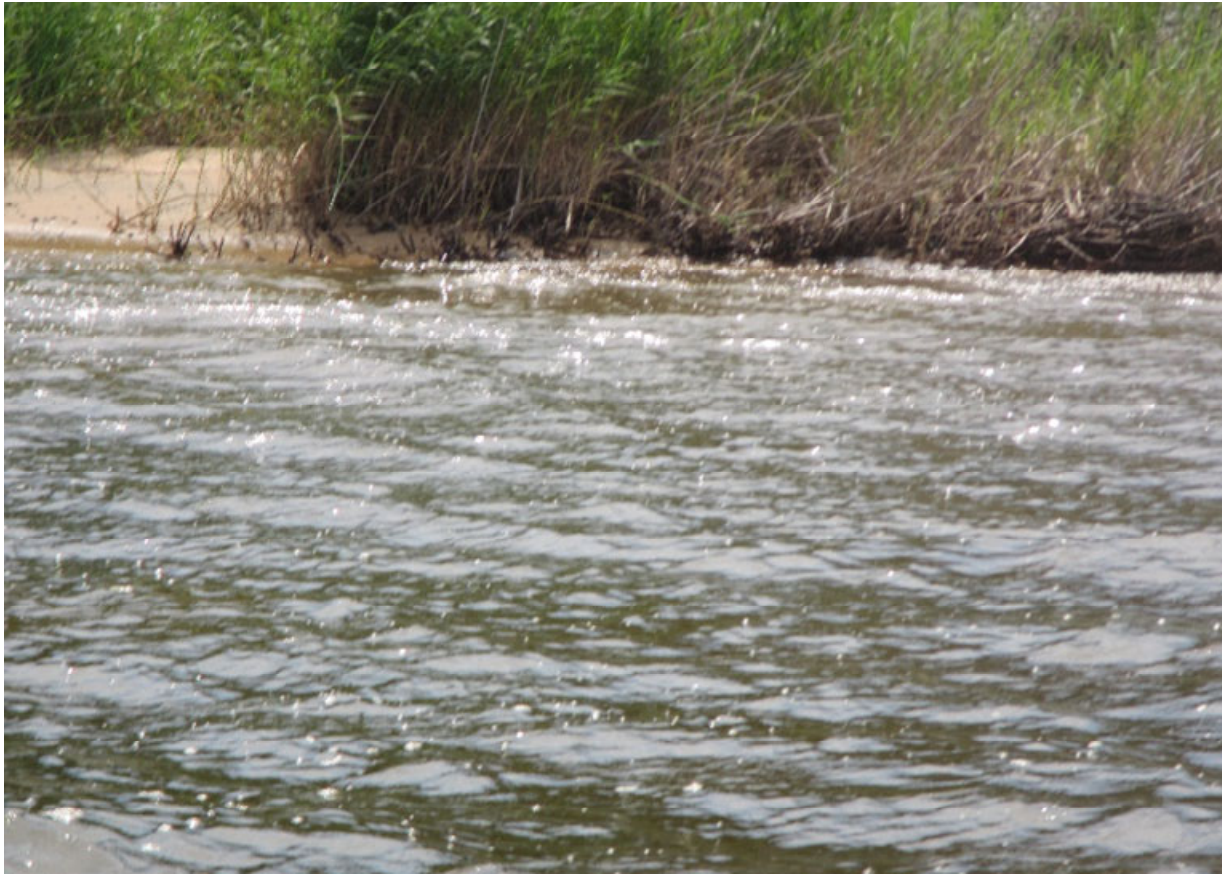
Figure 34. Station 25.

Intertidal Oyster Investigation		
Escambia Bay		Station: 25
County:	Escambia County	Latitude: 30°28.1141'N
Sample Date:	5/20/2021	Longitude: 87°9.6298'W

Notes		
Oyster Presence:	No	
No oysters present at site. Portions of driftwood were found on-site.

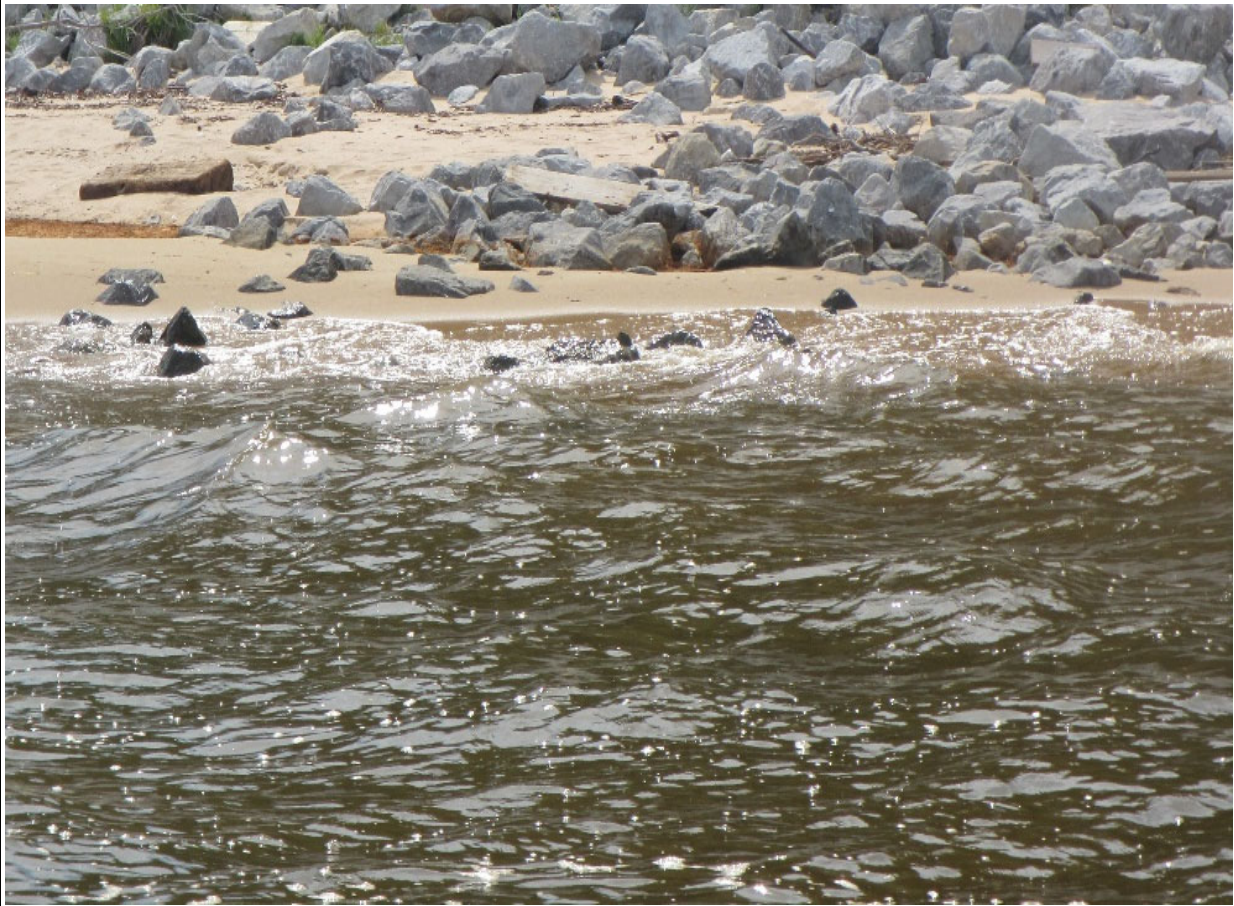
Figure 35. Station 26.

Intertidal Oyster Investigation		
Escambia Bay		Station: 26
County:	Escambia County	Latitude: 30°27.8175'N
Sample Date:	5/20/2021	Longitude: 87°9.7269'W

Notes		
Oyster Presence:	No	
No oysters were present at site. Submerged rocks was noted to be on-site.

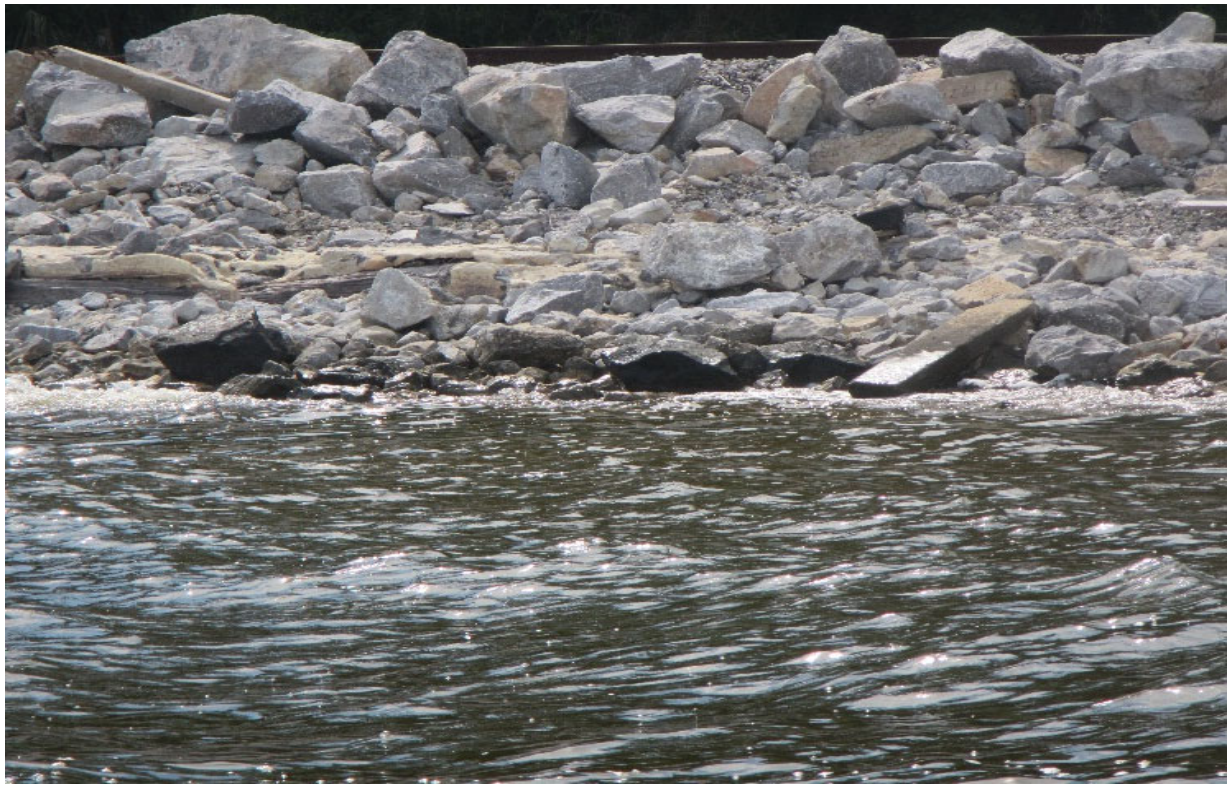
Figure 36. Station 27.

Intertidal Oyster Investigation		
Escambia Bay		Station: 27
County:	Escambia County	Latitude: 30°27.7766'N
Sample Date:	5/20/2021	Longitude: 87°9.7558'W

Notes		
Oyster Presence:	No	
No oysters were present at site. Large piles of rocks, including some submerged rocks, were used for bulkhead material, were identified at this location. The surrounding water bottom was composed of sand.

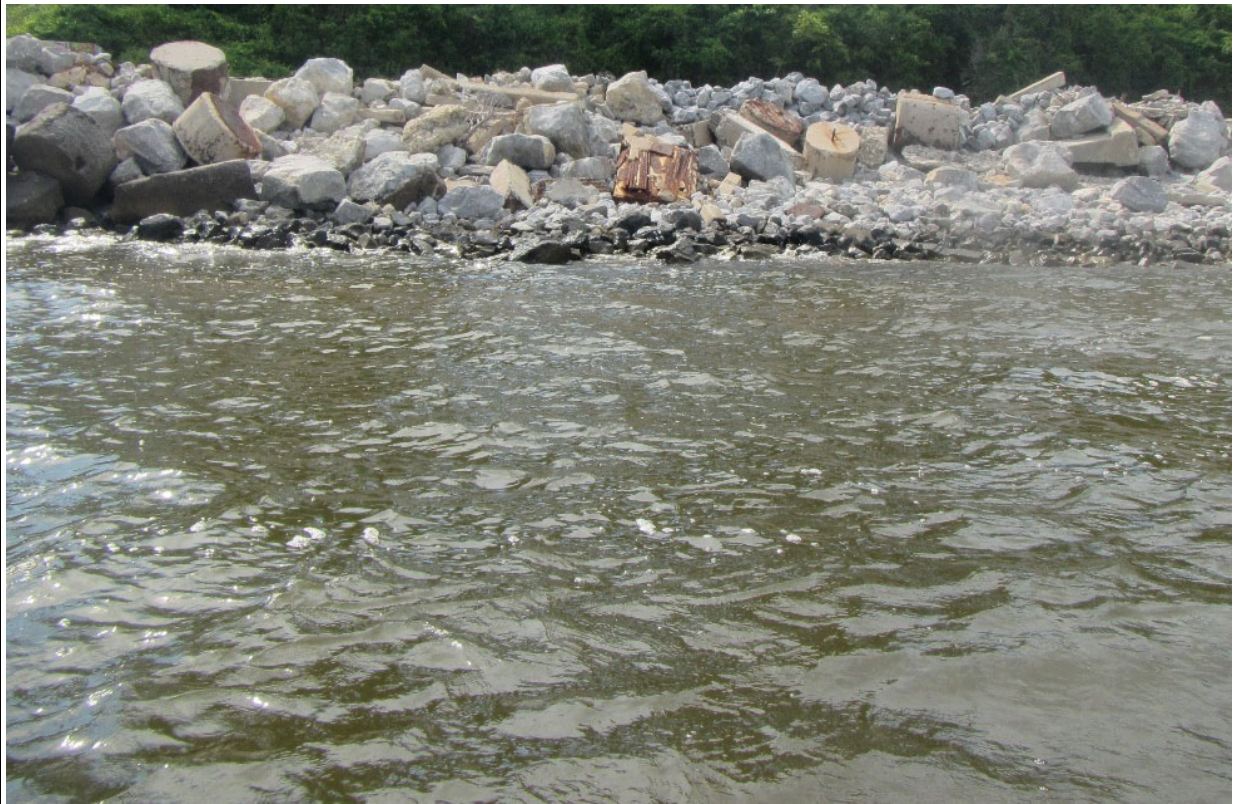
Figure 37. Station 28.

Intertidal Oyster Investigation		
Escambia Bay		Station: 28
County:	Escambia County	Latitude: 30°25.7565'N
Sample Date:	5/20/2021	Longitude: 87°10.4692'W

Notes		
Oyster Presence:	No	
No oysters were present at site. Large piles of rocks, including some submerged rocks, were used for bulkhead material, were identified at this location. The surrounding water bottom was composed of sand.

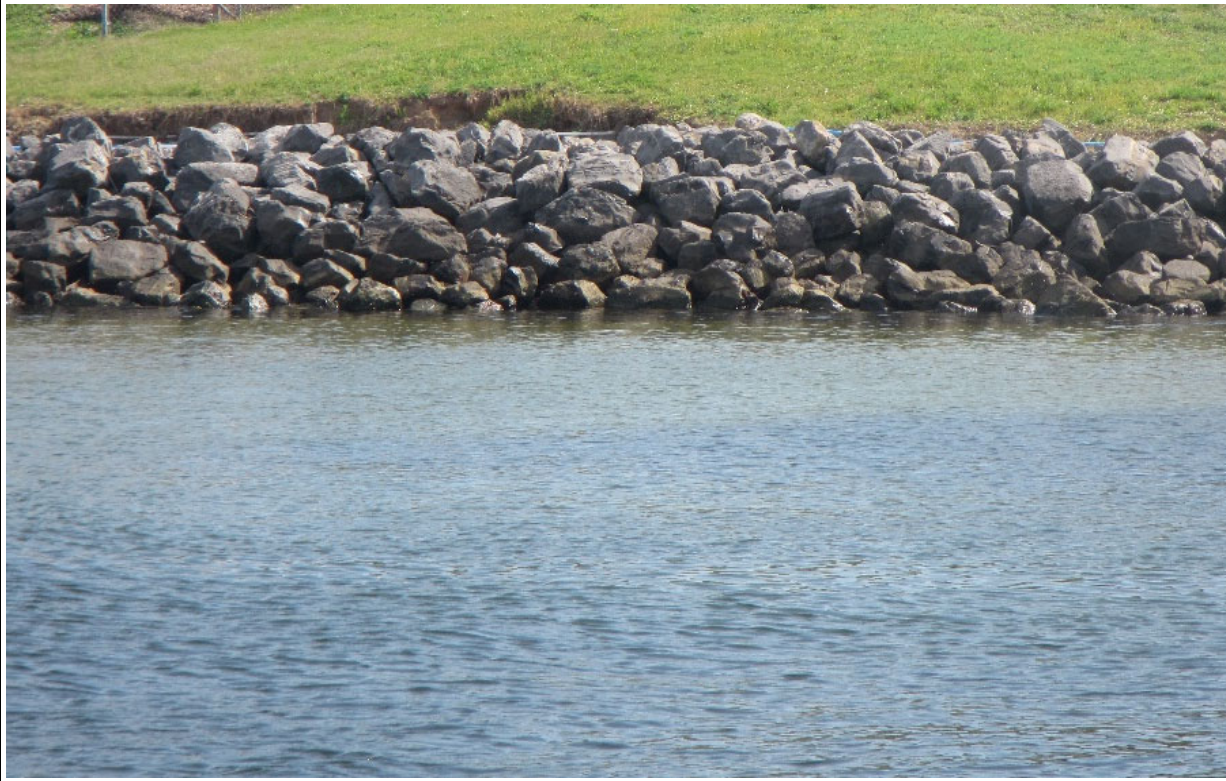
Figure 38. Station 29.

Intertidal Oyster Investigation		
Escambia Bay		Station: 29
County:	Escambia County	Latitude: 30°22.4610'N
Sample Date:	5/20/2021	Longitude: 87°10.6176'W

Notes		
Oyster Presence:	No	
No oysters were present at site. Large piles of rocks, including some submerged rocks, were used for bulkhead material, were identified at this location. The surrounding water bottom was composed of sand.

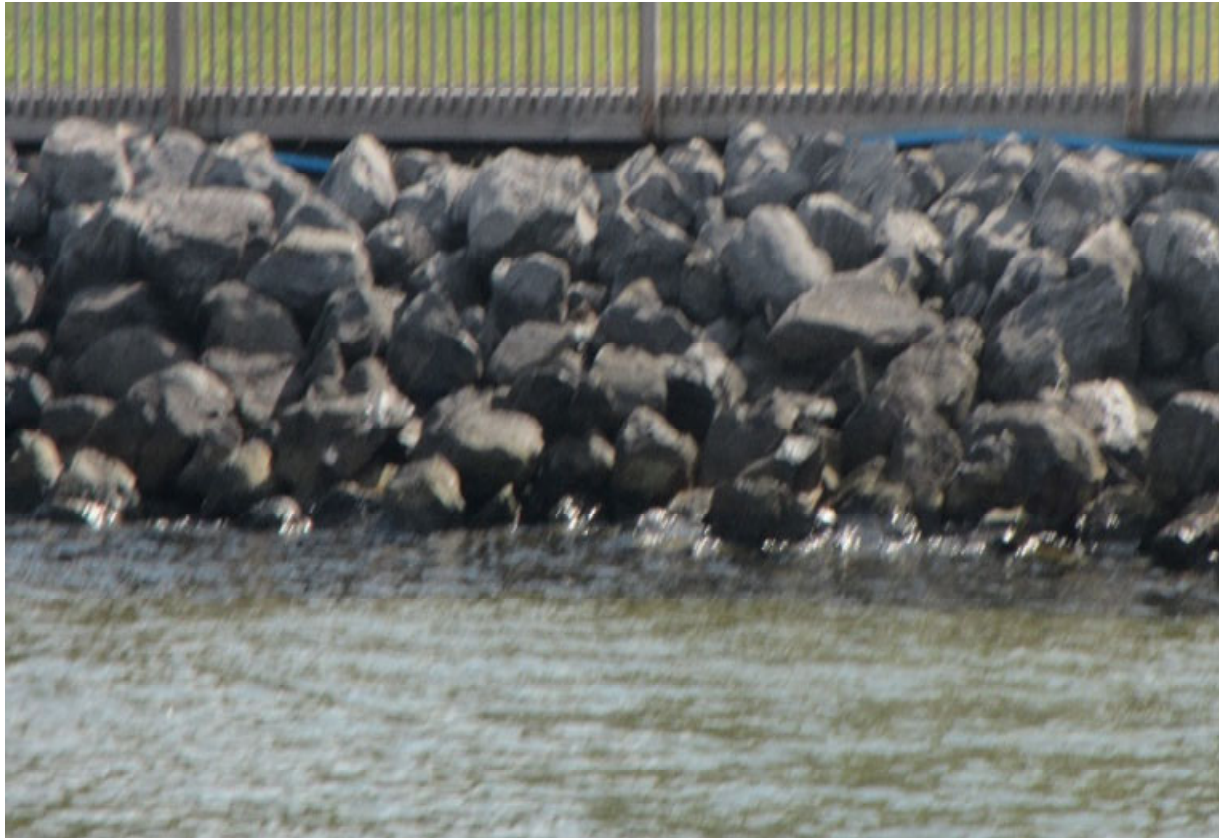
Figure 39. Station 30.

Intertidal Oyster Investigation			
<i>Pensacola Bay</i>		<i>Station:</i>	<i>30</i>
County:	Escambia County	Latitude:	30°22.4219'N
Sample Date:	5/20/2021	Longitude:	87°10.5728'W

Notes			
Oyster Presence:	No		
<p>No oysters were present at this site. Large piles of pieces of rocks used for bulkhead material, including submerged rocks, were identified at this location. The surrounding water bottom in this location was sandy.</p>

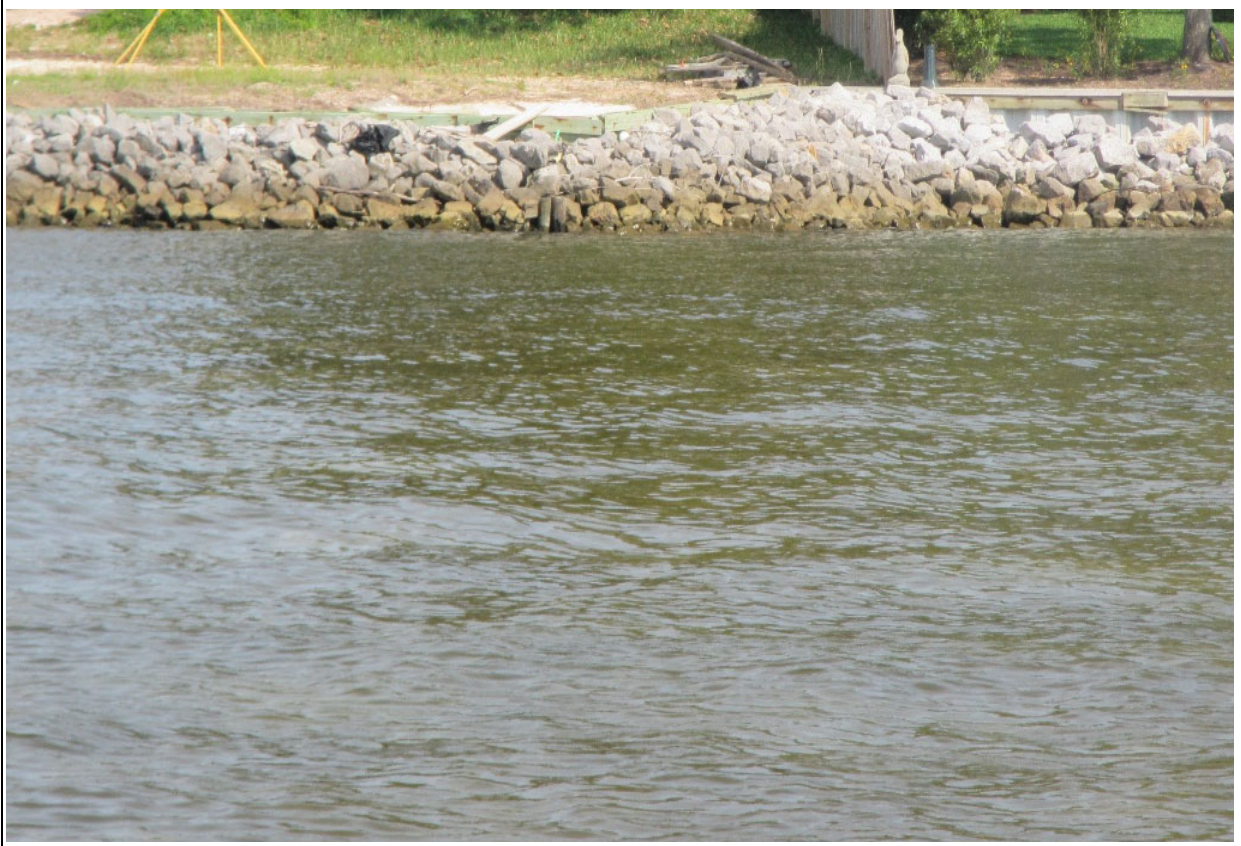
Figure 40. Station 31.

Intertidal Oyster Investigation		
<i>Pensacola Bay</i>		<i>Station: 31</i>
County:	Escambia County	Latitude: 30°22.8491'N
Sample Date:	5/20/2021	Longitude: 87°08.0508'W

Notes		
Oyster Presence:	No	
No oysters were present at this site. Large piles of pieces of rocks used for bulkhead material, including submerged rocks, were identified at this location. The surrounding water bottom in this location was sandy.

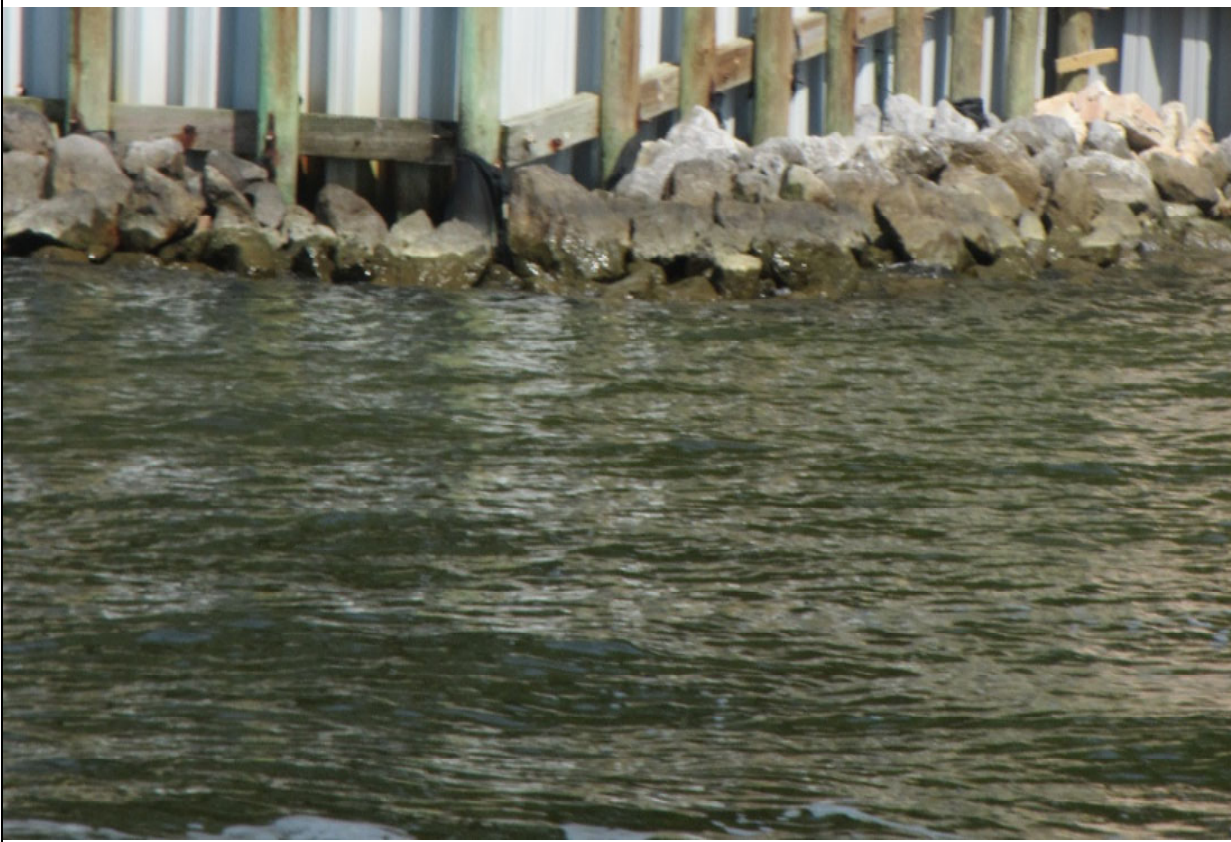
Figure 41. Station 32.

Intertidal Oyster Investigation		
<i>Pensacola Bay</i>		
<i>Station:</i>		32
County:	Escambia County	Latitude: 30°22.9132'N
Sample Date:	5/20/2021	Longitude: 87°07.9403'W

Notes		
Oyster Presence:	No	
No oysters were present at this site. Large piles of pieces of rocks used for bulkhead material, including submerged rocks, were identified at this location. The surrounding water bottom in this location was sandy.

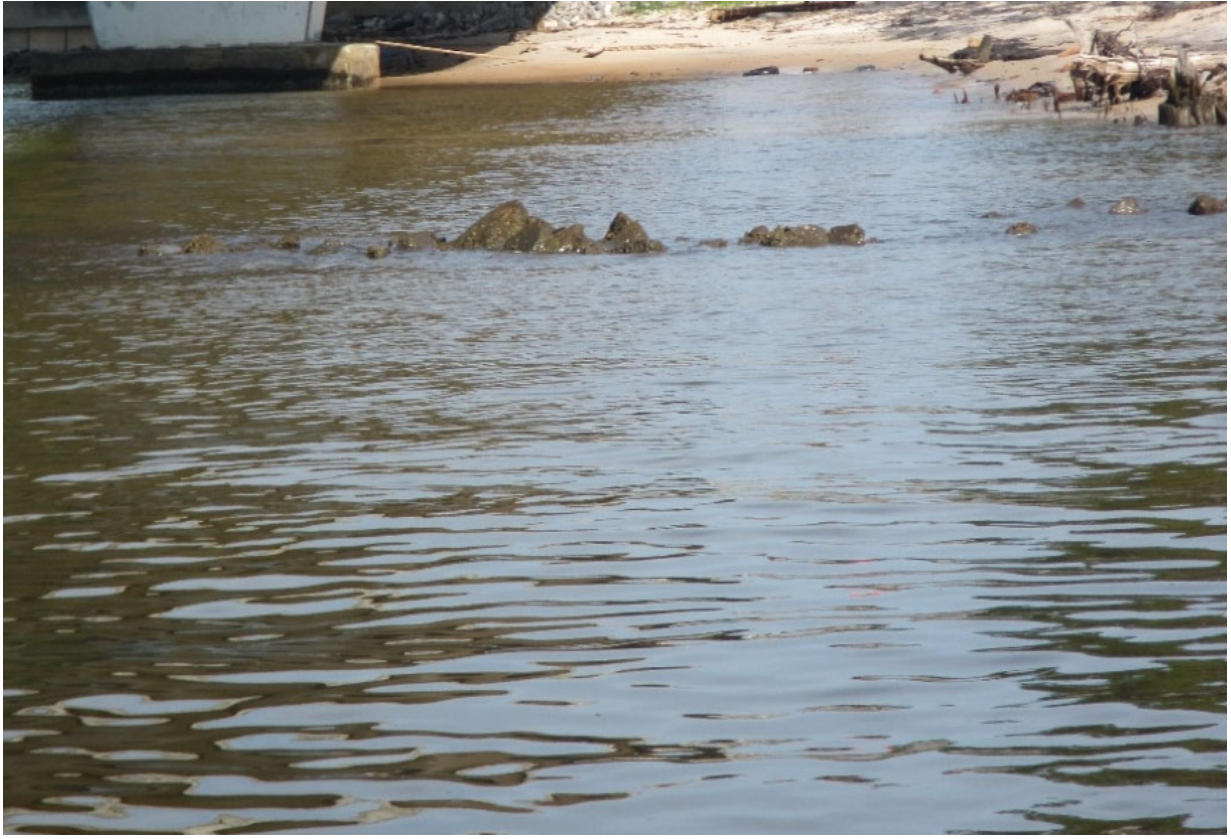
Figure 42. Station 33.

Intertidal Oyster Investigation		
<i>Pensacola Bay</i>		
Station:		33
County:	Escambia County	Latitude: 30°23.9597'N
Sample Date:	5/20/2021	Longitude: 87°04.6291'W

Notes		
Oyster Presence:	No	
<p>No oysters were present at this site. Large piles of submerged rocks were identified at this location. The surrounding water bottom in this location was sandy.</p>
