ESCAMBIA BAY & PENSACOLA BAY SUBTIDAL OYSTER REEF MAPPING & ASSESSMENT

Located in Escambia Bay & Pensacola Bay Escambia County Florida

Prepared for Pensacola and Perdido Bays Estuary Program

> Prepared by Gabriel Johnson OLDEB Certified Oyster Biologist MREC Environmental, LLC

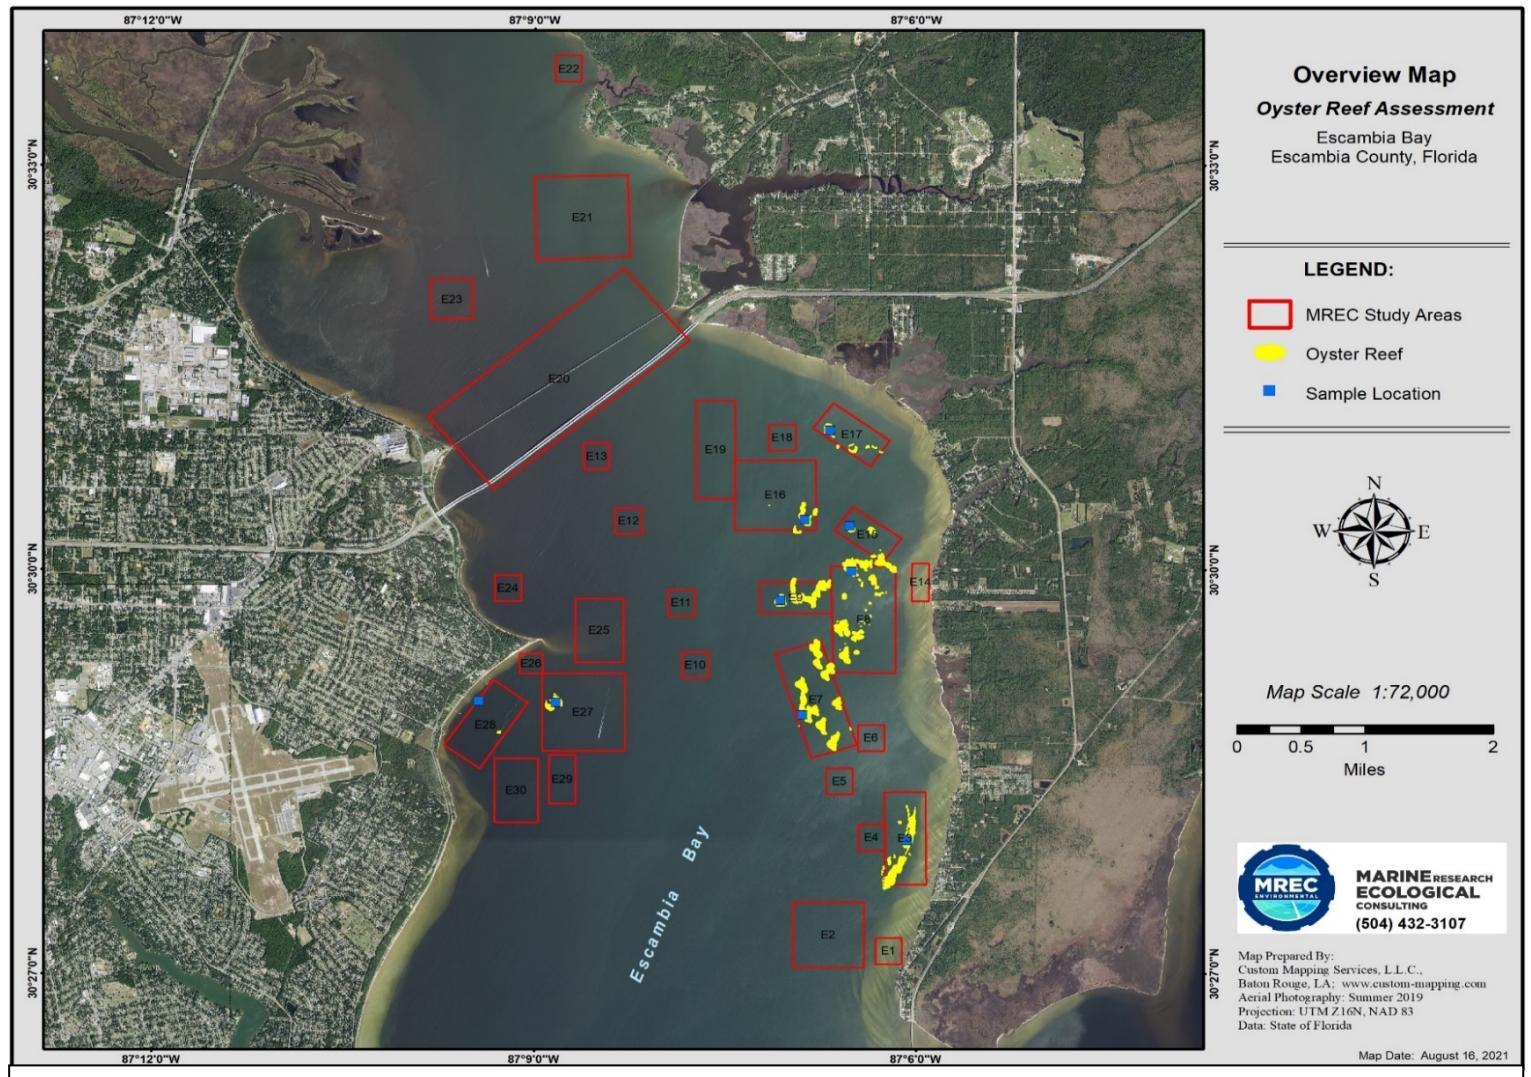
Figure 1. The 30 study areas in Escambia Bay, including found reef and sample site locations.

The Escambia Bay assessment covered a total of 4,050.7 acres in 30 study areas. Forty percent of the study areas contained exposed shell, and only 30% of the study areas contained exposed reef (9 of 30 areas) (Figure 1 and Table A), resulting in 190.3 acres of reef and 45.7 acres of exposed shell (Table B). The present reef is found within the depth ranges of 6.00ft-10.0ft. The reef and shell areas were often surrounded by soft/mud sand and/or moderately firm mud/sand. Of the exposed shell, 78% was found in the eastern portion of the bay, and of the reef, 96% was found in the eastern portion of the bay. Live oysters were found in 5 of the 9 areas where samples were performed. Individual sample data can be found in Appendix A.

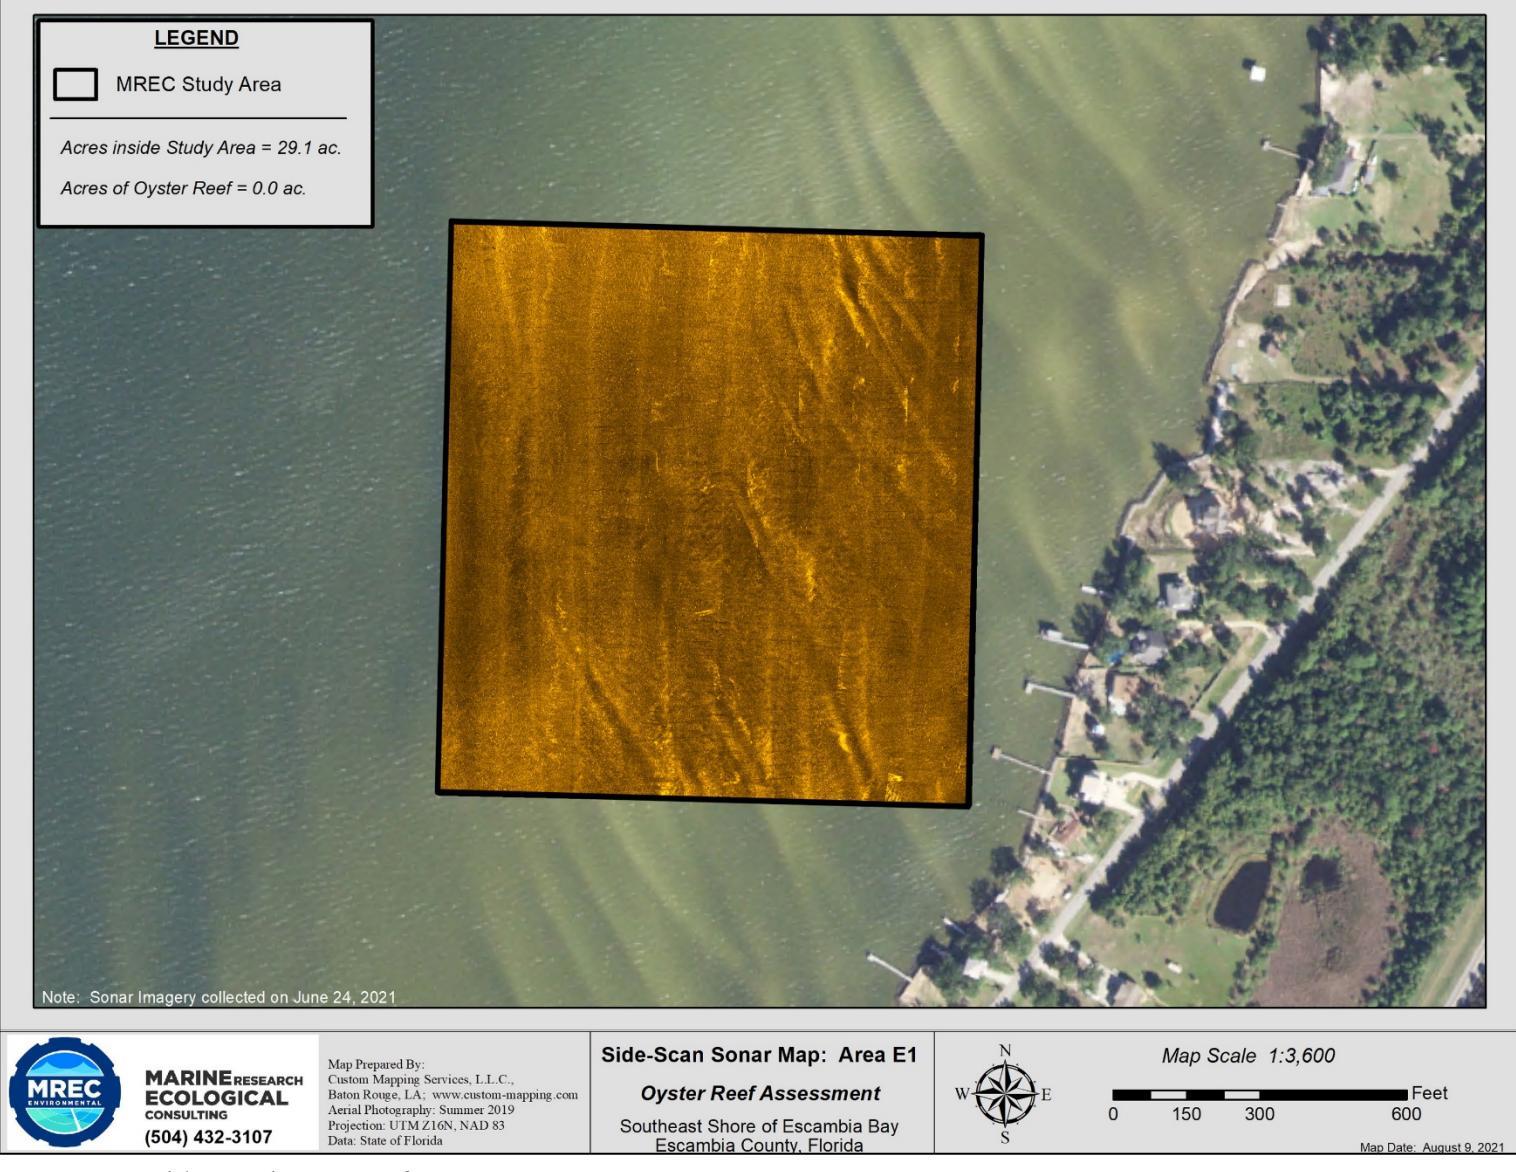
Figure 4. Sidescan imagery of area E1.

Area E1, consisted of 29.1 acres total in study with water depth ranges between 3.0ft – 6.0ft. The different bottom types present within the study area included 1.8 acres of moderately firm mud/sand, and 27.3 acres of sand. There was no reef found within the study area. Bottom type composition, sidescan imagery, and bathymetry are shown in Figures 3, 4, and 5, respectively.

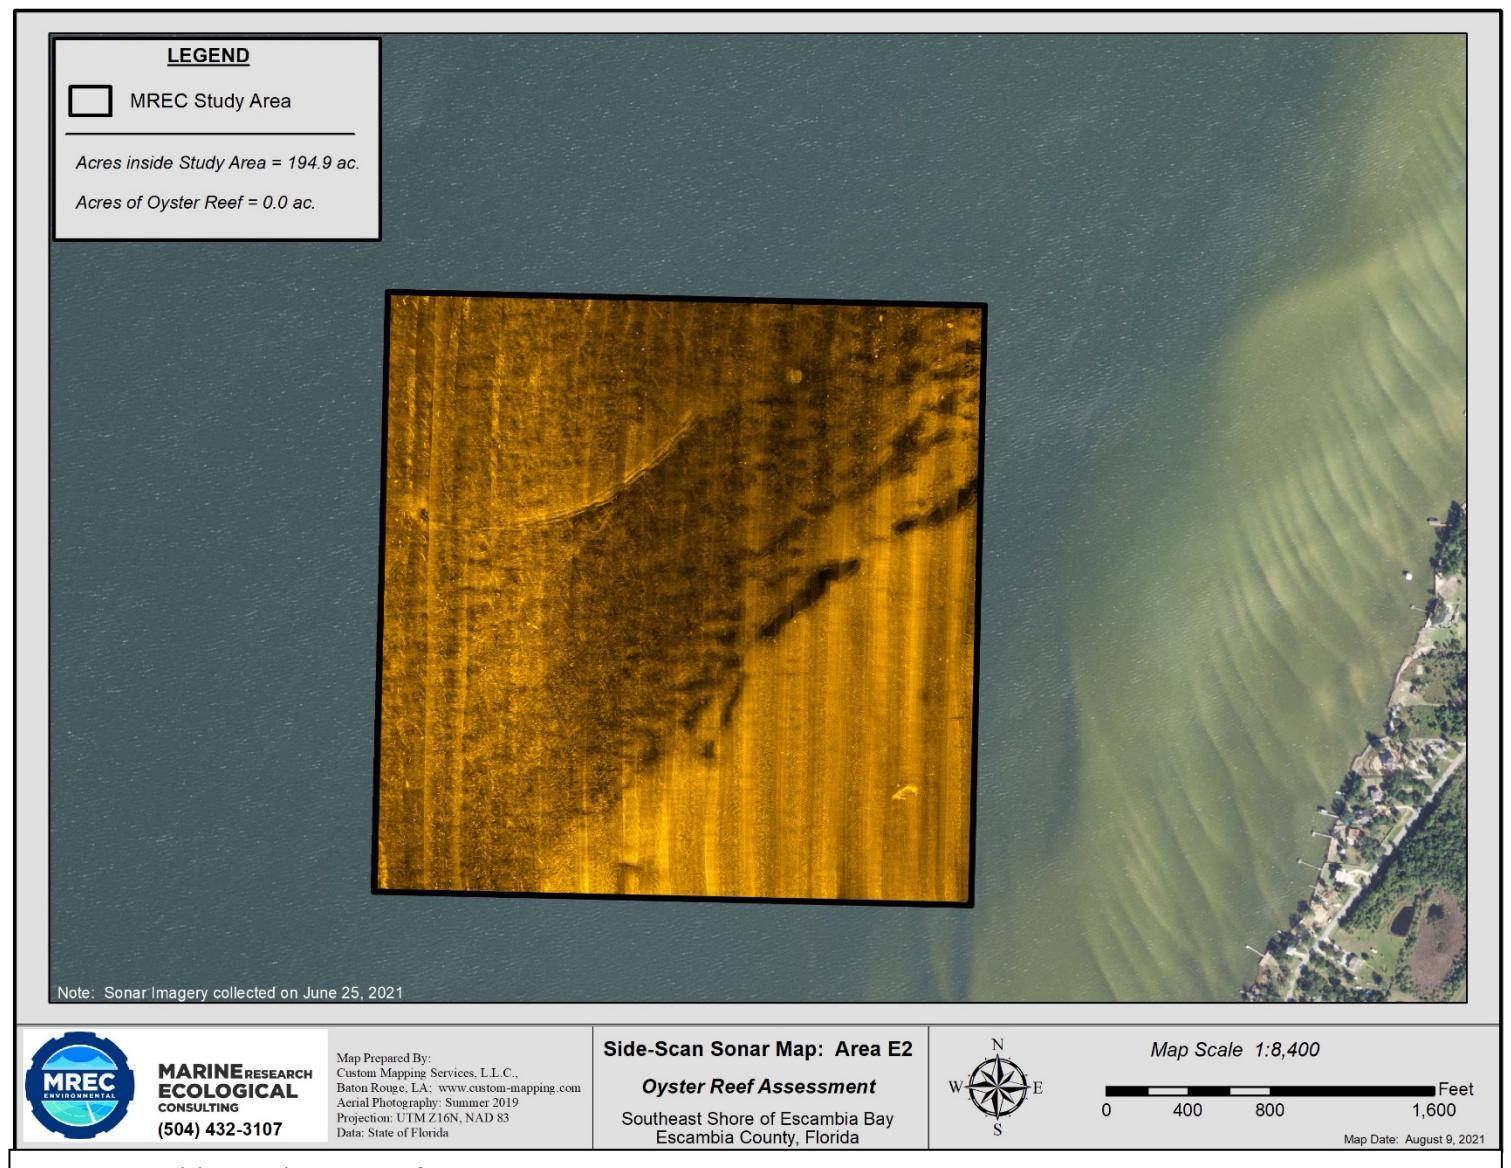
Figure 7. Sidescan imagery of area E2.

Area E2 consisted of 194.9 acres total in study with water depth ranges between 6.5ft – 13.0ft. The different bottom types present within the study area included 48.5 acres of soft mud/sand, 2.10 acres of buried shell, 89.4 acres of moderately firm mud/sand, 0.20 acres of exposed oyster shell, and 54.6 acres of sand. There was no reef found within the study area. Dissolved oxygen reading was 5.21 mg/L. Surface salinity was 6.2 ppt, while bottom salinity was 6.8 ppt. Surface temperature was 30.9°C, while bottom temperature was 30.6°C. Bottom type composition and bathymetry are shown in Figures 6, 7, and 8, respectively.

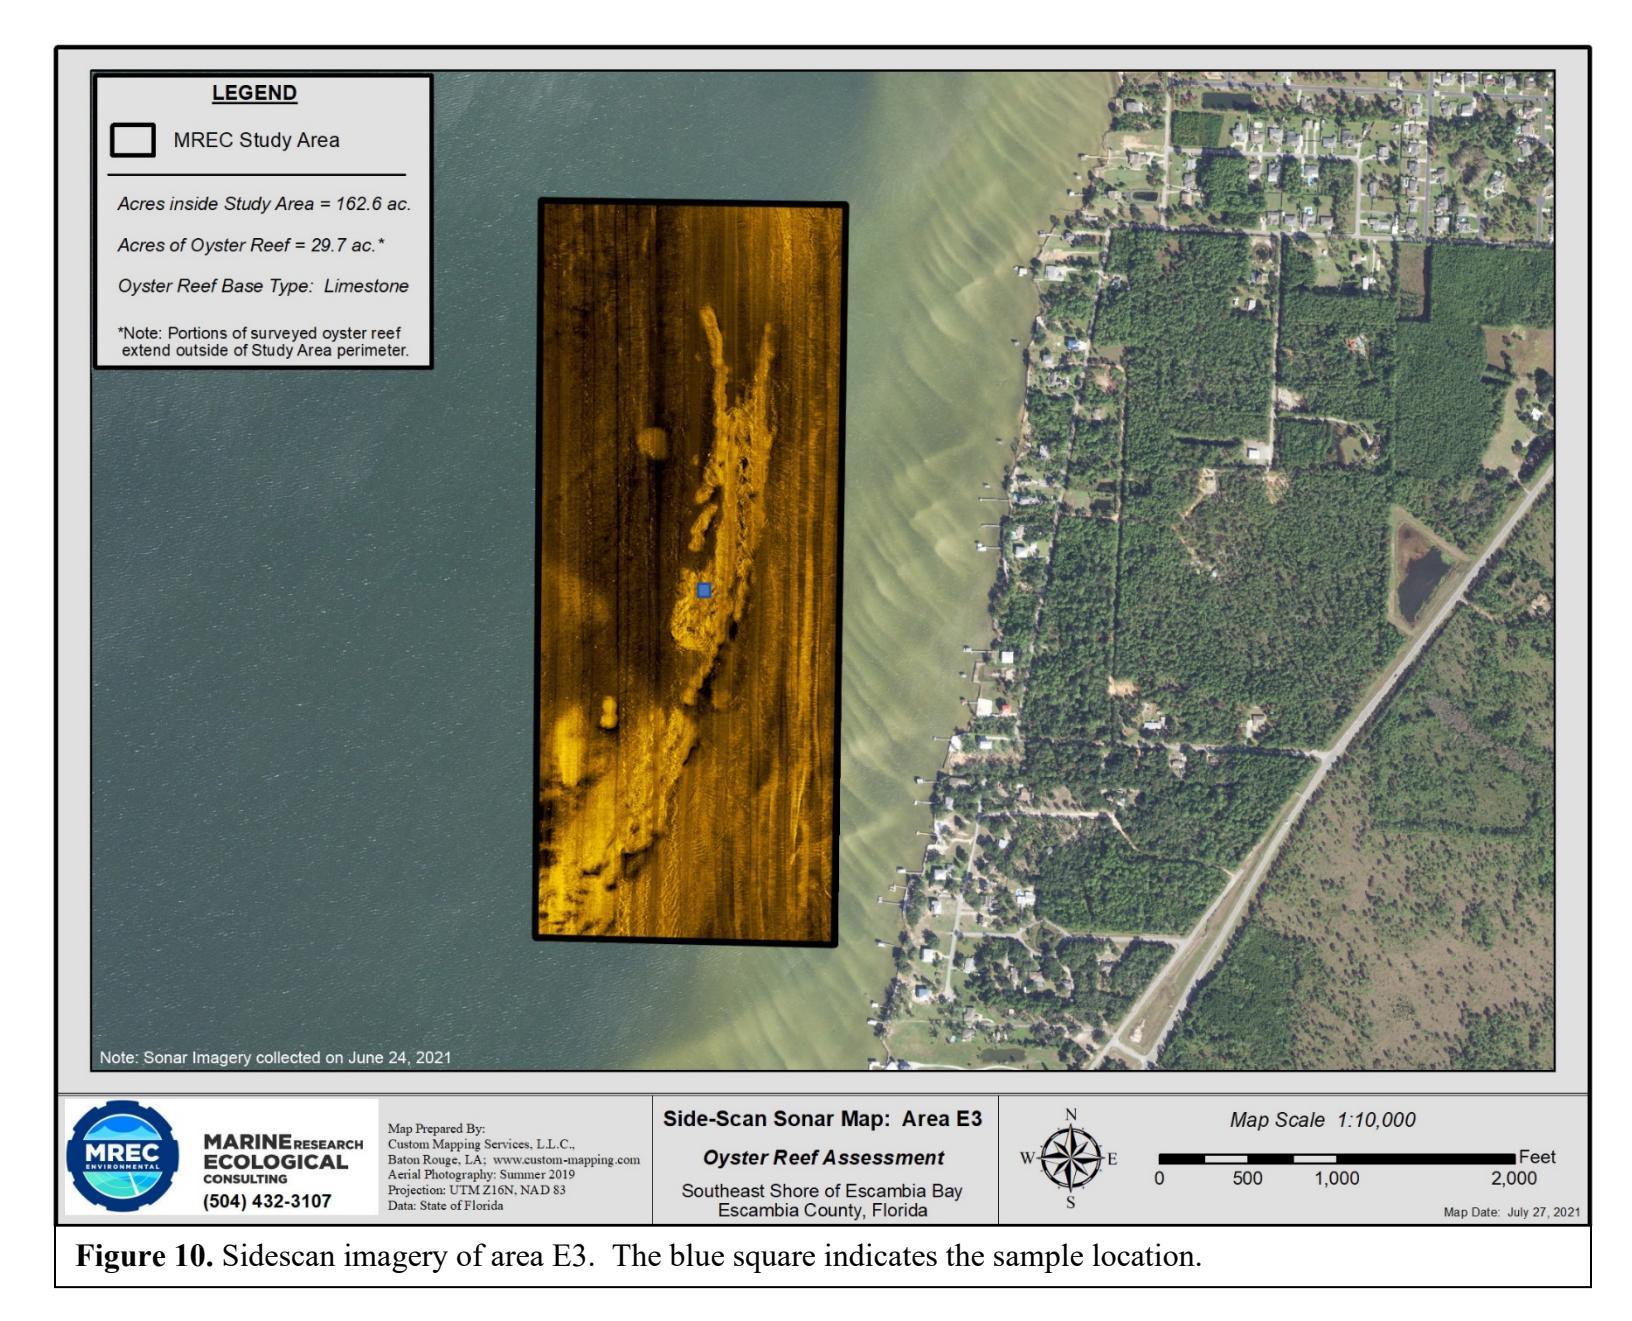
Figure 11. Bathymetry of area E3.

Area E3 consisted of 165.4 acres total in study with water depth ranges between 3.0ft - 11.5ft. The different bottom types present within the study area included 21.9 acres of soft mud/sand, 1.20 acres of buried shell, 46.0 acres of moderately firm mud/sand, 0.90 acres of exposed oyster shell, 65.7 acres of sand, and 29.7 acres of reef. Reef was relatively at level with surrounding soft/mud sand with a vertical relief of about 0in.-6in. The reef consisted of limestone and fragmented cultch material which held both live and dead spat. All shells obtained were gray in color. Reef organisms found in samples included barnacles, oyster drills, hermit crabs, mud crabs, and mussels. Dissolved oxygen reading was 5.95 mg/L. Surface salinity was 6.0 ppt, while bottom salinity was 7.0 ppt. Surface temperature was 30.8°C, while bottom temperature was 30.3°C. Bottom type composition and bathymetry are shown in Figures 9, 10, and 11, respectively.

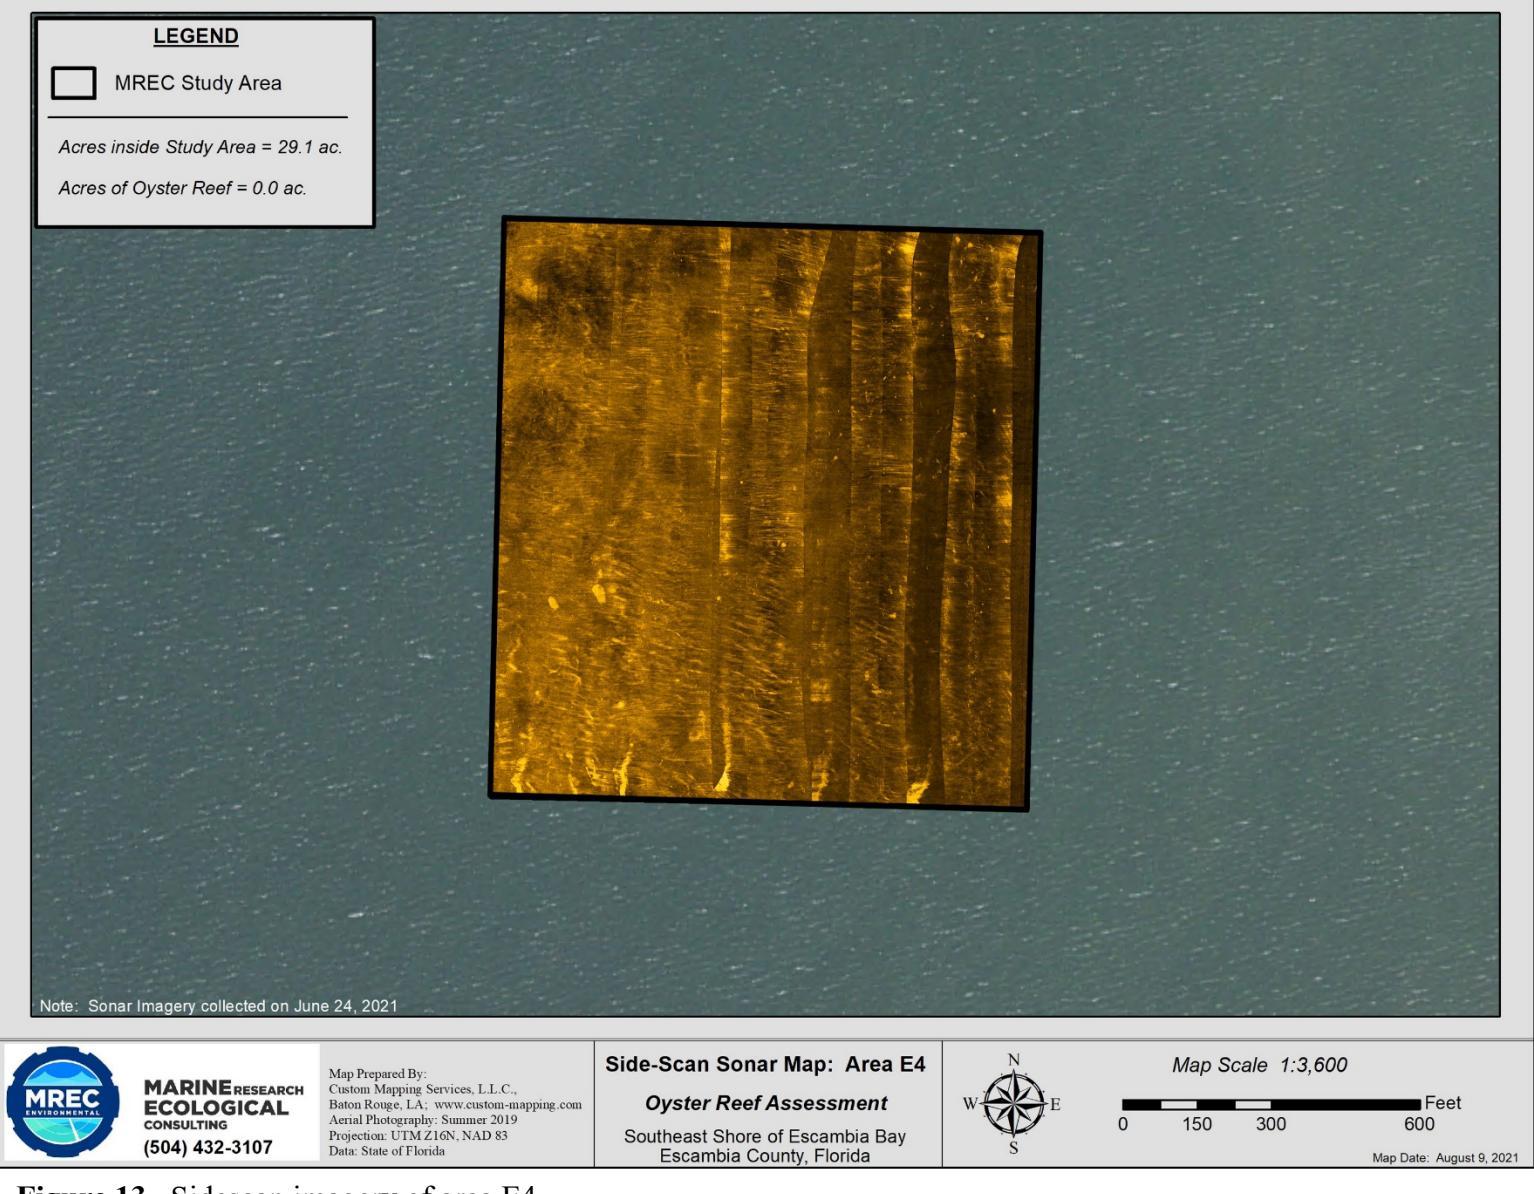
Figure 13. Sidescan imagery of area E4.

Area E4 consisted of 29.1 acres total in study with water depth ranges between 10.5ft – 11.0ft. The different bottom types present within the study area included 9.3 acres of soft mud/sand, and 19.8 acres of moderately firm mud/sand. There was no reef found within the study area. Bottom type composition, sidescan imagery, and bathymetry are shown in Figures 12, 13, and 14, respectively.

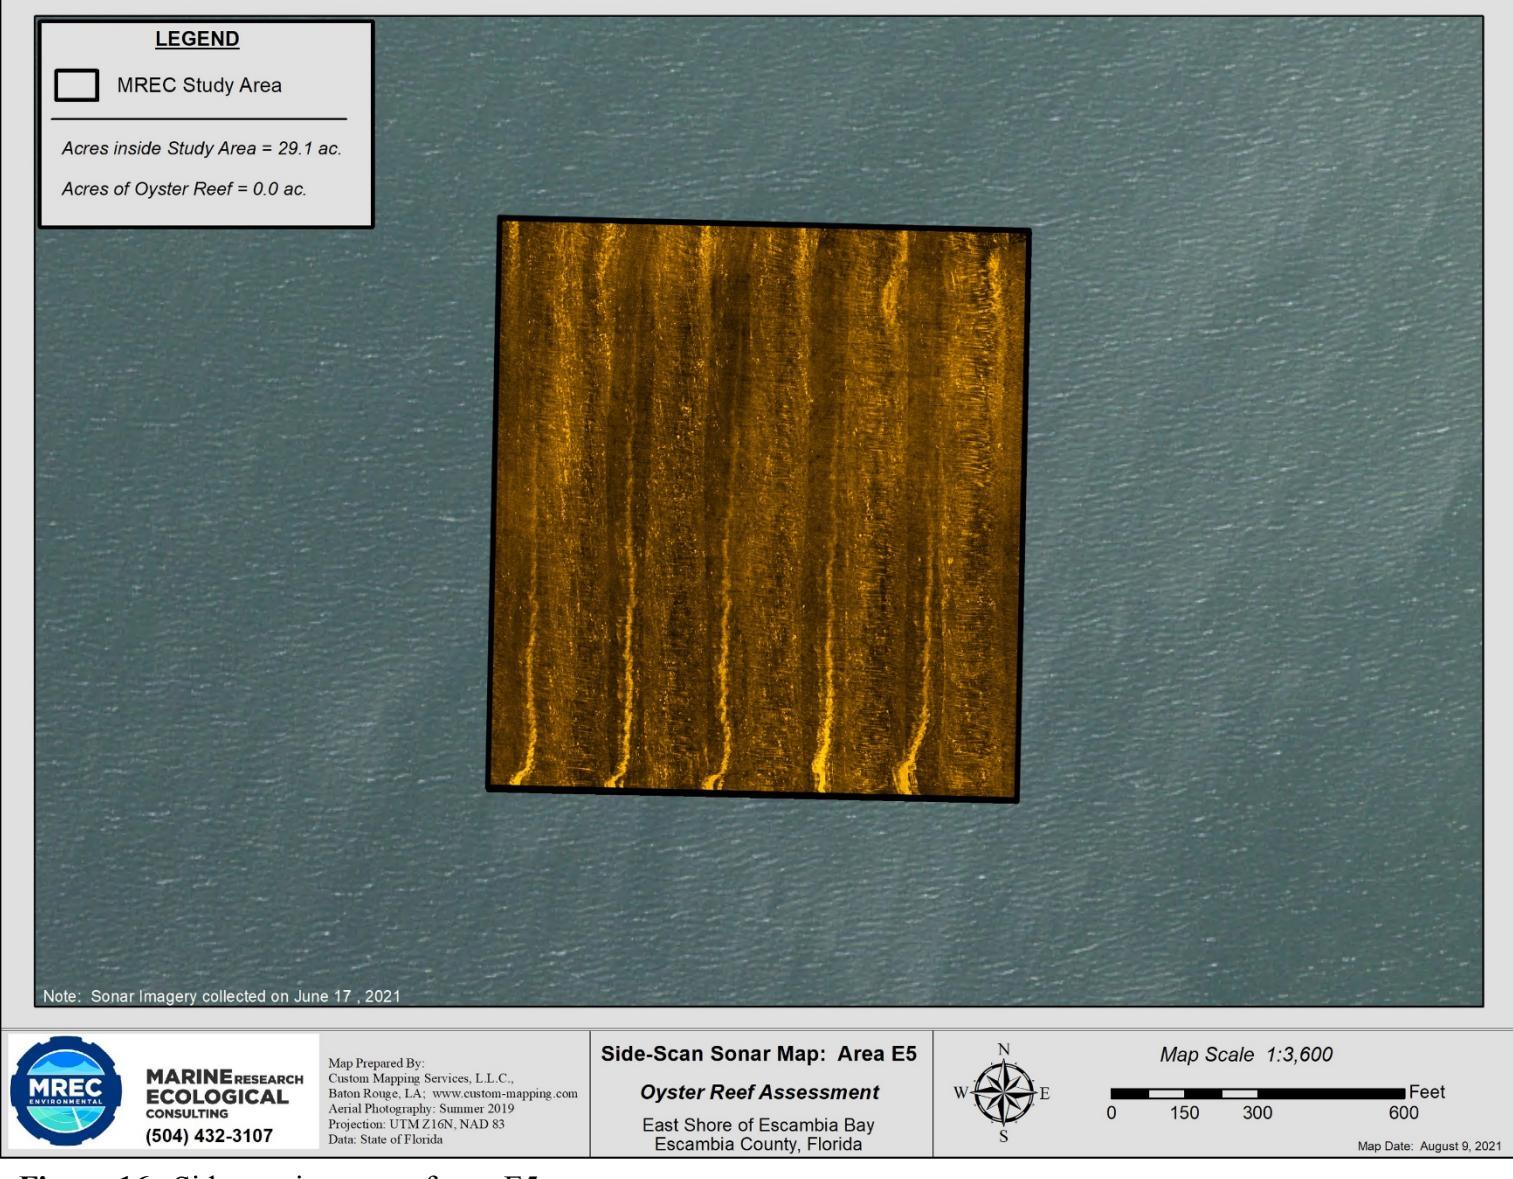
Figure 16. Sidescan imagery of area E5.

Area E5 consisted of 29.1 acres total in study with water depth ranges between 9.5ft – 10.5ft. The different bottom types present within the study area included 12.1 acres of soft mud/sand, and 17.0 acres of moderately firm mud/sand. There was no reef found within the study area. Bottom substrate type, sidescan imagery, and bathymetry are shown in Figures 15, 16, and 17 respectively.

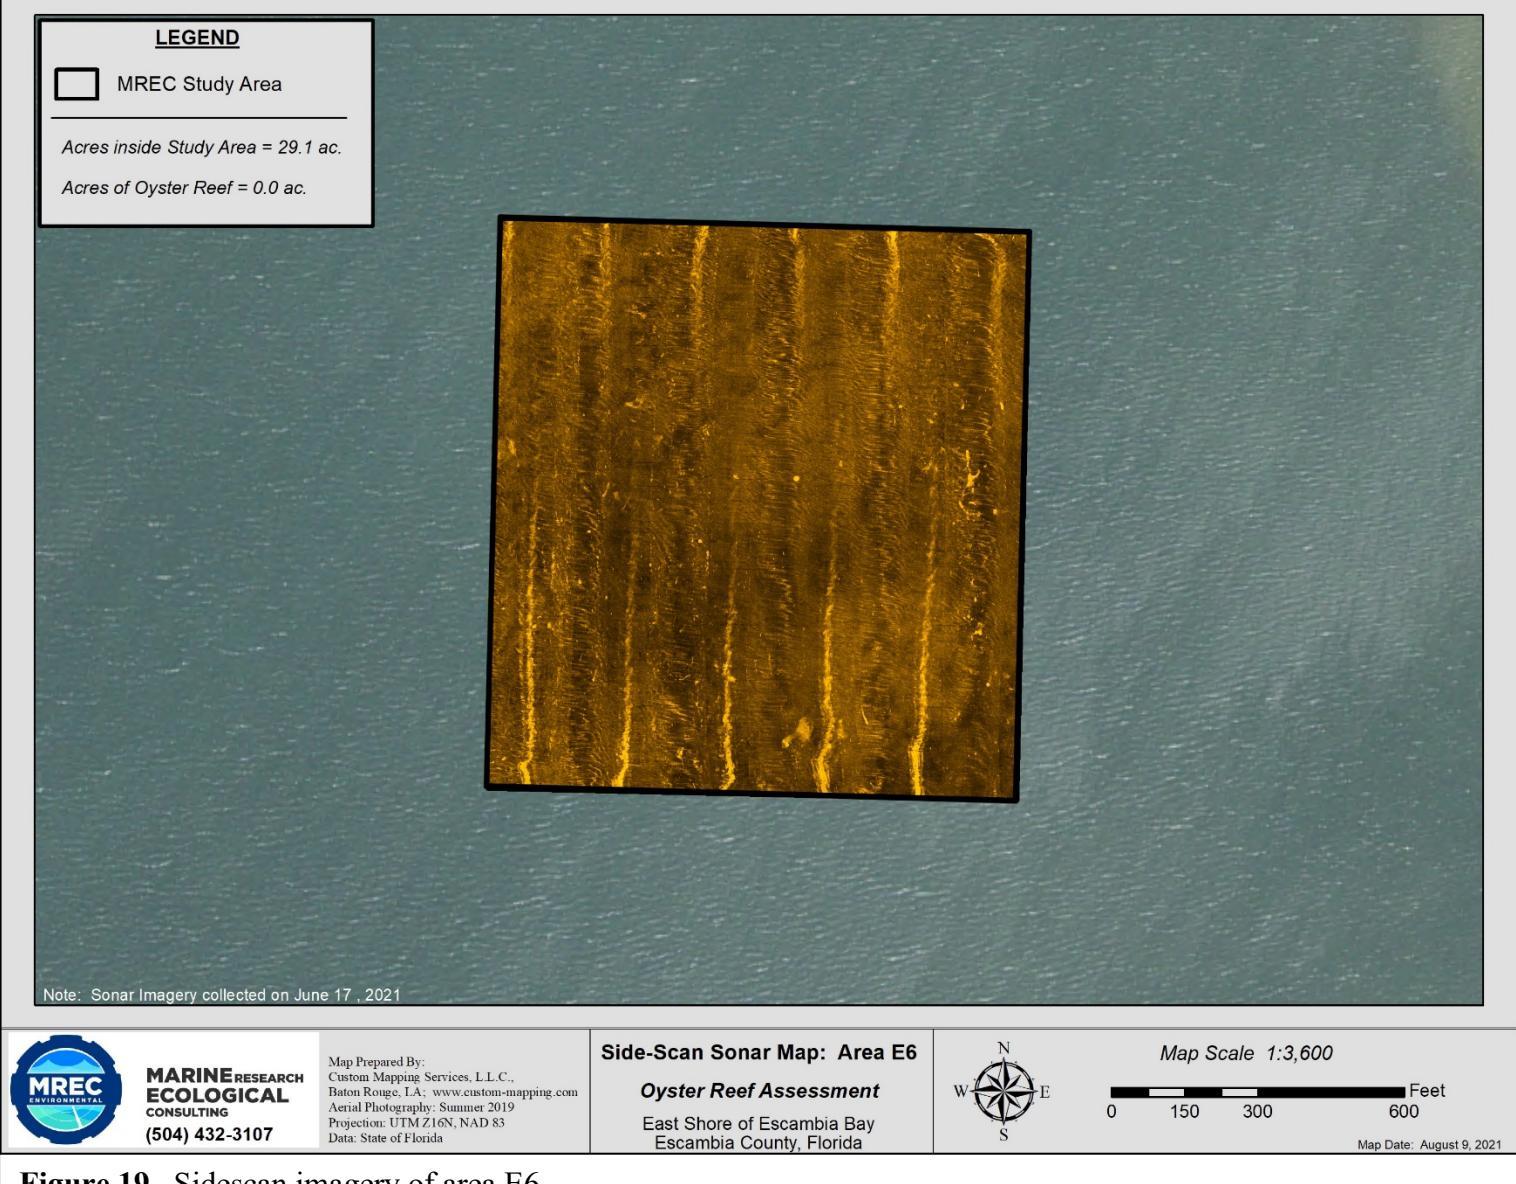
Figure 19. Sidescan imagery of area E6.

Area E6 consisted of 29.1 acres total in study with water depth ranges between 8.0ft – 9.5ft. The different bottom types present within the study area included 10.6 acres of soft mud/sand, 0.40 acres of buried shell, and 18.1 acres of moderately firm mud/sand. There was no reef found within the study area. Water bottom types, sidescan imagery, and bathymetry are shown in Figures 18, 19 and 20, respectively.

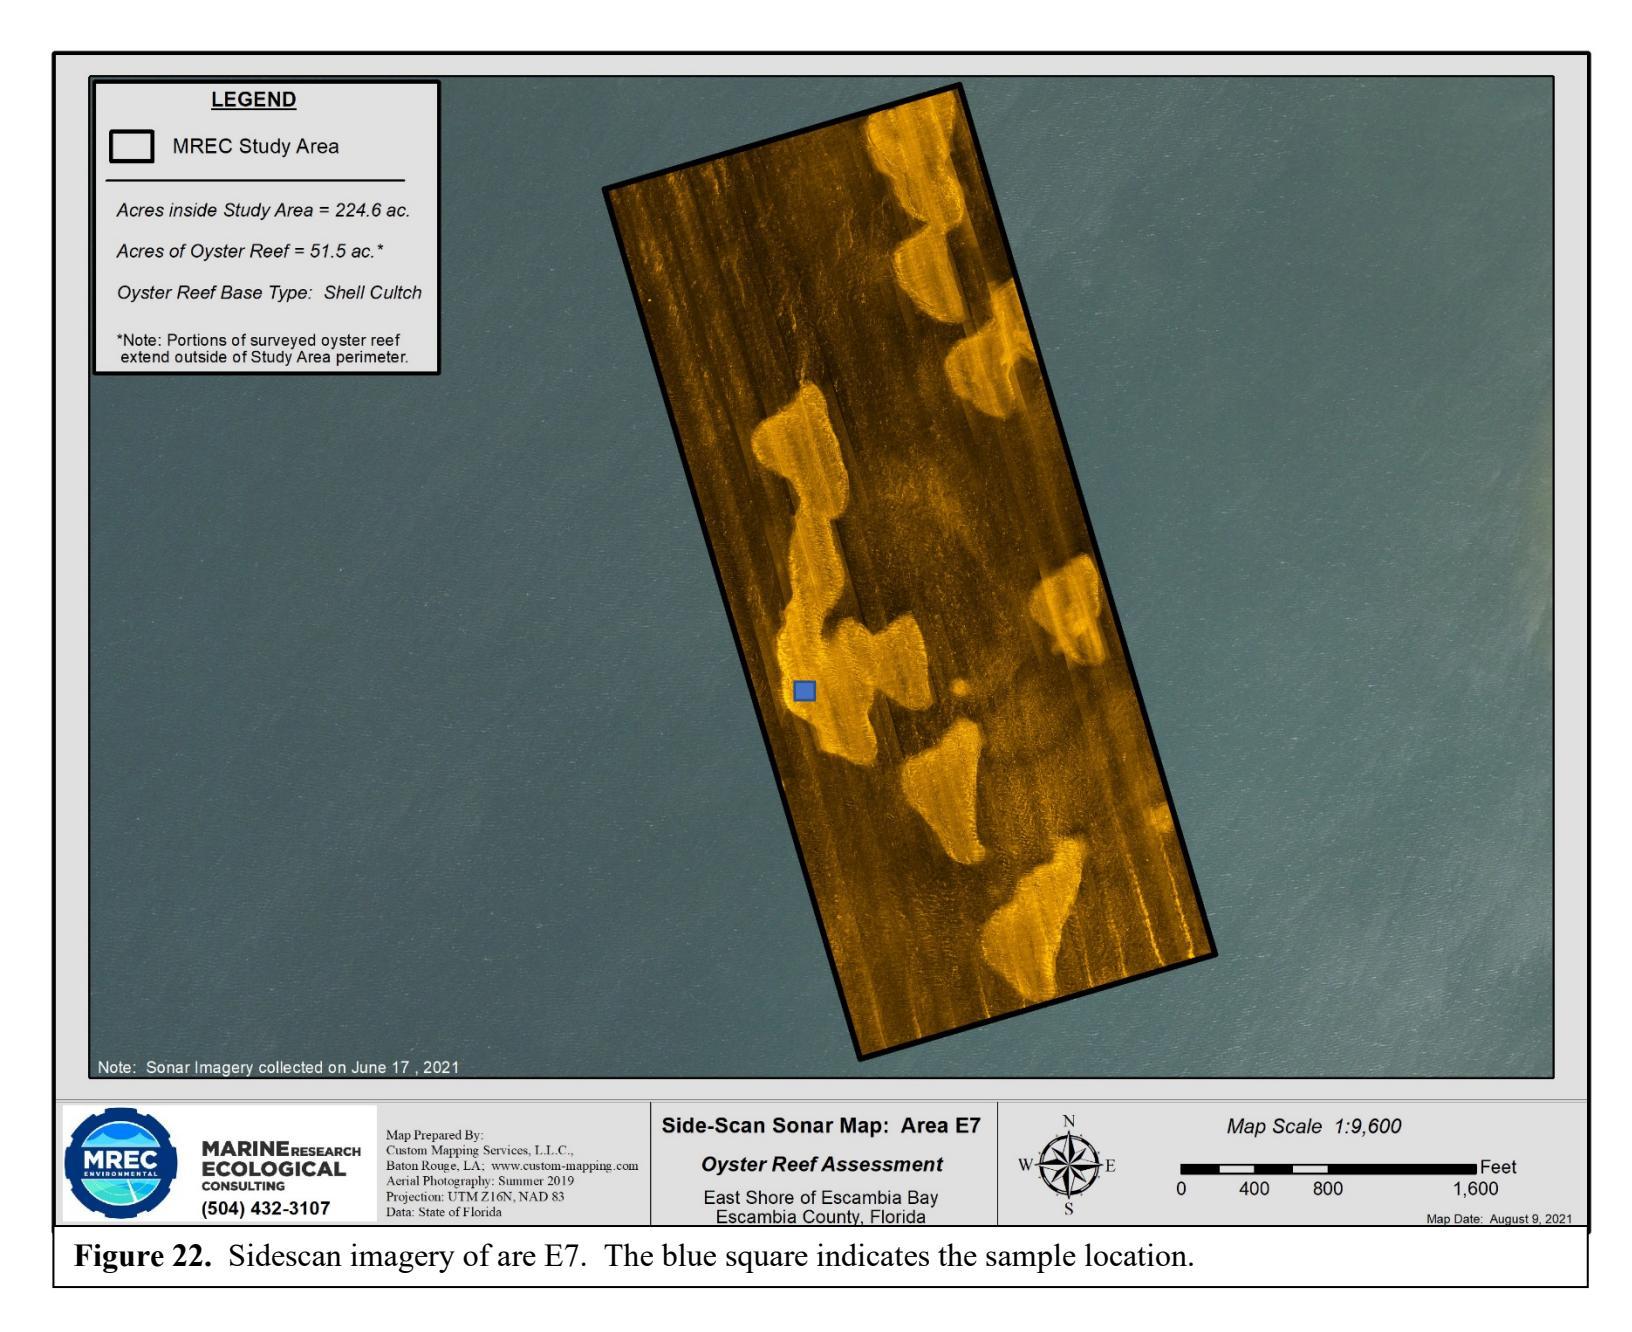
Figure 23. Bathymetry of area E7.

Area E7 consisted of 227.3 acres total in study with water depth ranges between 6.5ft - 11.0ft. The different bottom types present within the study area included 109.2 acres of soft mud/sand, 13.5 acres of buried shell, 46.4 acres of moderately firm mud/sand, 6.70 acres of exposed oyster shell, and 51.1 acres of reef. Reef was surrounded by soft/mud sand and moderately firm mud/sand with a vertical relief of up to a foot or higher. The reef consisted of fragmented cultch material which held old dead spat, seed, and sack. All shells obtained were gray in color. Reef organisms found in samples included oyster drills. Dissolved oxygen reading was 6.87 mg/L. Surface salinity was 5.0 ppt, while bottom salinity was 6.2 ppt. Surface temperature was 30.6°C, while bottom temperature was 30.3°C. Water bottom types, sidescan imagery, and bathymetry are shown in Figures 21, 22, and 23, respectively.

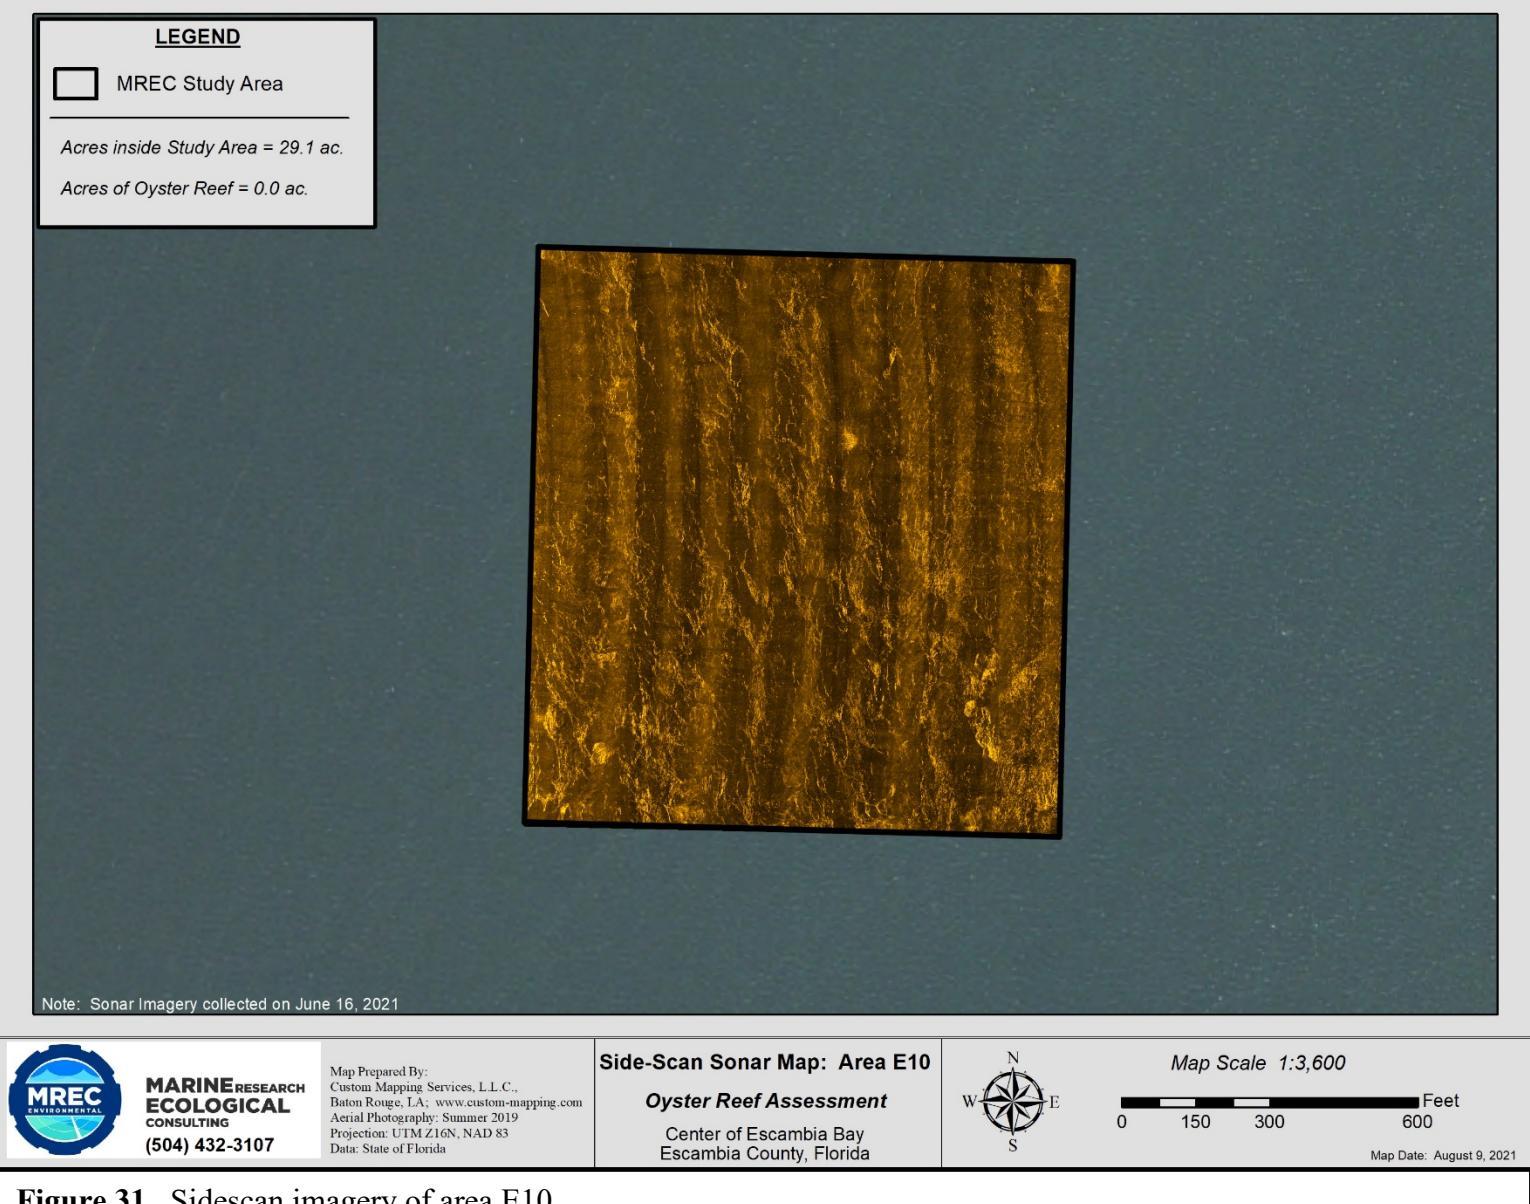
Figure 31. Sidescan imagery of area E10.

Area E10 consisted of 29.1 acres total in study with water depth ranges between 8.5ft – 10.5ft. The different bottom types present within the study area included 22.6 acres of soft mud/sand, and 6.50 acres of moderately firm mud/sand. There was no reef found within the study area. Dissolved oxygen reading was 5.81 mg/L. Surface salinity was 2.3 ppt, while bottom salinity was 4.7 ppt. Surface temperature was 29.5°C, while bottom temperature was 29.4°C. Water bottom types, sidescan imagery, and bathymetry are shown in Figures 30, 31, and 32, respectively.

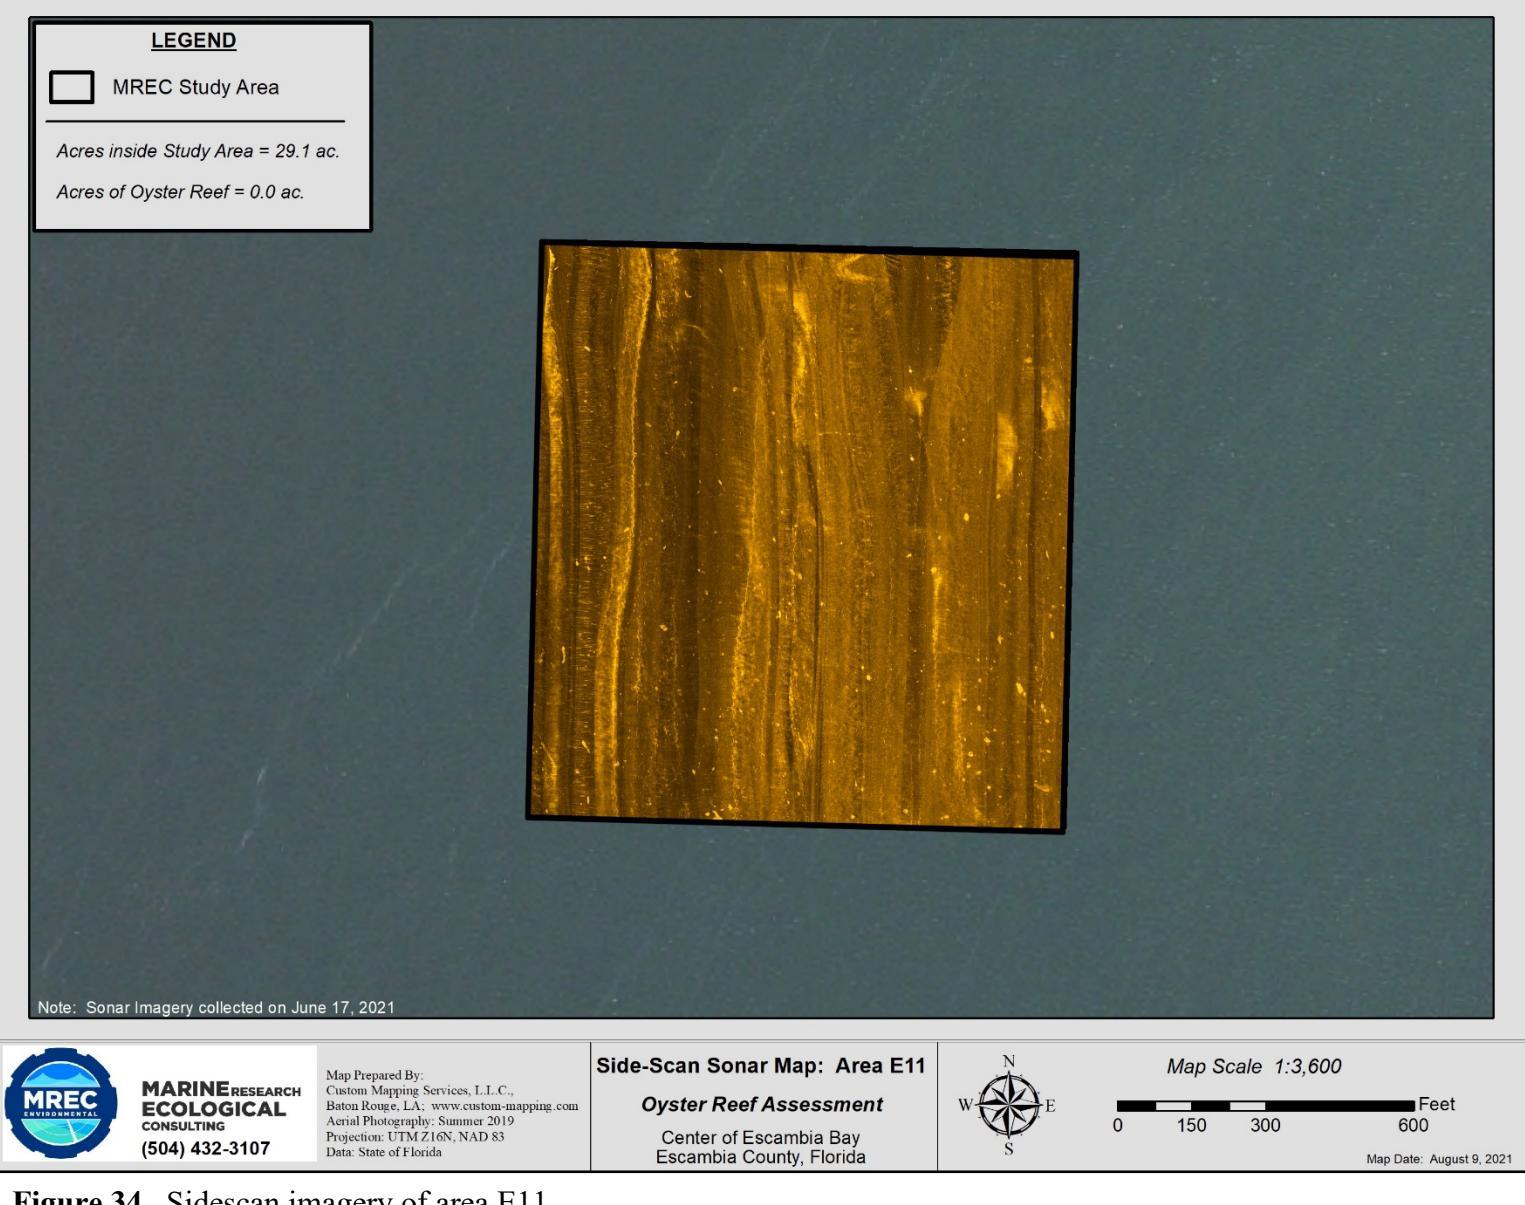
Figure 34. Sidescan imagery of area E11

Area E11 consisted of 29.1 acres total in study with water depth ranges between 8.0ft – 10.0ft. The different bottom types present within the study area included 22.4 acres of soft mud/sand, 0.60 acres of buried shell, and 6.10 acres of moderately firm mud/sand. There was no reef found within the study area. Dissolved oxygen reading was 5.07 mg/L. Surface salinity was 2.5 ppt, while bottom salinity was 4.2 ppt. Surface temperature was 30.1°C, while bottom temperature was 29.8°C. Water bottom types, sidescan imagery, and bathymetry are shown in Figures 33, 34, and 35, respectively.

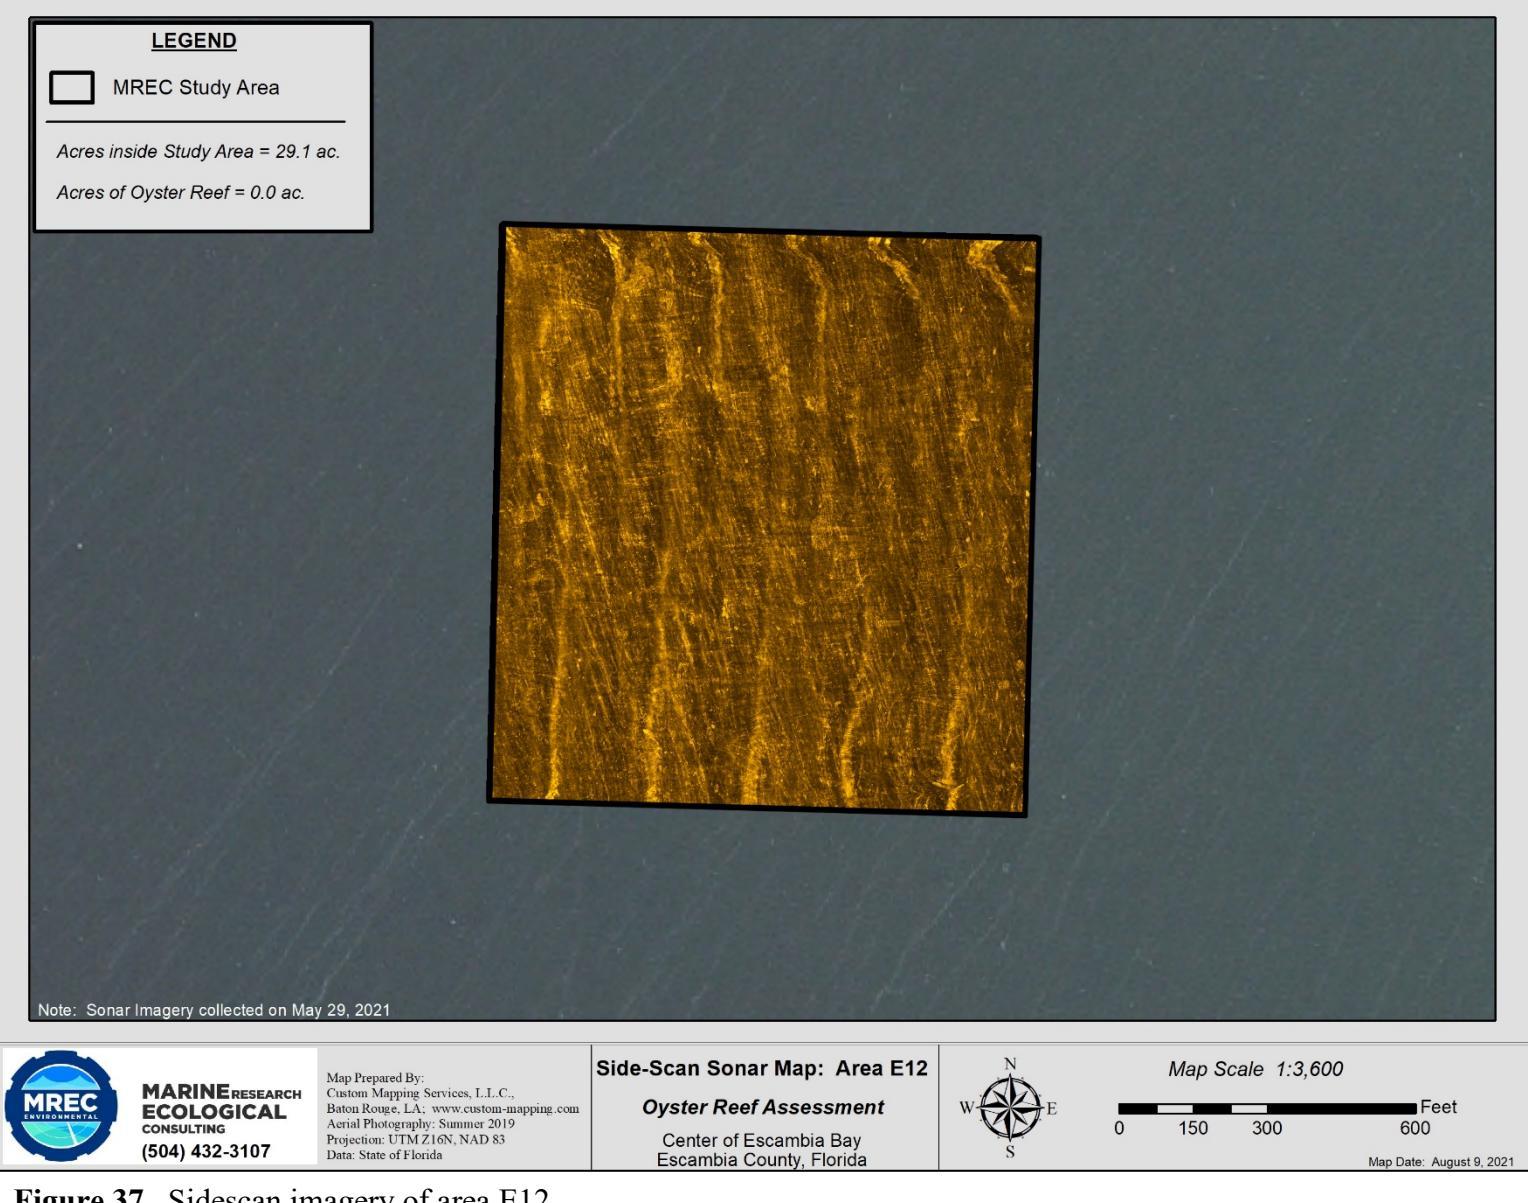
Figure 37. Sidescan imagery of area E12.

Area E12 consisted of 29.1 acres total in study with water depth ranges between 7.5ft – 9.5ft. The different bottom types present within the study area included 18.0 acres of soft mud/sand, 2.40 acres of buried shell, and 8.70 acres of moderately firm mud/sand. There was no reef found within the study area. Dissolved oxygen reading was 4.21 mg/L. Surface salinity was 1.4 ppt, while bottom salinity was 3.3 ppt. Surface temperature was 29.5°C, while bottom temperature was 29.4°C. Water bottom types, sidescan imagery, and bathymetry are shown in Figures 36, 37, and 38, respectively.
