ESCAMBIA BAY & PENSACOLA BAY SUBTIDAL OYSTER REEF MAPPING & ASSESSMENT

Located in Escambia Bay & Pensacola Bay Escambia County Florida

Prepared for Pensacola and Perdido Bays Estuary Program

> Prepared by Gabriel Johnson OLDEB Certified Oyster Biologist MREC Environmental, LLC

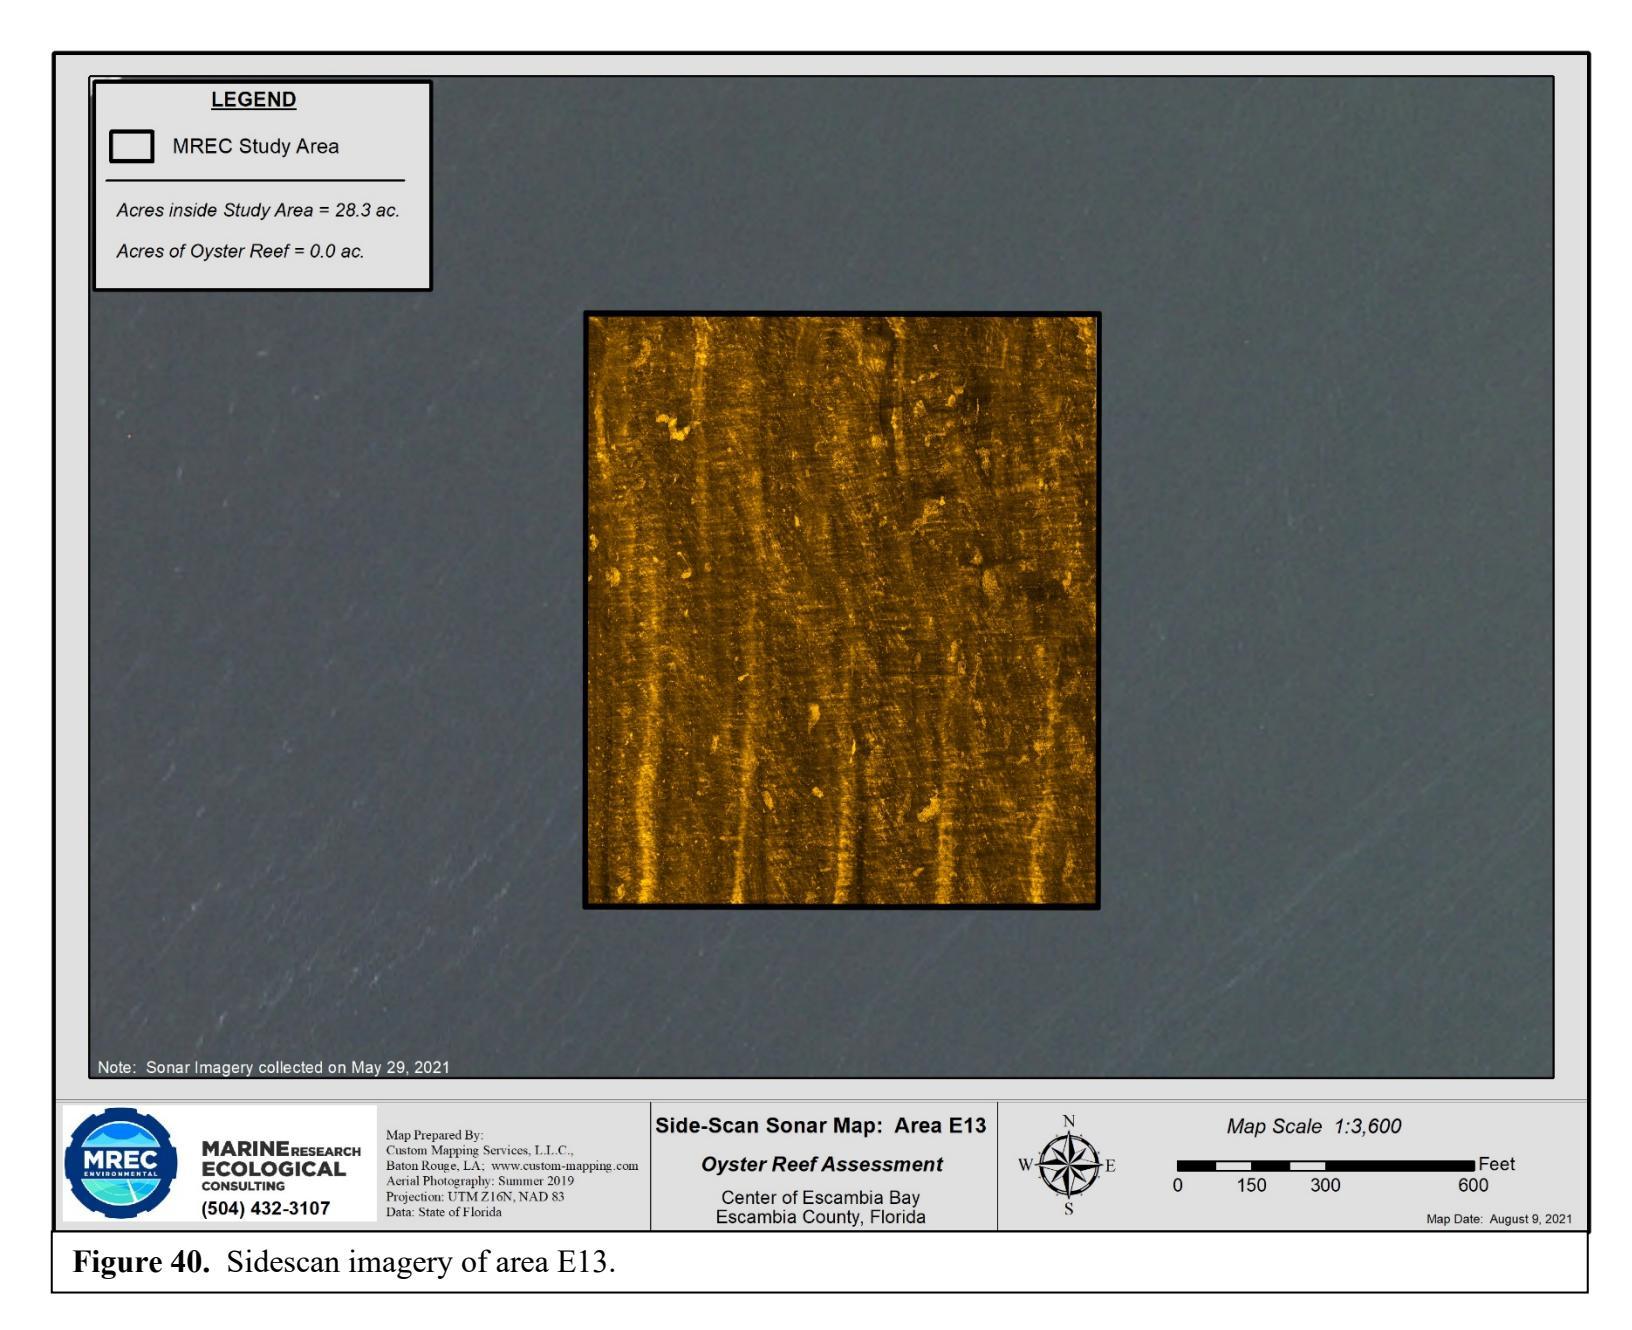
Figure 41. Bathymetry of area E13.

Area E13 consisted of 28.3 acres total in study with water depth ranges between 8.0ft – 8.5ft. The different bottom types present within the study area included 24.7 acres of soft mud/sand, 1.30 acres of buried shell, and 2.30 acres of moderately firm mud/sand. There was no reef found within the study area. Dissolved oxygen reading was 5.28 mg/L. Surface salinity was 1.1 ppt, while bottom salinity was 2.5 ppt. Surface temperature was 28.9°C, while bottom temperature was 29.8°C. Water bottom types, sidescan imagery, and bathymetry are shown in Figures 39, 40, and 41, respectively.

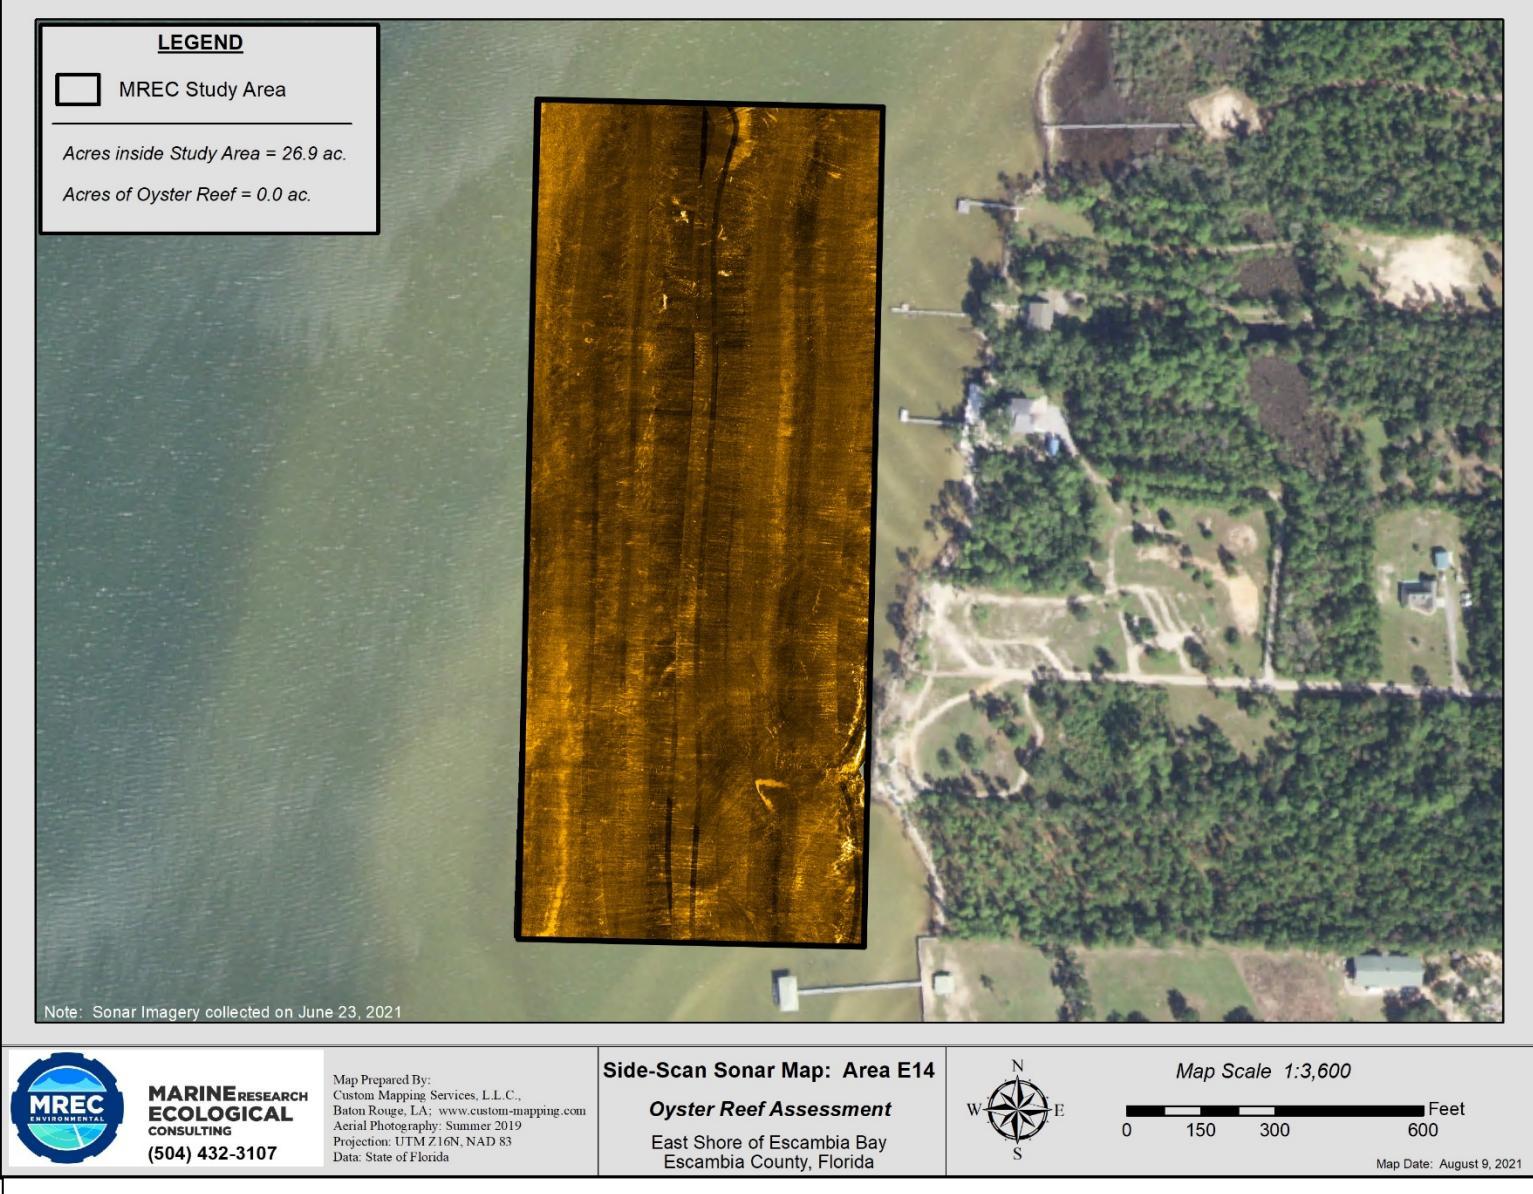
Figure 43. Sidescan imagery of area E14.

Area E14 consisted of 26.9 acres total in study with water depth ranges between 2.0ft – 4.5ft. The different bottom types present within the study area included 0.50 acres of moderately firm mud/sand, and 26.4 acres of sand. There was no reef found within the study area. Dissolved oxygen reading was 4.02mg/L. Water bottom types, sidescan imagery, and bathymetry are shown in Figures 42, 43, and 44, respectively.

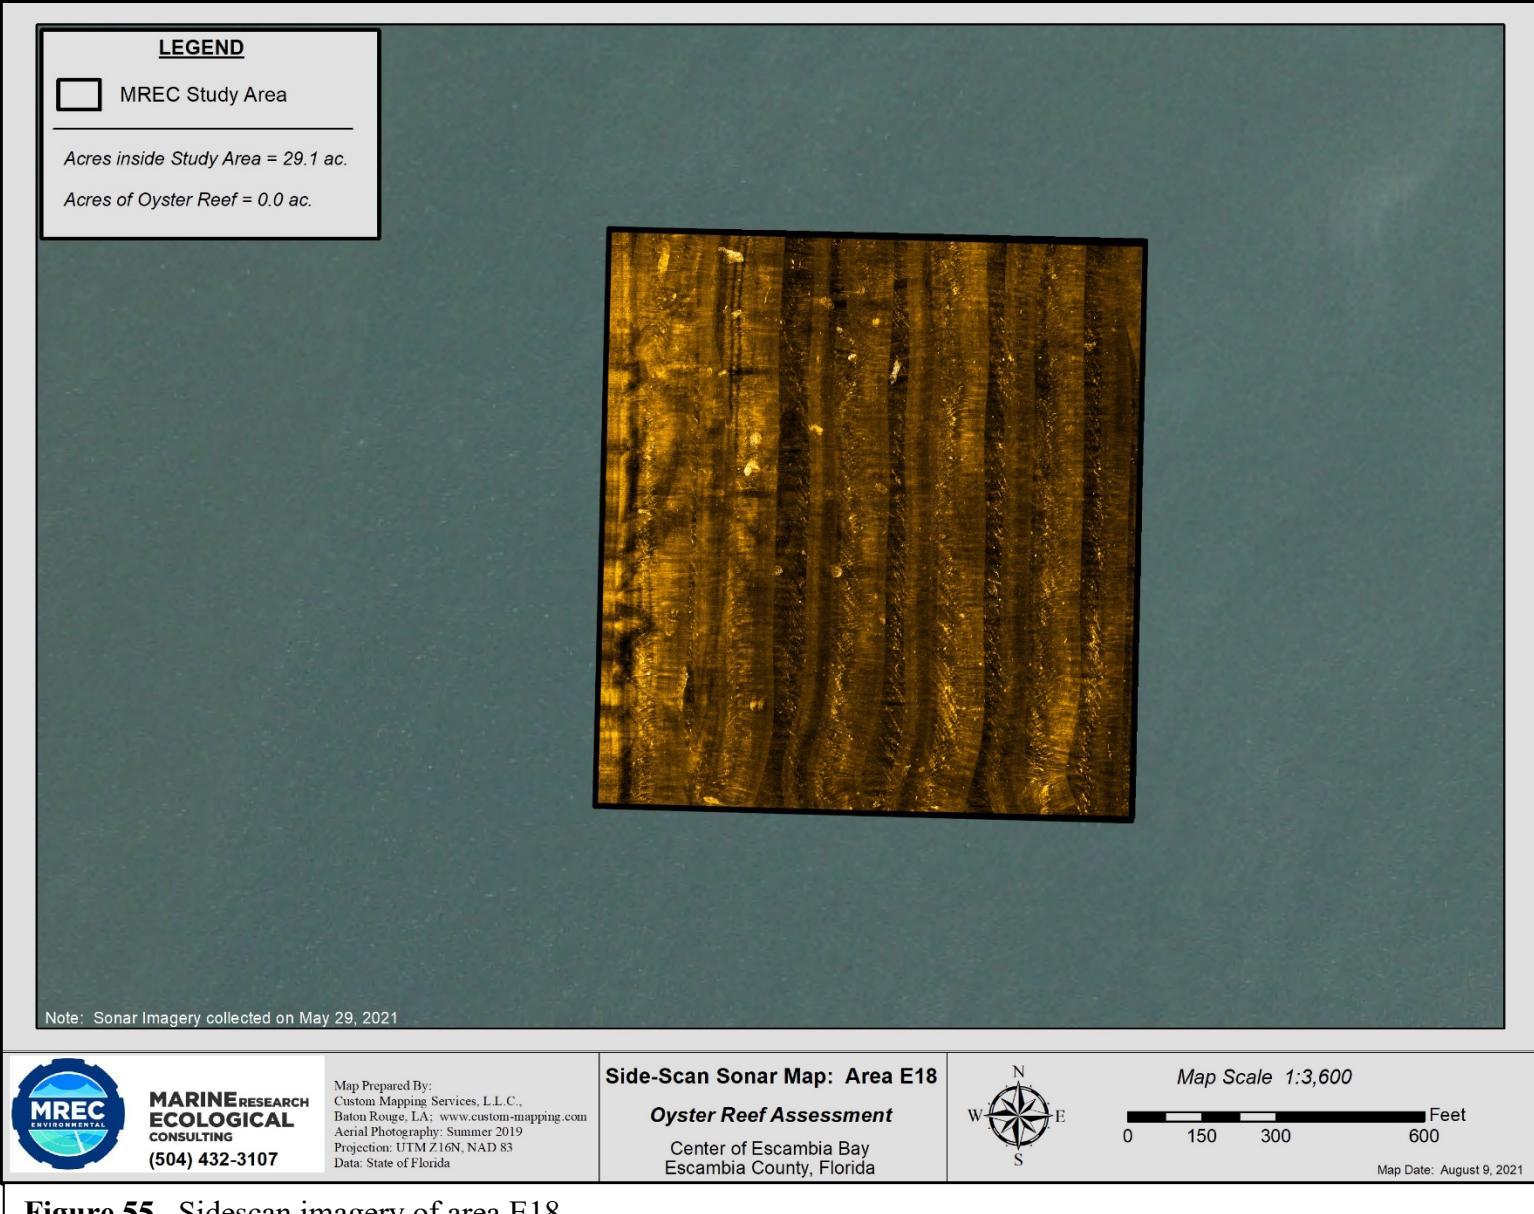
Figure 55. Sidescan imagery of area E18.

Area E18 consisted of 29.1 acres total in study with water depth ranges between 7.0ft – 8.5ft. The different bottom types present within the study area included 17.1 acres of soft mud/sand, 1.30 acres of buried shell, 8.70 acres of moderately firm mud/sand, and 2.00 acres of sand. There was no reef found within the study area. Dissolved oxygen reading was 6.02 mg/L. Surface salinity was 4.4 ppt, while bottom salinity was 4.8 ppt. Surface temperature was 30.8°C, while bottom temperature was 30.5°C. Water bottom types, sidescan imagery, and bathymetry are shown in Figures 54, 55, and 56, respectively.

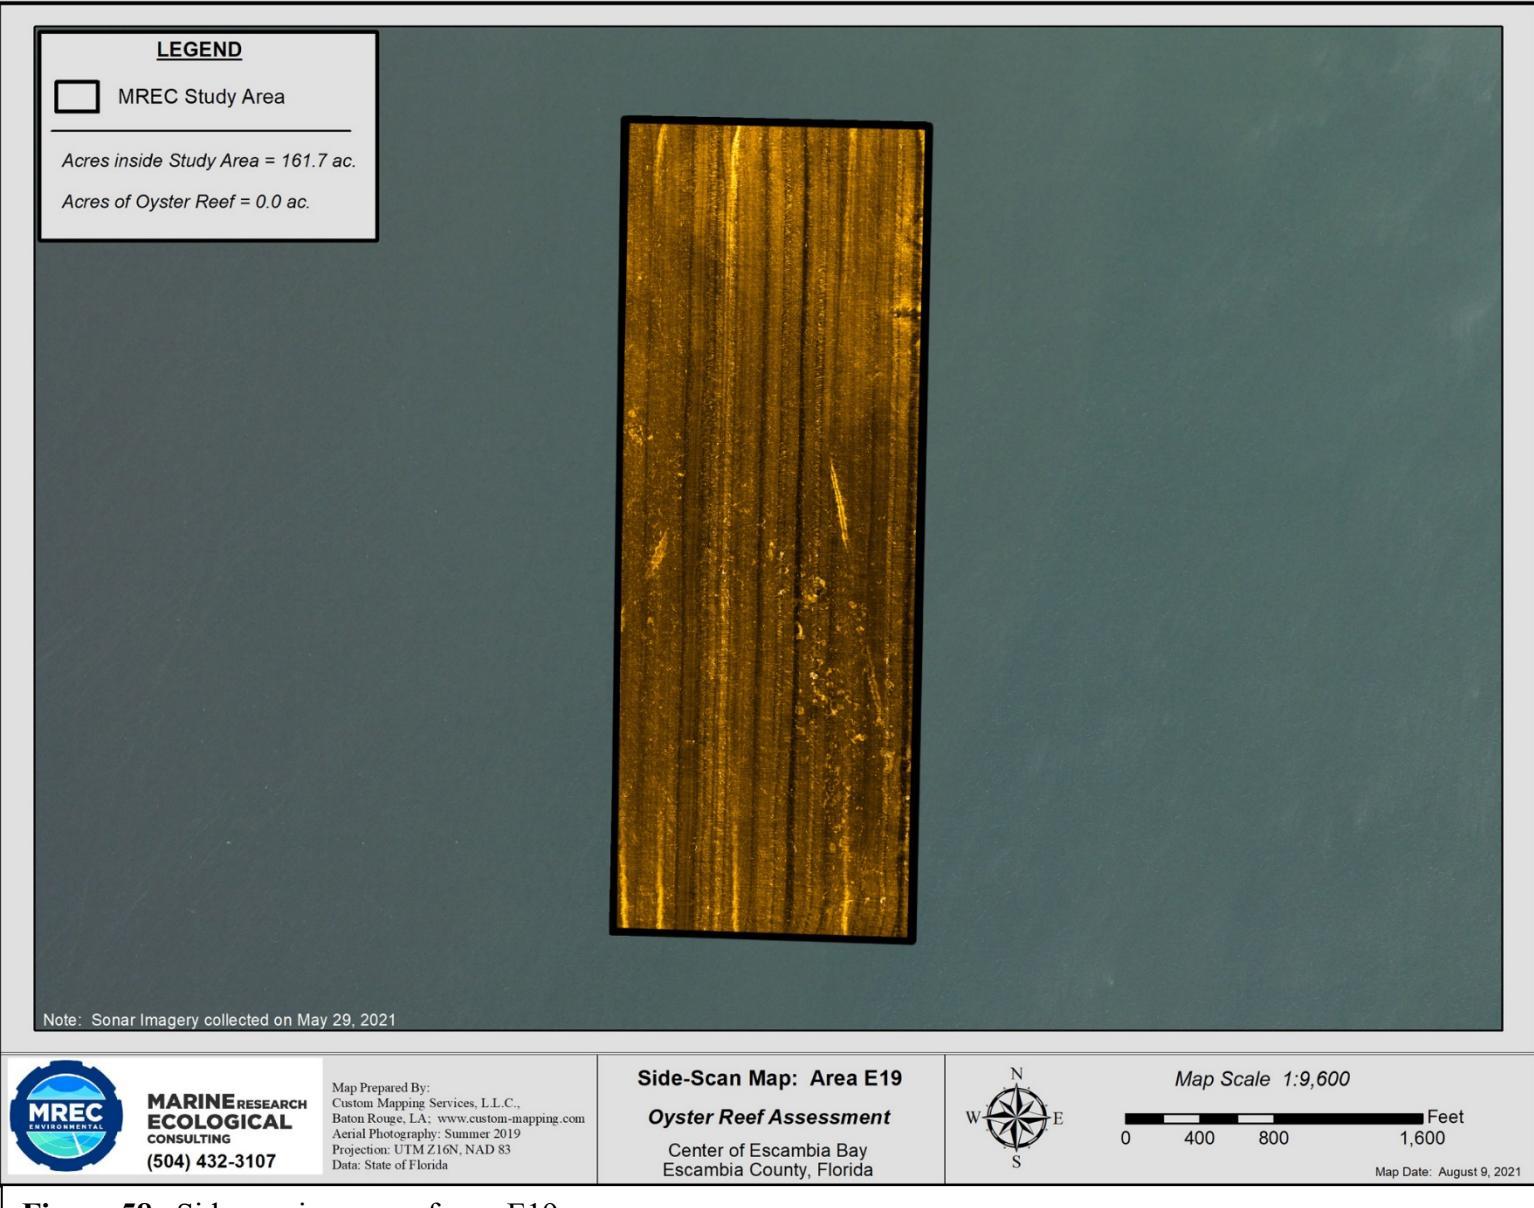
Figure 58. Sidescan imagery of area E19.

Area E19 consisted of 161.7acres total in study with water depth ranges between 6.5ft – 8.5ft. The different bottom types present within the study area included 66.0 acres of soft mud/sand, 2.30 acres of buried shell, 68.5 acres of moderately firm mud/sand, and 24.9 acres of sand. There was no reef found within the study area. Dissolved oxygen reading was 6.27 mg/L. Surface salinity was 3.1 ppt, while bottom salinity was 5.1 ppt. Surface temperature and bottom temperature were both 30.4°C. Water bottom types, sidescan imagery, and bathymetry are shown in Figures 57, 58, and 59, respectively.

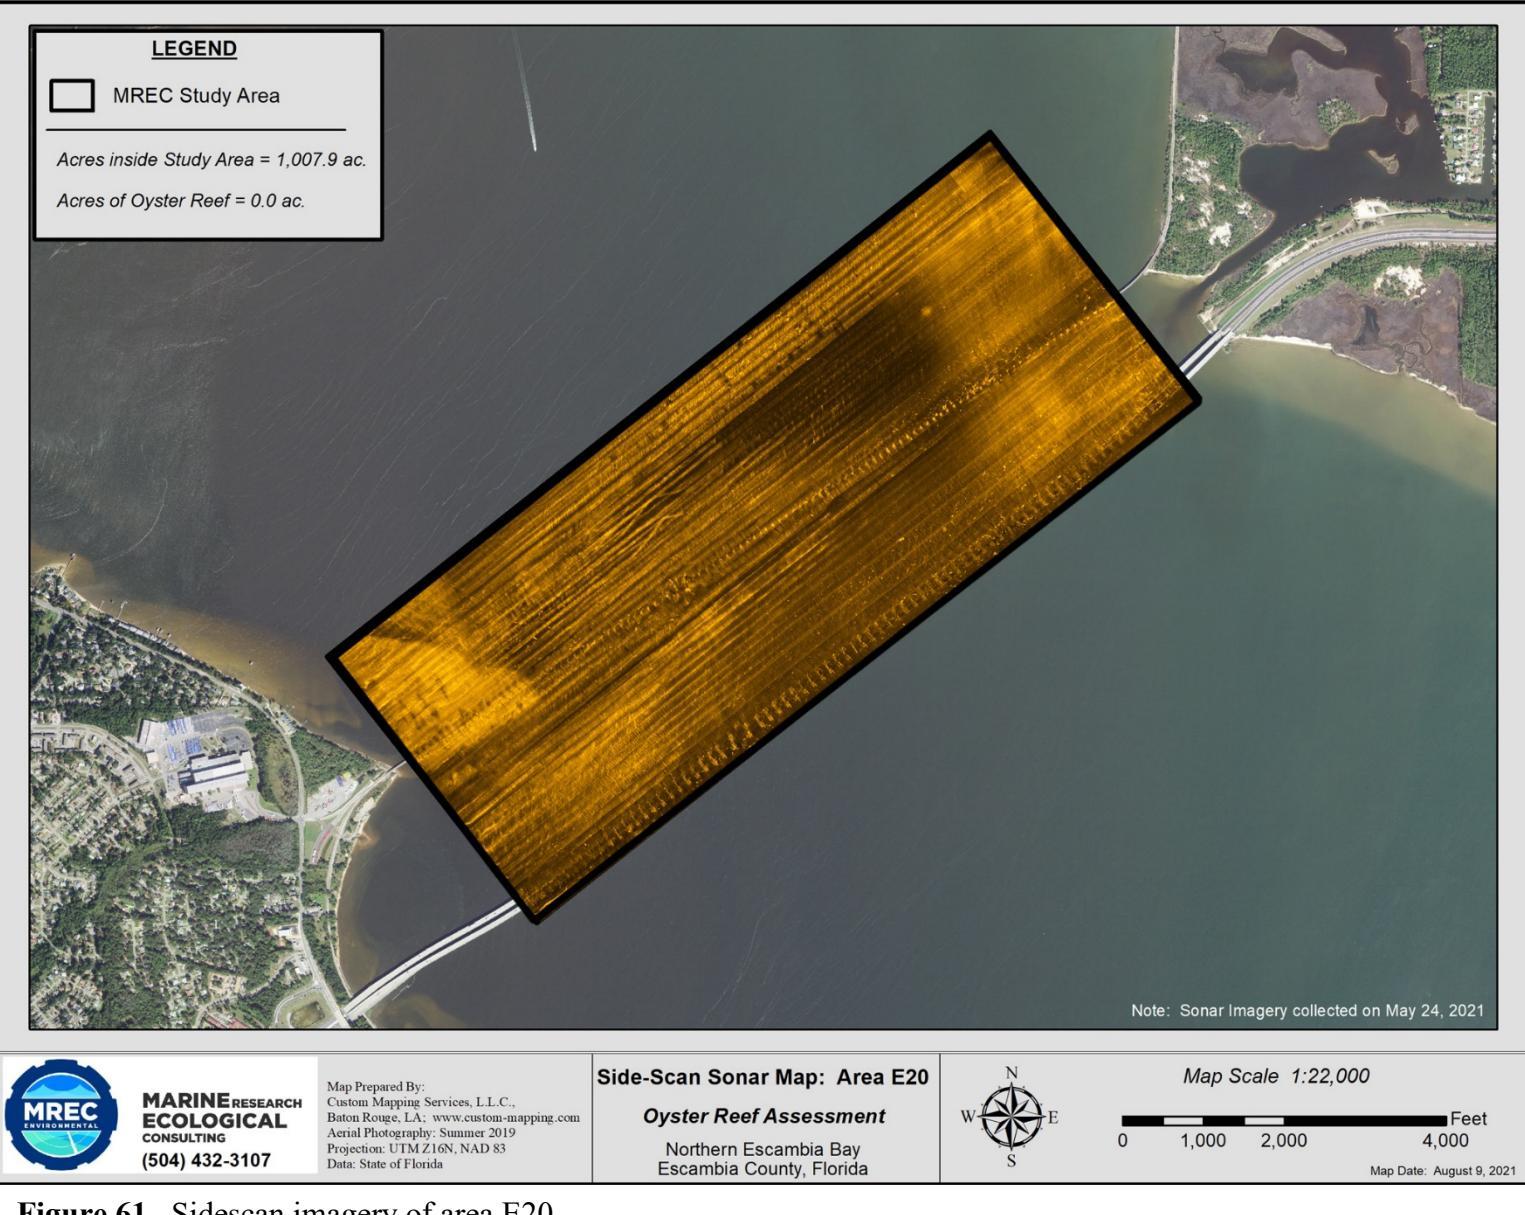
Figure 61. Sidescan imagery of area E20.

Area E20 consisted of 1,008.5 acres total in study with water depth ranges between 3.0ft – 16.0ft. The different bottom types present within the study area included 537.4 acres of soft mud/sand, 110.8 acres of buried shell, 168.9 acres of moderately firm mud/sand, and 201.4 acres of sand. There was no reef found within the study area. Dissolved oxygen reading was 4.52 mg/L. Surface salinity was 1.1 ppt, while bottom salinity was 2.0 ppt. Surface temperature was 29.5°C, while bottom temperature was 29.4°C. Water bottom types, sidescan imagery, and bathymetry are shown in Figures 60, 61, and 62, respectively.

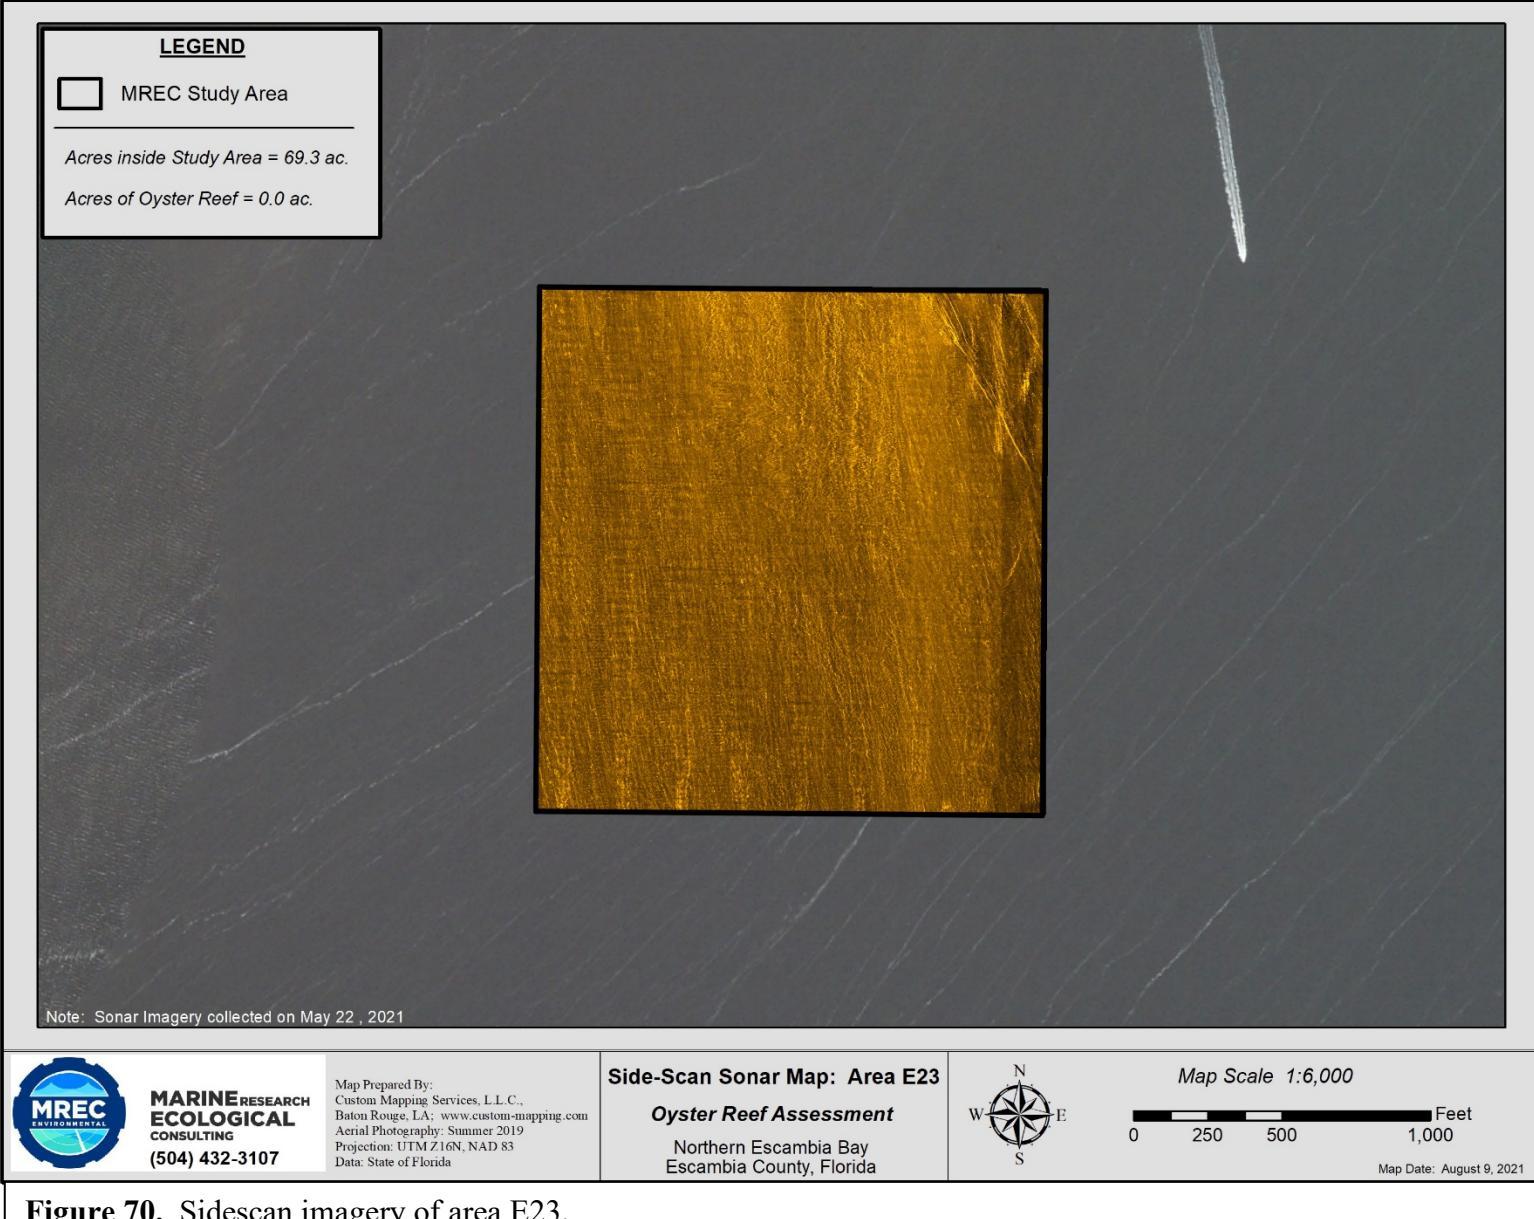
Figure 70. Sidescan imagery of area E23.

Area E23 consisted of 69.3 acres total in study with water depth ranges between 7.0ft – 14.0ft. The different bottom types present within the study area included 56.6 acres of soft mud/sand, 4.10 acres of buried shell, 5.00 acres of moderately firm mud/sand, and 3.60 acres of sand. There was no reef found within the study area. Dissolved oxygen reading was 2.27 mg/L. Surface salinity was 0.8 ppt, while bottom salinity was 3.3 ppt. Surface temperature was 29.0°C, while bottom temperature was 29.2°C. Water bottom types, sidescan imagery, and bathymetry are shown in Figures 69, 70, and 71, respectively.

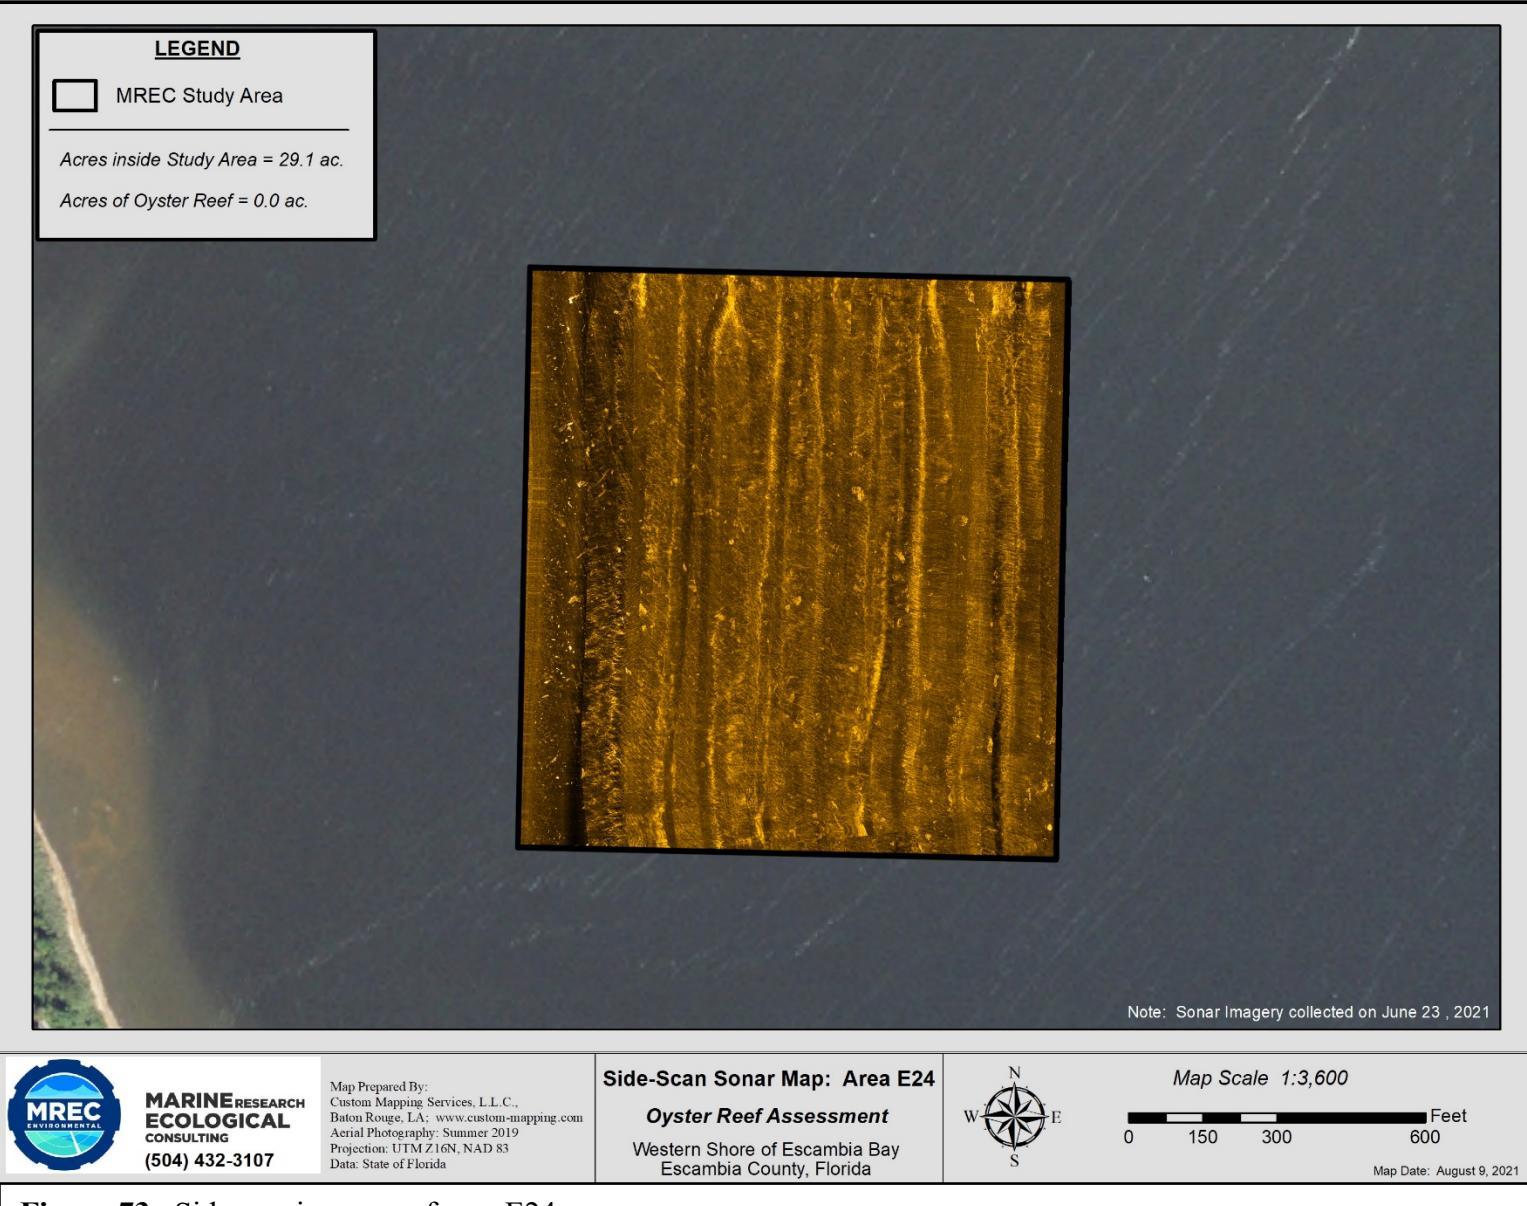
Figure 73. Sidescan imagery of area E24.

Area E24 consisted of 29.1 acres total in study with water depth ranges between 5.5ft – 7.5ft. The different bottom types present within the study area included 13.5 acres of soft mud/sand, 2.30 acres of buried shell, 12.3 acres of moderately firm mud/sand, and 1.00 acre of sand. There was no reef found within the study area. Water bottom types, sidescan imagery, and bathymetry are shown in Figures 72, 73, and 74, respectively.

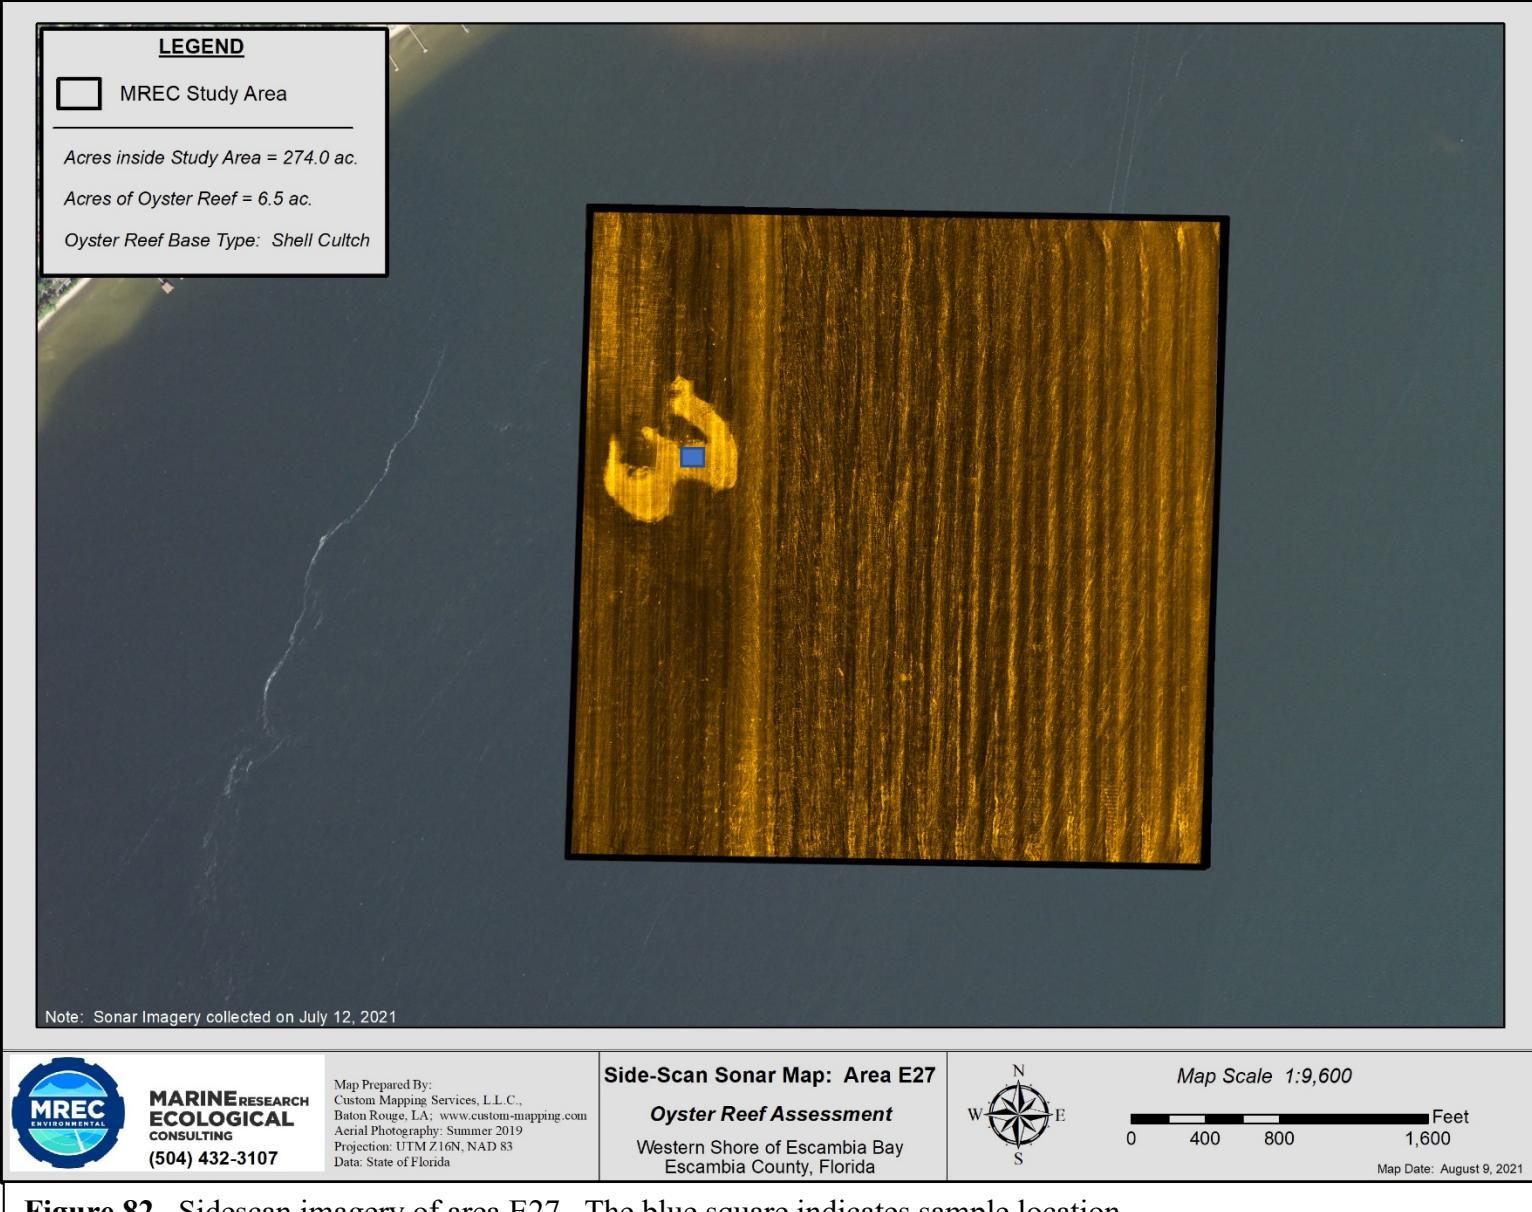
Figure 82. Sidescan imagery of area E27. The blue square indicates sample location.

Area E27 consisted of 274.0 acres total in study with water depth ranges between 6.5ft - 11.0ft. The different bottom types present within the study area included 128.8 acres of soft mud/sand, 13.3 acres of buried shell, 119.0 acres of moderately firm mud/sand, 6.40 acres of exposed oyster shell, and 6.50 acres of reef. Reef was relatively at level with surrounding soft mud/sand with a vertical relief of about 0in.-6in. The reef consisted of fragmented cultch material which held old dead seed and sack. All shells obtained were gray in color. Reef organisms found in samples included barnacles. Dissolved oxygen reading was 5.56 mg/L. Surface salinity was 3.1 ppt, while bottom salinity was 4.0 ppt. Surface and bottom temperatures were both 29.8°C. Water bottom types, sidescan imagery, and bathymetry are shown in Figures 81, 82, and 83, respectively.

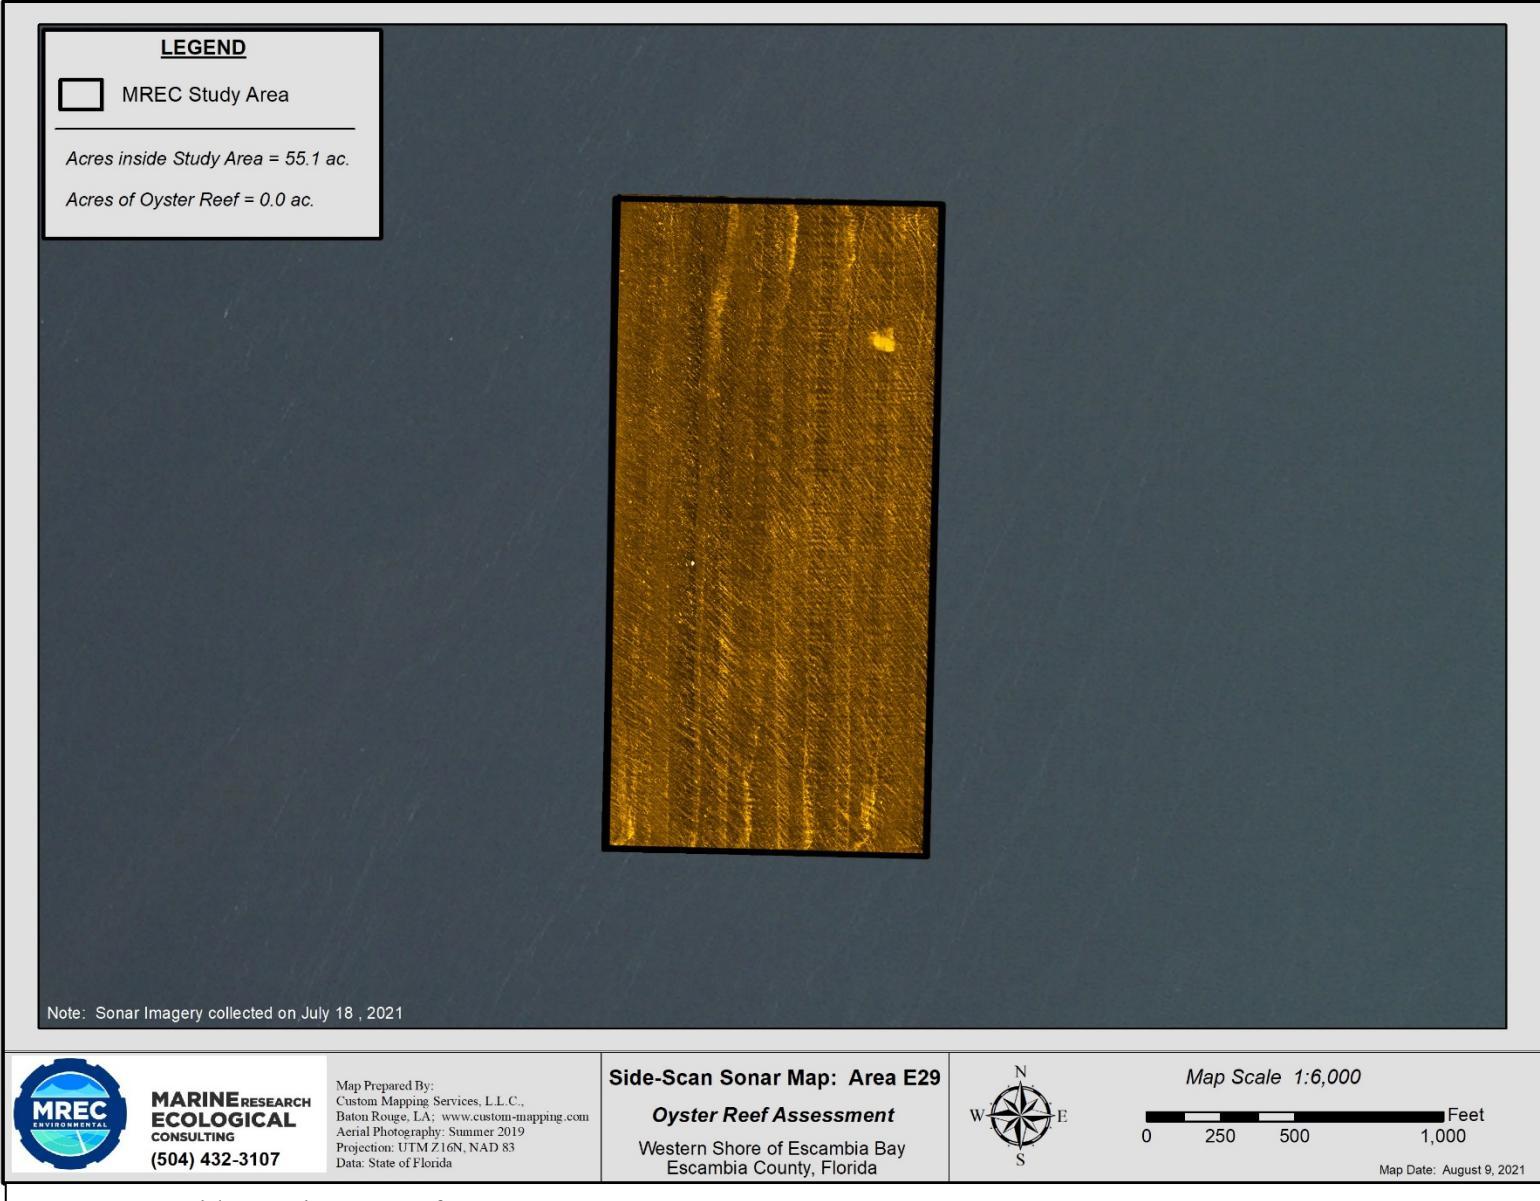
Figure 88. Sidescan imagery of area E29.

Area E29 consisted of 55.1 acres total in study with water depth ranges between 9.5ft – 12.5ft. The different bottom types present within the study area included 52.1 acres of soft mud/sand, 2.80 acres of buried shell, and 0.20 acres of exposed oyster shell. There was no reef found within the study area. Water bottom types, sidescan imagery, and bathymetry are shown in Figures 87, 88, and, 89, respectively.

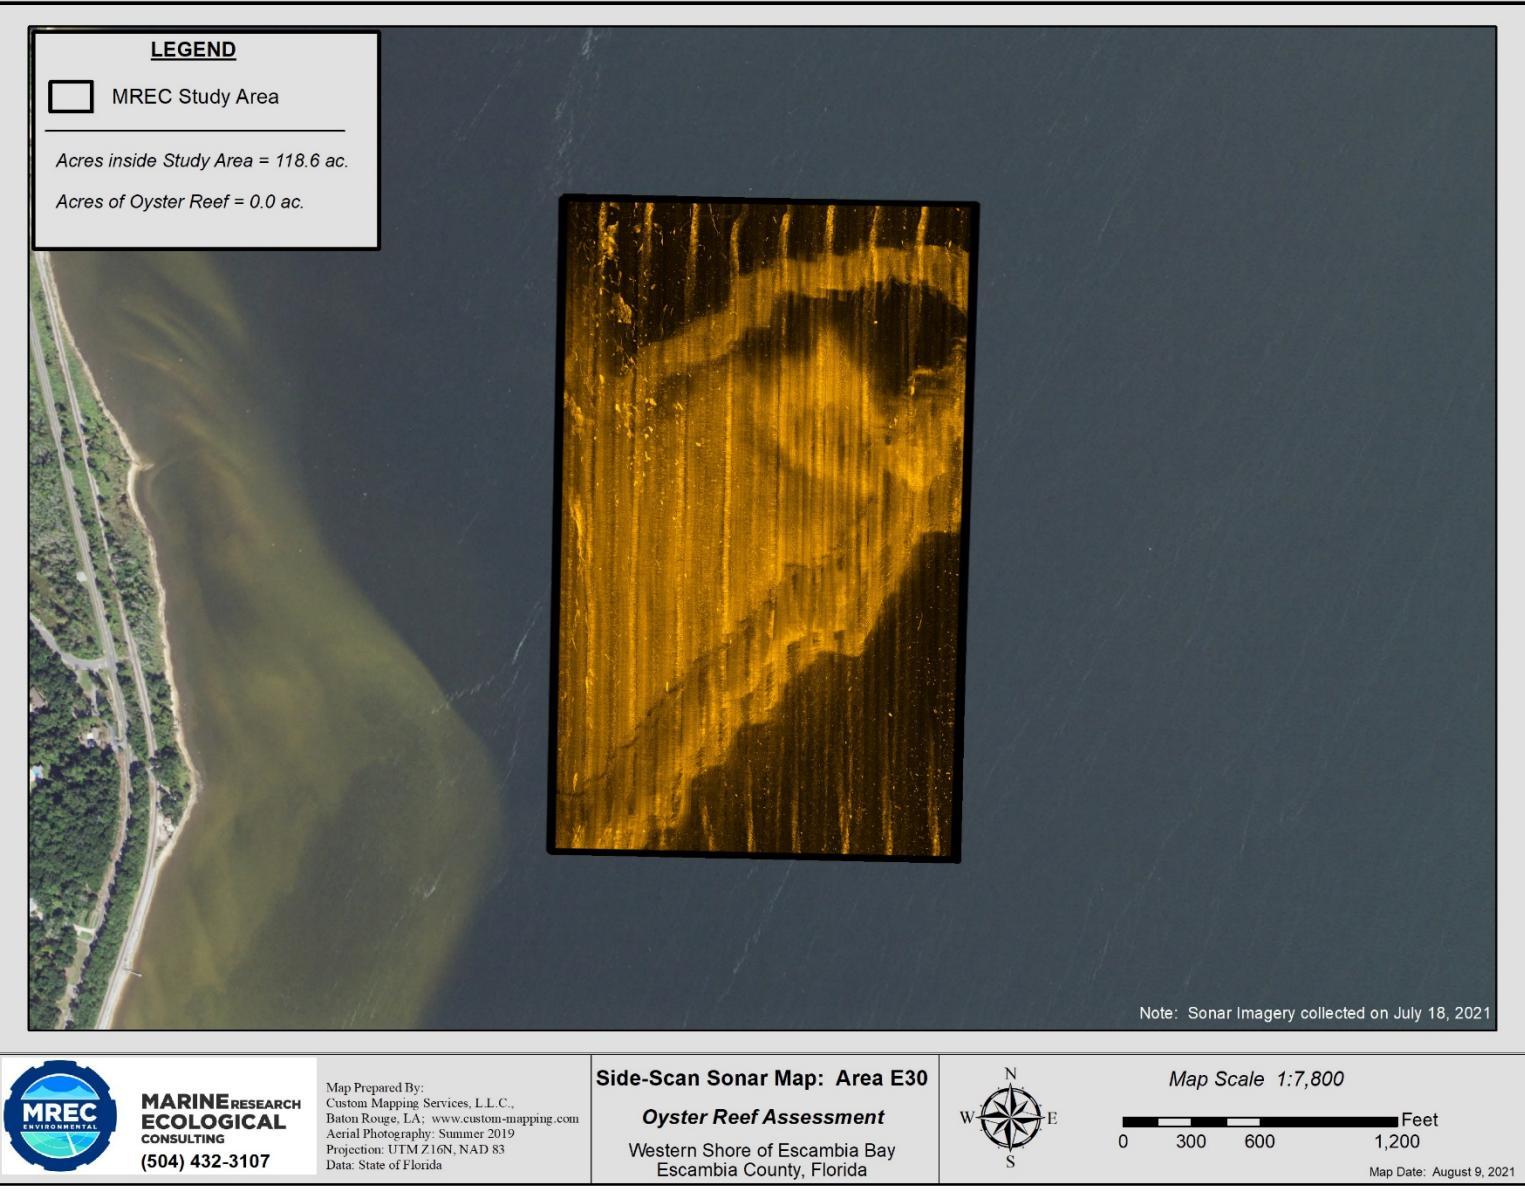
Figure 91. Sidescan imagery of area E30.

Area E30 consisted of 118.6 acres total in study with water depth ranges between 6.0ft – 11.5ft. The different bottom types present within the study area included 30.1 acres of soft mud/sand, 8.40 acres of buried shell, 4.20 acres of exposed oyster shell, and 75.9 acres of sand. There was no reef found within the study area. Dissolved oxygen reading was 5.55 mg/L. Surface salinity was 3.2 ppt, while bottom salinity was 3.7 ppt. Surface temperature was 29.7°C, while bottom temperature was 29.6°C. Water bottom types, sidescan imagery, and bathymetry are shown in Figures 90, 91, and 92, respectively.

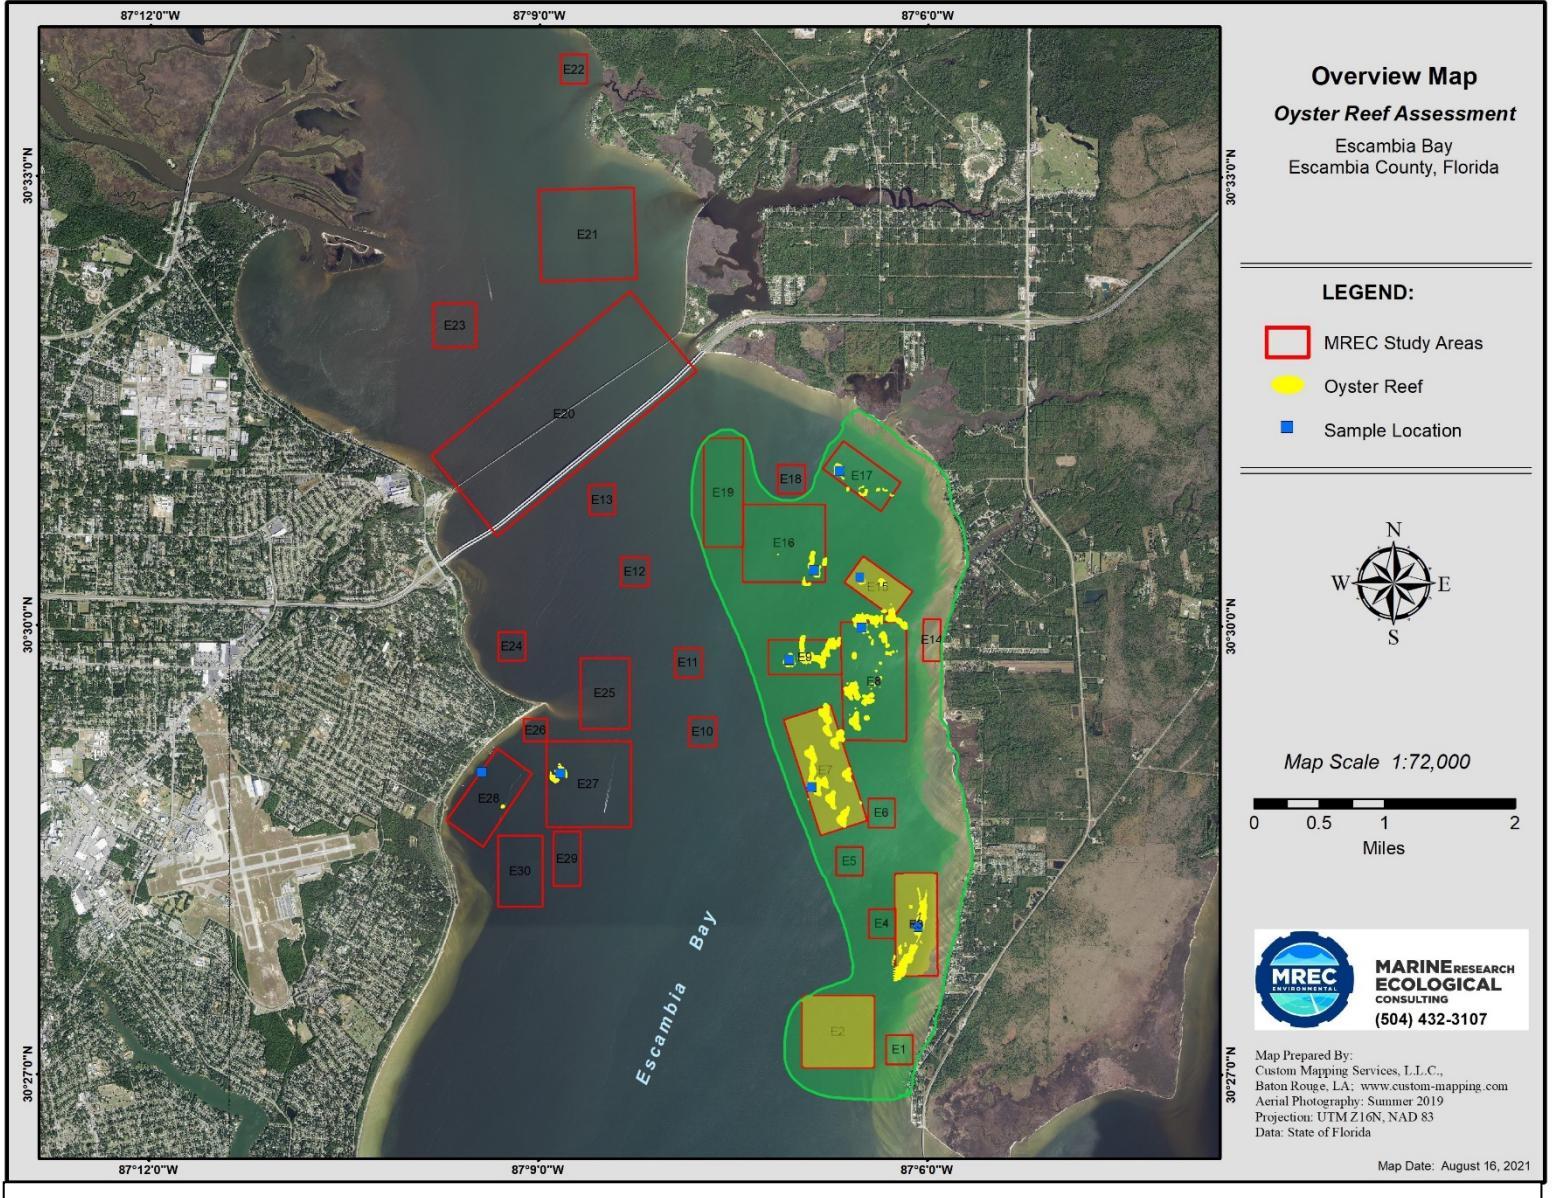
There does appear to be an effect of salinity on oyster population health and location in Escambia Bay. Figure 92 shows the portion of the bay that was found to have salinity measurements over 5.0 ppt both at the bottom and at the surface. Even this moderate salinity regime seems to have significant impact on the overall oyster population structure throughout the bay. Oyster populations struggle in salinities under 5 ppt (Starke 2011). In fact, despite populations existing in salinity ranges from 5 - 40 ppt (USDA 2018), a various articles in literature indicate ideal conditions area somwhere in the middle: 14 - 34 ppt (Baggett 2014), 12 - 20 ppt (Starke 2011), 15 - 25 ppt (Mann 2004). As can be seen throughout the entire bay, overall low salinity is a likely restriction on overall oyster population health in the area.

Figure 93. Green area indicates bottom salinity over 5 ppt. Yellow areas indicate both bottom and surface salinities over 5 ppt.

Future efforts for oyster repopulation in Escambia Bay should focus on the eastern portion where reefal habitats are still present in higher abundance, and a small population of oysters are currently residing. There is likely some hydrodynamic function of the bay causing freshwater influx to remain in the western portion, creating a salinity regime that demarcates the eastern portion as the only viable area for growth, albeit minimally in the current low salinity regimes. More in depth hydrographic surveys would be key in understanding if this regime fluctuates temporally or even consistently. This data may be key in understanding where the highest salinities in the bay are dominant. Likely restoration areas should include areas devoid of reefal structures but with better salinity conditions, proximal to existing reefal areas in order to maximize larval settlement and continued growth.

It should be noted that unless the current salinity regime can be modified, restoration efforts will likely be hampered by consistent freshwater influx. Future surveys as part of the Habitat Suitability Model (HMS) should consider the possibility of either restoration of natural meandering freshwater flow upstream (i.e. reduction of streamlined freshwater flow due to development along riparian zones), or increased saltwater influx (i.e. additional channel cuts in the PBS system) if prioritization of restoring healthy oyster reefs.
